Report: TAB Report
Function: Test, Adjust, & Balance
Date: 11/06/2025
Completed By: National TAB

PROJECT
01-05-26 QT #1115 GREENVILLE, SC

Project: 01-05-26 QT #1115 GREENVILLE, SC

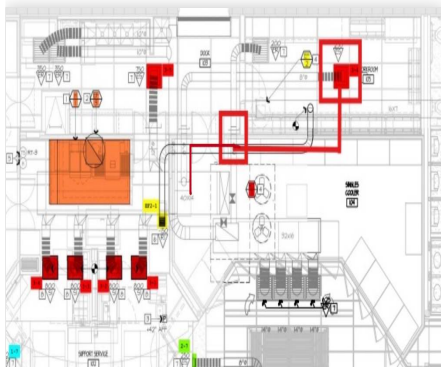
Issue Name : Damper 3-6 Inaccessible
Description : The damper for 3-6 is inaccessible. It is behind a wall in a spot that cannot be reached. Low flow on diffuser.
Created By : National TAB **Assigned To :** National TAB - Dan Hertenstein
Status : Open
Priority : Low **Asset Tag :** SGRD6
Originated Date : 01/05/2026 - Alex Bauer - National TAB

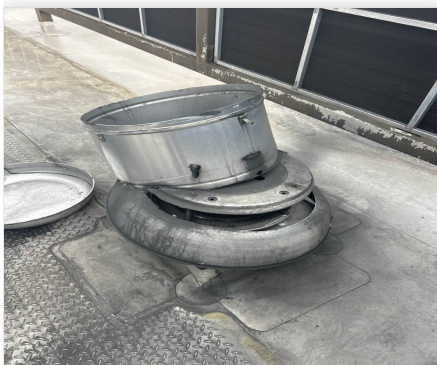
Issue Name : EF-2 Not Operational
Description : EF-2 has stopped operating after the test, adjust, and balance. The balance and building pressure tests were completed prior (on the second day) to the fan operation failing.
Created By : National TAB **Assigned To :** National TAB - Dan Hertenstein
Status : Open
Priority : High **Asset Tag :** EF2
Originated Date : 01/06/2026 - Alex Bauer - National TAB

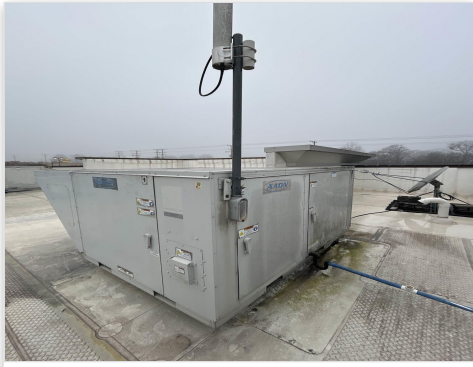
Asset: RT-1

Unit Data	
	Actual
MFG	AAON
Serial Num	201111ANEK05829
Model Num	RN01380EA0A152
Num OA Filters 1	1
OA Filter Size 1	44.5X22.5

Test Data		
	Design	Actual
SF CFM	4200	4091
SF RPM	-	1261
OA CFM (Hoods On)	800	751
OA CFM (Hoods Off)	350	319
RL Voltage	-	142 VFD
RL Amperage	-	8.76 VFD
VFD Max SetPt	-	43 Hz
OA Damper Position (Hoods On)	-	46%
OA Damper Position (Hoods Off)	-	30%

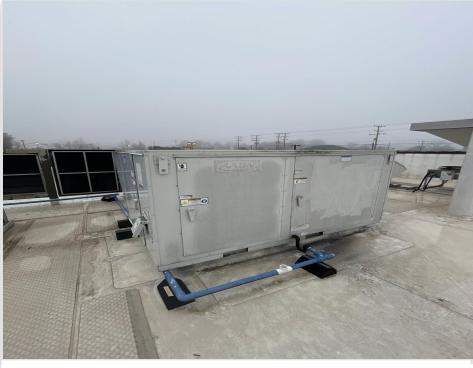
Asset: RT-2

Unit Data	
	Actual
MFG	AAON
Serial Num	201111ANEK05830
Model Num	RN01380EA0A152
Num OA Filters 1	1
OA Filter Size 1	44.5X22.5

Test Data		
	Design	Actual
SF CFM	4200	3867
SF RPM	-	1125
OA CFM (Hoods On)	800	848
OA CFM (Hoods Off)	350	362
RL Voltage	-	113 VFD
RL Amperage	-	7.88 VFD
VFD Max SetPt	-	38.4 Hz
OA Damper Position (Hoods On)	-	46%
OA Damper Position (Hoods Off)	-	36%

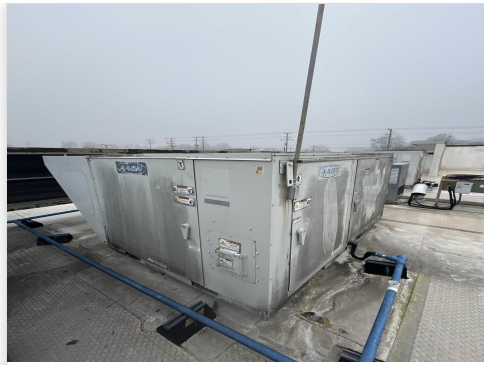
Asset: RT-3

Unit Data	
	Actual
MFG	AAON
Serial Num	201111ANEK05831
Model Num	RN01380EA0A152
Num OA Filters 1	1
OA Filter Size 1	44.5X22.5

Test Data		
	Design	Actual
SF CFM	4200	3792
SF RPM	-	1291
OA CFM (Hoods On)	800	834
OA CFM (Hoods Off)	350	355
RL Voltage	-	149 VFD
RL Amperage	-	9.30 VFD
VFD Max SetPt	-	43 Hz
OA Damper Position (Hoods On)	-	46%
OA Damper Position (Hoods Off)	-	40%

Damper 3-6 inaccessible.

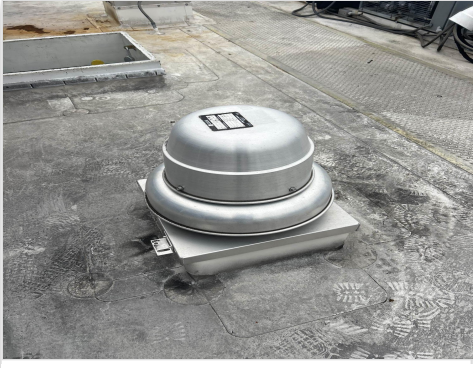
Asset: EF1

Unit Data		
	Design	Actual
MFG	NA	COOK
Model Num	NA	90 ACEH
Serial Num	-	418SD83622
Type	-	UPBLAST
Configuration	-	VERTICAL

Test Data		
	Design	Actual
CFM	225	219
Fan RPM	-	DD
Fan Rotation	-	CCW
Motor RPM	-	DD
System SetPt	-	MAX ON DAIL
RL Voltage	-	NA
RL Amperage	-	NA
Total ESP	-	0.21"
Fan Inlet SP	-	-0.21"
Fan Discharge SP	-	ATMO

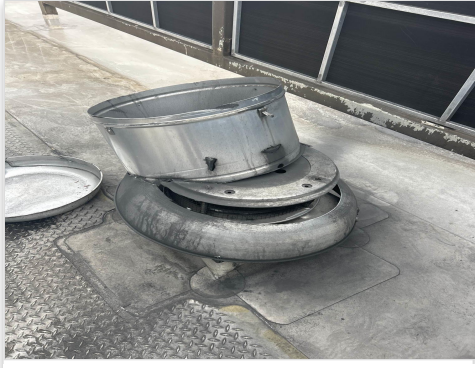
Asset: EF2

Unit Data		
	Design	Actual
MFG	NA	COOK
Model Num	NA	120 ACE
Serial Num	-	418SD83623
Type	-	UPBLAST
Configuration	-	VERTICAL

Test Data		
	Design	Actual
CFM	525	530
Fan RPM	-	DD
Fan Rotation	-	CCW
Motor RPM	-	DD
System SetPt	-	MAX ON DAIL
RL Voltage	-	115
RL Amperage	-	2.36
Total ESP	-	0.18"
Fan Inlet SP	-	-0.18"
Fan Discharge SP	-	ATMO

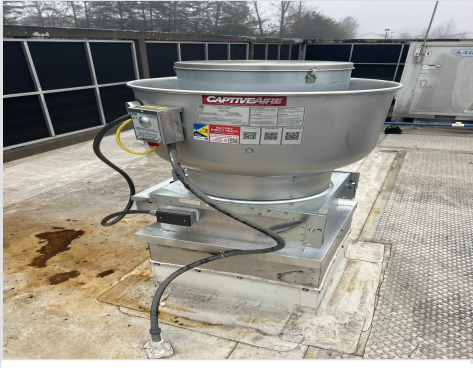
Asset: EF3

Unit Data		
	Design	Actual
MFG	NA	CAPTIVEAIRE
Model Num	NA	DU50HFA
Serial Num	-	7644856
Type	UPBLAST	UPBLAST
Configuration	VERTICAL	VERTICAL

Test Data		
	Design	Actual
CFM	1350	1435
Fan RPM	-	1582
Fan Rotation	-	CCW
Motor RPM	-	1582
System SetPt	-	68.8 Hz
RL Voltage	-	NA
RL Amperage	-	NA
Total ESP	-	0.37"
Fan Inlet SP	-	-0.37"
Fan Discharge SP	-	ATMO

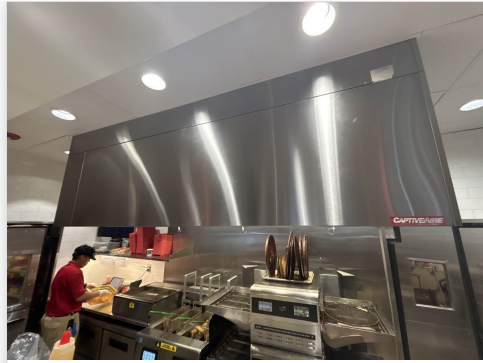
Asset: HD1

Unit Data		
	Design	Actual
MFG	CAPTIVEAIRE	CAPTIVEAIRE
Model Num	6030ND-2-F	6030ND-2-F
Job / Serial Num	-	7644856
Type	-	TYPE I CANOPY
Hood length	-	121
Hood Width	-	60

Test Data Exhaust		
	Design	Actual
Filter Type	-	CAPTRATE
Filter Size 1	-	16X20
Filter Qty 1	-	6
Filter AK factor size 1	-	2.08
Filter Total AK Area	-	12.48
Filter1 FPM	-	109
Filter2 FPM	-	120
Filter3 FPM	-	125
Filter4 FPM	-	122
Filter5 FPM	-	105
Filter6 FPM	-	112
Filter Ave FPM(corr)	-	115
CFM	1350	1435
