**Report: TAB REPORT
Function: Test, Adjust, & Balance
Date: 12/02/2022**

PROJECT
11-28 CHIPOTLE #10-4314 LAGRANGE, GA
(LAGRANGE)
1509 LAFAYETTE PARKWAY
LAGRANGE, GA 30240

Project: 11-28 CHIPOTLE #10-4314 LAGRANGE, GA (LAGRANGE)

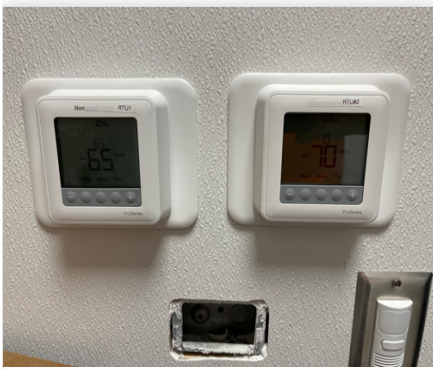
Issue Name : GRIDPOINT THERMOSTATS

Description : GRIDPOINT THERMOSTAT & SENSORS ARE NOT INSTALLED

Do actual net building airflow, design net building airflow, and pressure coincide? If not why? (All three should either be positive or negative)	YES
Thermostats are programmed? (If Lightstats put "N/A")	NO / GRIDPOINT NOT INSTALLED
