**National TAB
1329 E. KEMPER ROAD
SUITE 4210
CINCINNATI, OH 45246**

**Report: TAB REPORT
Function: Test, Adjust, & Balance
Date: 12/02/2022**

**PROJECT
11-28 CHIPOTLE #10-4314 LAGRANGE, GA
(LAGRANGE)**

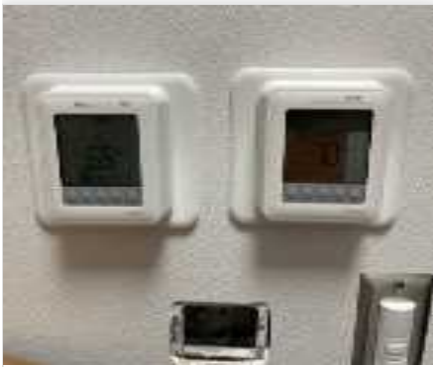
stats.jpg

Issue Name : GRIDPOINT THERMOSTATS

Description : GRIDPOINT THERMOSTAT & SENSORS ARE NOT INSTALLED

Do actual net building airflow, design net building airflow, and pressure coincide? If not why? (All three should either be positive or negative)	YES
Thermostats are programmed? (If Lightstats put "N/A")	NO / GRIDPOINT NOT INSTALLED

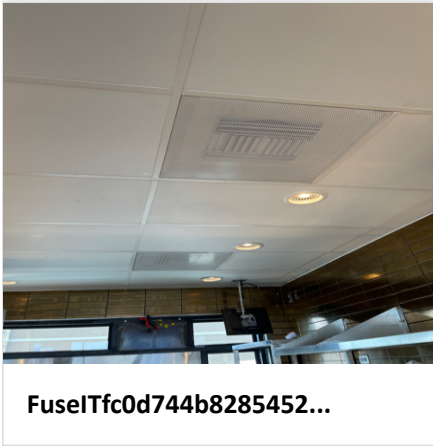
Issue Name : RTU1 / EXTRA SUPPLY GRILL

Description : AN EXTRA SUPPLY GRILL WAS INSTALLED IN THE DRIVE THROUGH AREA THAT WAS NOT CALLED FOR ON PRINTS. THE AMOUNT OF AIR THAT IS DESIGNED FOR THIS SPACE 550CFM WAS DIVIDED BETWEEN THE TWO GRILLS. THIS IS A NON-CRITICAL ISSUE.

All diffusers and grilles are installed and match design?	NO / RTU1 ONE DIFFUSER WAS ADDED IN THE DRIVE THROUGH AREA THAT IS NOT SHOWN ON PLANS. THE TOTAL AMOUNT OF AIR FOR THAT AREA "550 CFM" WAS DIVIDED BETWEEN BOTH GRILLS.
Deflector plates are removed from 1x1 diffusers on the serve line (double check that this is specified on the diffuser schedule first)	YES
All hood filters installed and accounted for?	YES
Hoods are wired and have power?	YES
Hood is free of alarms?	YES
Thermostats have power?	YES / BUT GRIDPOINT IS NOT INSTALLED AT THIS TIME
Have trades/general contractor been notified about any issues and are they created on FaciliBuild?	YES

Notes: AN EXTRA DIFFUSER WAS ADDED IN THE DRIVE THROUGH AREA THAT IS NOT SHOWN ON PLANS. THE TOTAL AMOUNT OF AIR FOR THAT AREA "550 CFM" WAS DIVIDED BETWEEN BOTH GRILLS.
