**National TAB  
1329 E. KEMPER ROAD  
SUITE 4210  
CINCINNATI, OH 45246**

**Report: TAB REPORT  
Function: Test, Adjust, & Balance  
Date: 12/02/2022**

**PROJECT  
11-28 CHIPOTLE #10-4314 LAGRANGE, GA  
(LAGRANGE)**

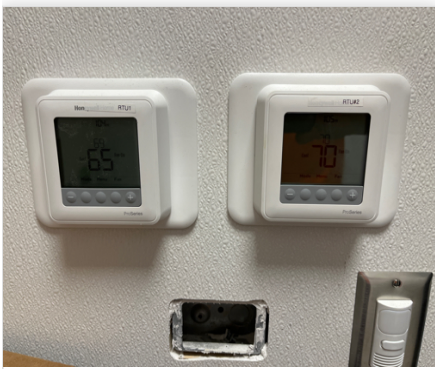
**Issue Name :** GRIDPOINT THERMOSTATS

**Description :** GRIDPOINT THERMOSTAT & SENSORS ARE NOT INSTALLED

Do actual net building airflow, design net building airflow, and pressure coincide? If not why? (All three should either be positive or negative)	YES
Thermostats are programmed? (If Lightstats put "N/A")	NO / GRIDPOINT NOT INSTALLED

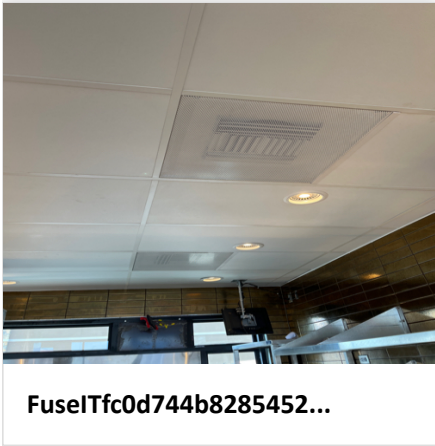
**Issue Name :** RTU1 / EXTRA SUPPLY GRILL

**Description :** AN EXTRA SUPPLY GRILL WAS INSTALLED IN THE DRIVE THROUGH AREA THAT WAS NOT CALLED FOR ON PRINTS. THE AMOUNT OF AIR THAT IS DESIGNED FOR THIS SPACE 550CFM WAS DIVIDED BETWEEN THE TWO GRILLS. THIS IS A NON-CRITICAL ISSUE.

All diffusers and grilles are installed and match design?	NO / RTU1 ONE DIFFUSER WAS ADDED IN THE DRIVE THROUGH AREA THAT IS NOT SHOWN ON PLANS. THE TOTAL AMOUNT OF AIR FOR THAT AREA "550 CFM" WAS DIVIDED BETWEEN BOTH GRILLS.
Deflector plates are removed from 1x1 diffusers on the serve line (double check that this is specified on the diffuser schedule first)	YES
All hood filters installed and accounted for?	YES
Hoods are wired and have power?	YES
Hood is free of alarms?	YES
Thermostats have power?	YES / BUT GRIDPOINT IS NOT INSTALLED AT THIS TIME
Have trades/general contractor been notified about any issues and are they created on FaciliBuild?	YES

Notes: AN EXTRA DIFFUSER WAS ADDED IN THE DRIVE THROUGH AREA THAT IS NOT SHOWN ON PLANS. THE TOTAL AMOUNT OF AIR FOR THAT AREA "550 CFM" WAS DIVIDED BETWEEN BOTH GRILLS.
