**National TAB
1329 E. KEMPER ROAD
SUITE 4210
CINCINNATI, OH 45246**

**Report: TAB REPORT
Function: Test, Adjust, & Balance
Date: 12/02/2022**

**PROJECT
11-28 CHIPOTLE #10-4314 LAGRANGE, GA
(LAGRANGE)**

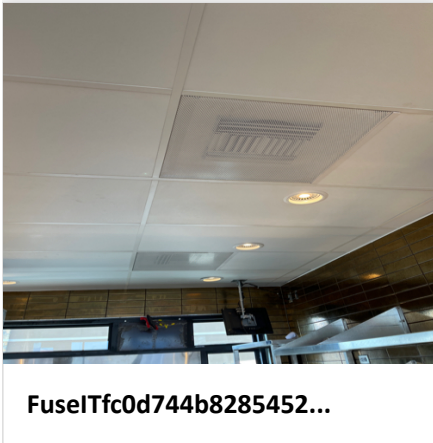
Issue Name : RTU1 / EXTRA SUPPLY GRILL

Description : AN EXTRA SUPPLY GRILL WAS INSTALLED IN THE DRIVE THROUGH AREA THAT WAS NOT CALLED FOR ON PRINTS. THE AMOUNT OF AIR THAT IS DESIGNED FOR THIS SPACE 550CFM WAS DIVIDED BETWEEN THE TWO GRILLS. THIS IS A NON-CRITICAL ISSUE.

All diffusers and grilles are installed and match design?	NO / RTU1 ONE DIFFUSER WAS ADDED IN THE DRIVE THROUGH AREA THAT IS NOT SHOWN ON PLANS. THE TOTAL AMOUNT OF AIR FOR THAT AREA "550 CFM" WAS DIVIDED BETWEEN BOTH GRILLS.
Deflector plates are removed from 1x1 diffusers on the serve line (double check that this is specified on the diffuser schedule first)	YES
All hood filters installed and accounted for?	YES
Hoods are wired and have power?	YES
Hood is free of alarms?	YES
Thermostats have power?	YES / BUT GRIDPOINT IS NOT INSTALLED AT THIS TIME
Have trades/general contractor been notified about any issues and are they created on FaciliBuild?	YES

Notes: AN EXTRA DIFFUSER WAS ADDED IN THE DRIVE THROUGH AREA THAT IS NOT SHOWN ON PLANS. THE TOTAL AMOUNT OF AIR FOR THAT AREA "550 CFM" WAS DIVIDED BETWEEN BOTH GRILLS.
