Report: 1547 TAB REPORT
Function: Test, Adjust, & Balance
Date: 07/24/2025
Completed By: National TAB

PROJECT
07-21-25 WHATABURGER #1547 DULUTH,
GA

Project: 07-21-25 WHATABURGER #1547 DULUTH, GA

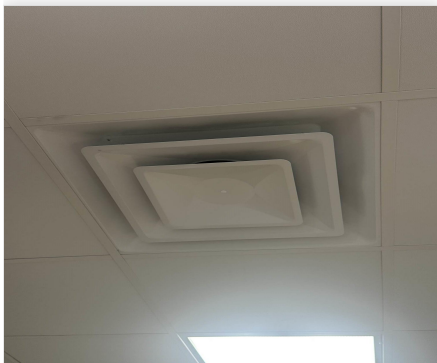
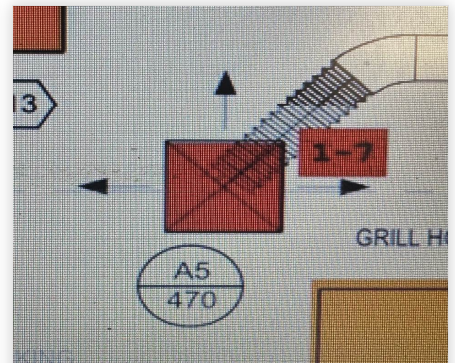
Issue Name : DIFFUSER 1-7 IS THE WRONG TYPE
Description : The diffuser serving over hood one is supposed to blow in three directions, with the side blowing to the hood blocked off. The installed diffuser is unable to achieve that. The diffuser should be A5, but A4 was installed.
Created By : National TAB **Assigned To :** National TAB - Ben Searles
Status : Open
Priority : Medium **Asset Tag :**
Originated Date : 07/24/2025 - Ben Searles - National TAB

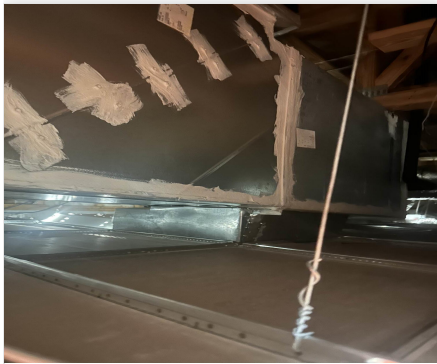
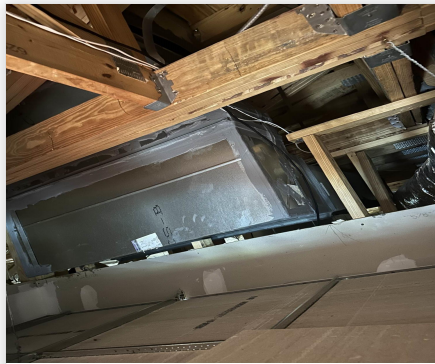
Issue Name : DUCTWORK INSULATION
Description : The supply and return drops for both RTUs are not externally insulated. The return duct is also not internally insulated, and the technician was unable to verify if the supply was internally insulated either.
Created By : National TAB **Assigned To :** National TAB - Ben Searles
Status : Open
Priority : Medium **Asset Tag :**
Originated Date : 07/24/2025 - Ben Searles - National TAB

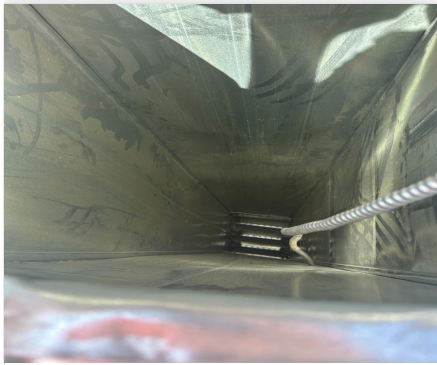
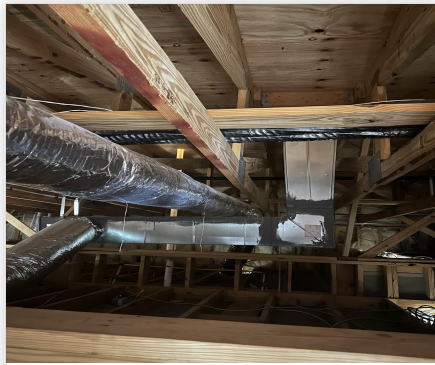
Issue Name : EF INSULATION
Description : The restroom fan's ductwork is not internally or externally insulated.
Created By : National TAB **Assigned To :** National TAB - Ben Searles
Status : Open
Priority : Medium **Asset Tag :**
Originated Date : 07/24/2025 - Ben Searles - National TAB

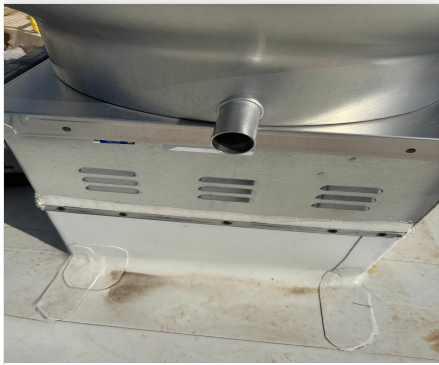
Issue Name : KEF GREASE TRAPS
Description : The grease traps for both kitchen exhaust fans are not installed.
Created By : National TAB **Assigned To :** National TAB - Ben Searles
Status : Open
Priority : Medium **Asset Tag :**
Originated Date : 07/24/2025 - Ben Searles - National TAB

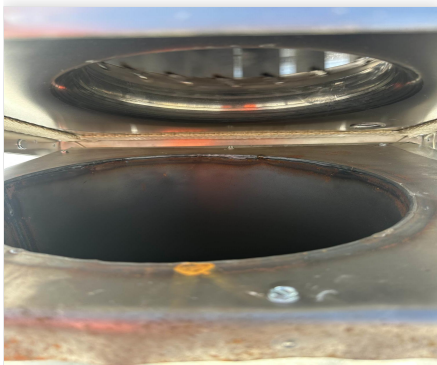
Issue Name : KEF2 GREASE DUCT
Description : The grease duct does not align with the intake of KEF2. This discrepancy did not appear to affect the balance, as the technician was able to achieve the design airflow while staying below FLA.
Created By : National TAB **Assigned To :** National TAB - Ben Searles
Status : Open
Priority : Medium **Asset Tag :**
Originated Date : 07/24/2025 - Ben Searles - National TAB

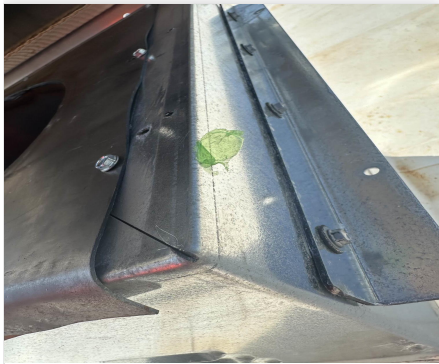
Issue Name : KEF2 NEEDS FIRE CAULKING
Description : The grease duct for KEF2 is not centered with the curb, causing the duct to end short on one side, with a lip under the fan itself. This lip can fill with grease and could become a major fire hazard.
Created By : National TAB **Assigned To :** National TAB - Ben Searles
Status : Open
Priority : Urgent **Asset Tag :**
Originated Date : 07/24/2025 - Ben Searles - National TAB

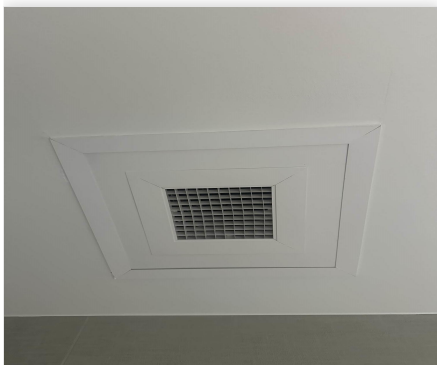
Issue Name : RESTROOM RETURNS ARE THE WRONG SIZE
Description : The restroom return grilles are 6X6 instead of the 12X12 that is called for in the schedule. The EF has been balanced with the 6X6 returns. Seek ME's approval for the size difference on the grilles. If the ME says the grilles will need to be 12X12, the fan may need to be rebalanced.
Created By : National TAB **Assigned To :** National TAB - Ben Searles
Status : Open
Priority : Low **Asset Tag :**
Originated Date : 07/24/2025 - Ben Searles - National TAB

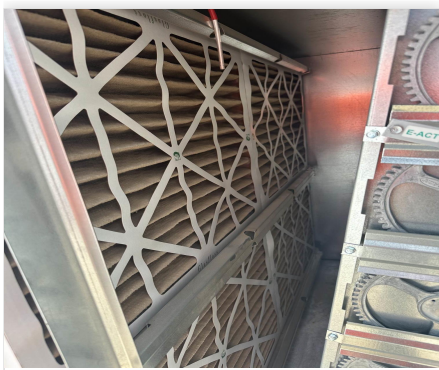
Issue Name : RTU FILTERS ARE DIRTY
Description : At the time of inspection, both RTUs had dirty filters that will need to be replaced.
Created By : National TAB **Assigned To :** National TAB - Ben Searles
Status : Open
Priority : Medium **Asset Tag :**
Originated Date : 07/24/2025 - Ben Searles - National TAB

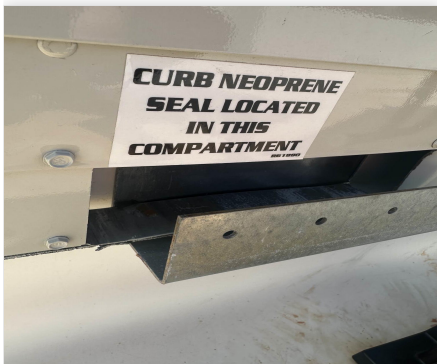
Issue Name : SEISMIC CLIPS
Description : The seismic clips are fastened to the curb, but are not attached to either RTU.
Created By : National TAB **Assigned To :** National TAB - Ben Searles
Status : Open
Priority : High **Asset Tag :**
Originated Date : 07/24/2025 - Ben Searles - National TAB

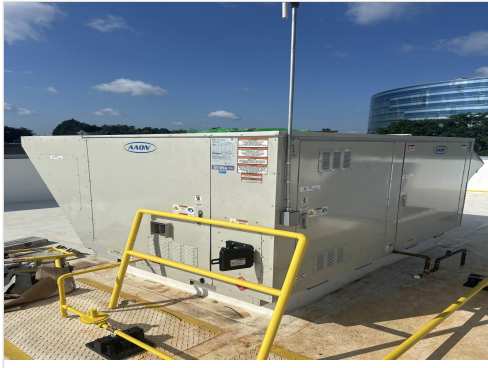
Asset: RTU1

Unit Data		
	Design	Actual
MFG	AAON	AAON
Serial Num	-	202503-BNGP121645
Model Num	RNA-020-C-A-8-BAB04-CB1L0	RNA-020-C-A-8-BAB04-CB1L0
Num OA Filters 1	-	3
OA Filter Size 1	-	18.25X22
Num Final Filter 1	-	6
Final Filter Size 1	-	20X25X2

General	
	Actual
Unit free of Damage	YES
Fan Rotation Correct	YES
Unit Filters Clean	NO
Condensate Drain Installed	YES

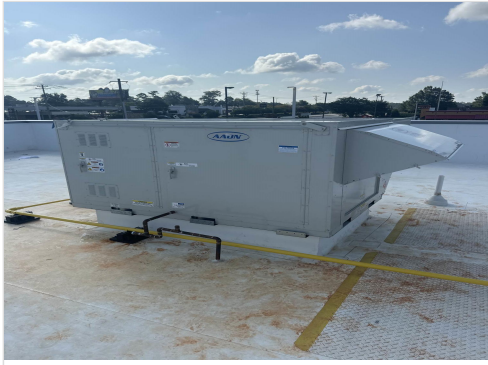
Asset: RTU2

Unit Data		
	Design	Actual
MFG	AAON	AAON
Serial Num	-	202503-BNGZ121632
Model Num	RN-011-8-0-GB04-3F9	RN-011-8-0-GB04-3F9
Num OA Filters 1	-	2
OA Filter Size 1	-	17X23.25
Num Final Filter 1	-	4
Final Filter Size 1	-	20X25X2

General	
	Actual
Unit free of Damage	YES
Fan Rotation Correct	YES
Unit Filters Clean	NO
Condensate Drain Installed	YES

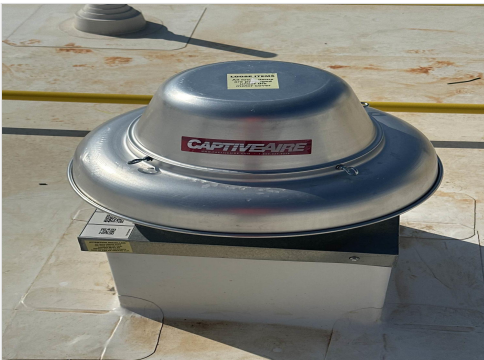
Asset: EF1

Unit Data		
	Design	Actual
MFG	GREENHECK	CAPTIVEAIRE
Model Num	G-080-VG	DR12HFA
Serial Num	-	7328416
Type	DOWNBLAST	DOWNBLAST
Configuration	VERTICAL	VERTICAL

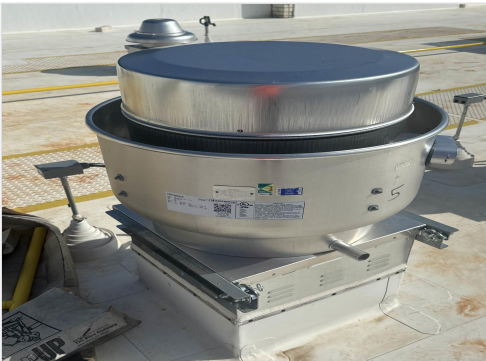
Asset: KEF1

Unit Data		
	Design	Actual
MFG	GREENHECK	GREENHECK
Model Num	CUE-140-VG	CUE-140-VG
Serial Num	-	26525693
Type	UPBLAST	UPBLAST
Configuration	VERTICAL	VERTICAL

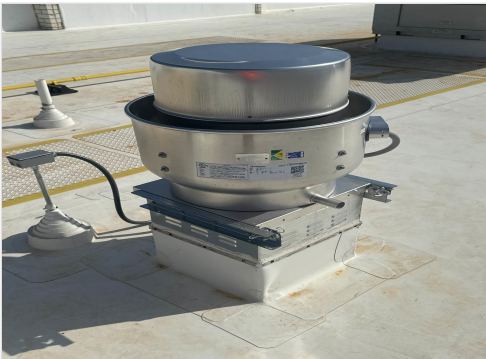
Asset: KEF2

Unit Data		
	Design	Actual
MFG	GREENHECK	GREENHECK
Model Num	CUE-120-VG	CUE-120-VG
Serial Num	-	26525695
Type	UPBLAST	UPBLAST
Configuration	VERTICAL	VERTICAL

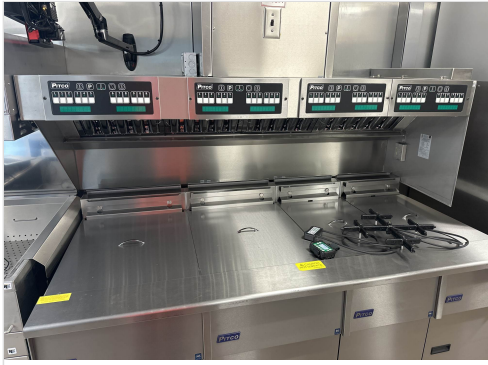
Asset: HD1

Unit Data		
	Design	Actual
MFG	H&K	H&K
Model Num	MH16346	HKD023
Job / Serial Num	-	8157811-001
Type	TYPE I	TYPE I LOW PROXIMITY
Hood length	73"	73"
Hood Width	22"	26"

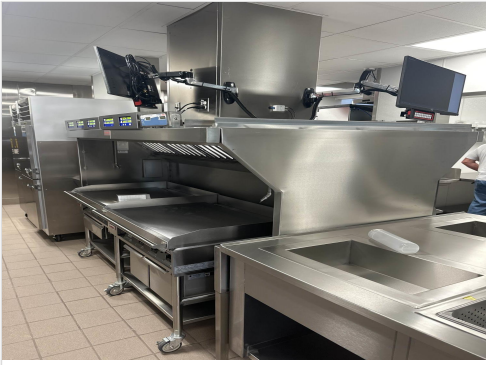
Asset: HD2

Cooking Equipment	
	Actual
Item 1	GRILL
