Report: TAB Report
Function: Test, Adjust, & Balance
Date: 11/17/2025
Completed By: National TAB

**11-10-25 CHIPOTLE #5584 GEORGETOWN,
KY**

Project: 11-10-25 CHIPOTLE #5584 GEORGETOWN, KY

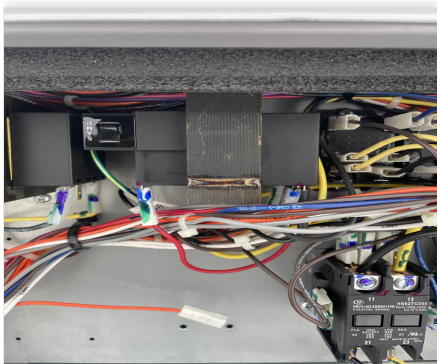
Project Issue File Details

Issue Name : RTU-2 Occupancy / Functionality
Description : RTU-2 controller will not display as occupied, despite thermostat being programmed for occupancy. Attempted to install a jumper to force fan on, fan does not engage and internal breaker trips @ unit. Unable to measure building pressure with unit on, and unit not running is causing negative building pressure. Recommend MC inspect low voltage wiring.

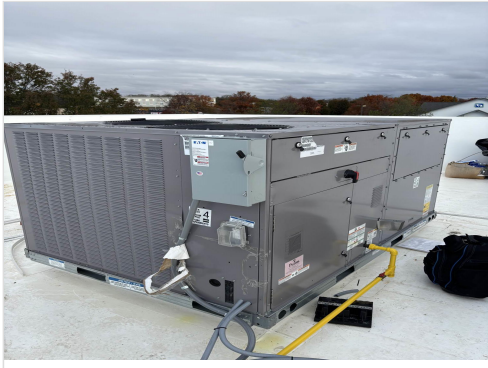
Unit Data - PHOTO LOG

Unit Data		
	Design	Actual
MFG	CARRIER	CARRIER
Serial Num	-	2223P62120
Model Num	48FC_M11	48FC_M11
Type	RTU	RTU
Configuration	VERTICAL	VERTICAL
Num OA Filters 1	-	1
OA Filter Size 1	-	35"x19"
Num Final Filter 1	-	4
Final Filter Size 1	-	20"x20"x2"

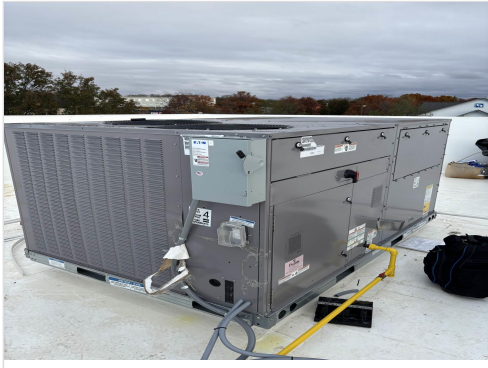
Unit Data - PHOTO LOG

Unit Data		
	Design	Actual
MFG	CARRIER	CARRIER
Serial Num	-	2023P60542
Model Num	48FC_M11	48FC_M11
Type	RTU	RTU
Configuration	VERTICAL	VERTICAL
Num OA Filters 1	-	1
OA Filter Size 1	-	35"x19"
Num Final Filter 1	-	4
Final Filter Size 1	-	20"x20"x2"
Num Final Filter 2	-	
Final Filter Size 2	-

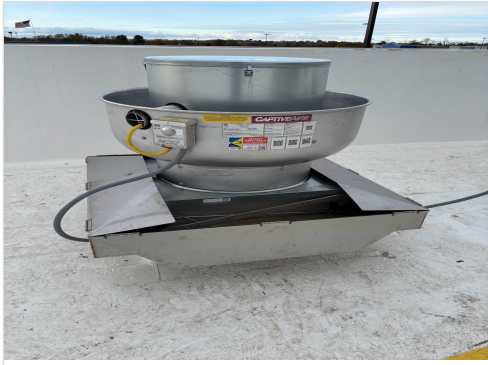
Unit Data - PHOTO LOG

Unit Data		
	Design	Actual
MFG	CAPTIVEAIRE	CAPTIVEAIRE
Model Num	DU180HFA	DU180HFA
Serial Num	-	7501877
Type	UPBLAST	UPBLAST
Configuration	VERTICAL	VERTICAL

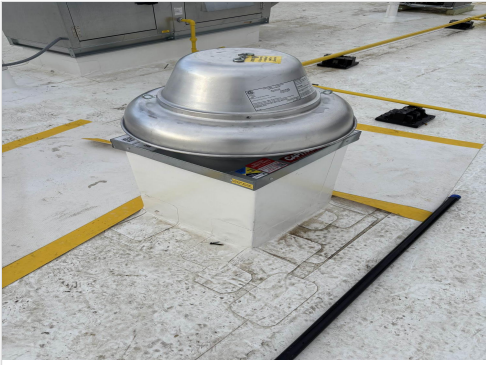
Unit Data - PHOTO LOG

Unit Data		
	Design	Actual
MFG	CAPTIVEAIRE	CAPTIVEAIRE
Model Num	DR12HFA	DR12HFA
Serial Num	-	7501877
Type	DOWNBLAST	DOWNBLAST
Configuration	VERTICAL	VERTICAL

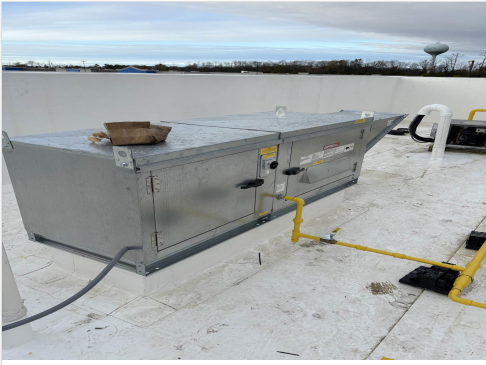
Unit Data - PHOTO LOG

Unit Data		
	Design	Actual
MFG	CAPTIVEAIRE	CAPTIVEAIRE
Model Num	A1-D.250-15D	A1-D.250-15D
Serial Num	-	7501877
Type	MAU	MAU
Configuration	VERTICAL	VERTICAL
