**National TAB  
1329 E. KEMPER ROAD  
SUITE 4210  
CINCINNATI, OH 45246**

**Report: TAB REPORT  
Function: Test, Adjust, & Balance  
Date: 12/07/2022**

**PROJECT  
12-05 FREDDY'S WILLIAMSBURG, VA**

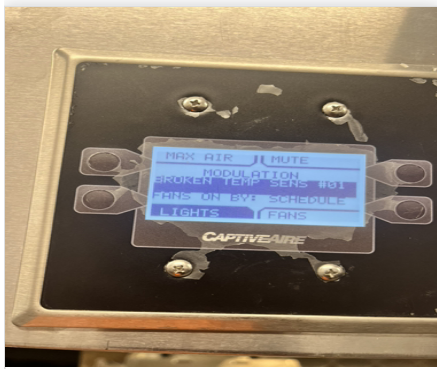
FuseITf597c87225fa48....

**Issue Name :** Hood alarm "Broken Temp sensor"  
**Description :** The hood displayed a " BROKEN TEMP SENS #01" alarm.  
**Created By :** National TAB **Assigned To :** National TAB - Will Turnbough  
**Status :** Open  
**Originated Date :** 12/07/2022 - David Annan - National TAB

- **12/07/2022 National TAB - Will Turnbough**
  - Did not affect ability to complete TAB. Recommend contacting Captive Aire.

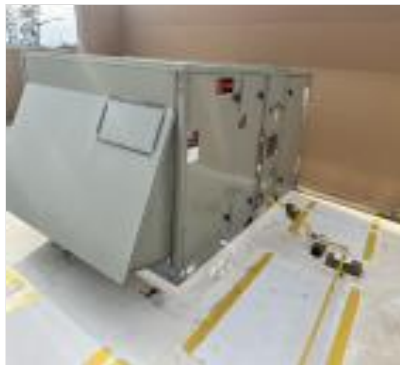
RTU-1

Test Data		
	Design	Actual
SF CFM	5000	4890
SF RPM	-	642
RA CFM	4128	4011
OA CFM	872	879
RL Voltage	-	212/211/210
RL Amperage	-	9.1/9.3/8.9
SF Rotation	-	CW
RA Damper Position	-	Marked
Min OA Damper Position	-	Marked
Min OA Damper Type	-	SBD
OA Enthalpy Setpt	-	"E"

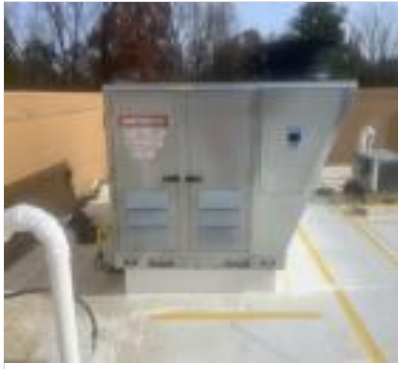
DOAS-1

Test Data		
	Design	Actual
SF CFM	2900	2827
SF RPM	1105	1077
RA CFM	0	0
OA CFM	2900	2827
RL Voltage	-	212/213/212
RL Amperage	-	5.8 "VFD"
SF Rotation	-	CW
RA Damper Position	-	0%
Min OA Damper Position	-	100%
Min OA Damper Type	-	OBD

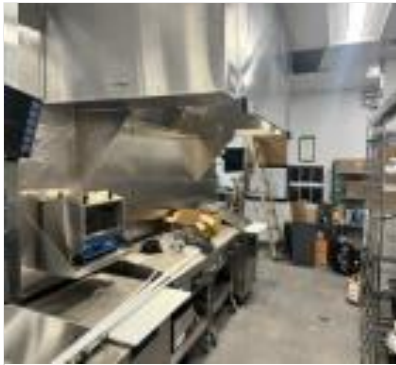
HOOD-1

Test Data Exhaust		
	Design	Actual
<b>Filter Type</b>	CAPTRATE SOLO	Captrate Solo
<b>Filter Size 1</b>	16X16	16X16
<b>Filter Qty 1</b>	5	5
<b>Filter AK factor size 1</b>	1.62	1.62
<b>Filter Total AK Area</b>	8.1	8.1
<b>Filter1 FPM</b>	-	-196
<b>Filter2 FPM</b>	-	-210
<b>Filter3 FPM</b>	-	-205
<b>Filter4 FPM</b>	-	-198
<b>Filter5 FPM</b>	-	-190
<b>Filter Ave FPM(corr)</b>	-	-200
<b>CFM</b>	1600	1620

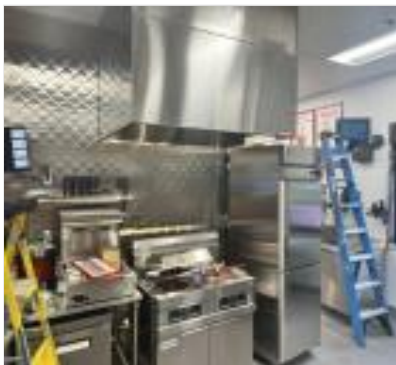
HOOD-2

Test Data Exhaust		
	Design	Actual
Filter Type	CAPTRATE SOLO	Captrate Solo
Filter Size 1	16X16	16X16
Filter Qty 1	3	3
Filter AK factor size 1	1.62	1.62
Filter Total AK Area	4.86	4.86
Filter1 FPM	-	-169
Filter2 FPM	-	-159
Filter3 FPM	-	-162
Filter Ave FPM(corr)	-	-163
CFM	775	792
