**Report: TAB REPORT  
Function: Test, Adjust, & Balance  
Date: 12/07/2022**

**PROJECT  
12-05 FREDDY'S WILLIAMSBURG, VA  
NEED**

Project: 12-05 FREDDY'S WILLIAMSBURG, VA

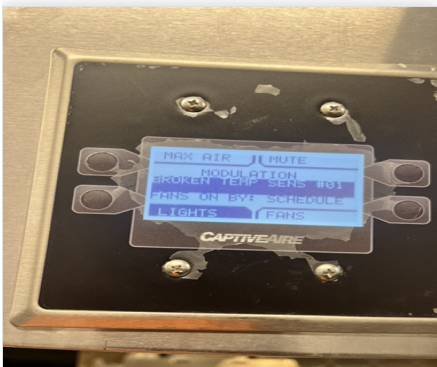
FuselTf597c87225fa48....

**Issue Name :** Hood alarm “Broken Temp sensor”  
**Description :** The hood displayed a “ BROKEN TEMP SENS #01” alarm.  
**Created By :** National TAB **Assigned To :** National TAB - Will Turnbough  
**Status :** Open  
**Originated Date :** 12/07/2022 - David Annan - National TAB

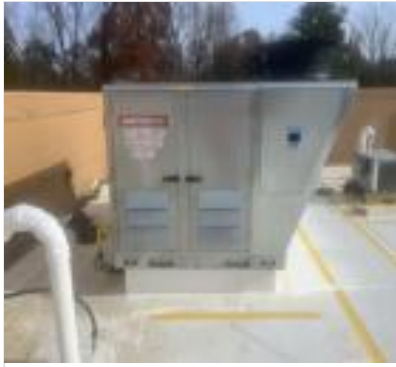
DOAS-1

Notes: There is no proper location to get fan suction on the DOAS unit.
