**Report: Test and Balance**

**Date: 10/16/2018**

**PROJECT**  
**FREDDY'S - EL DORADO, KS (EL DORADO)**

1809 W CENTRAL  
EL DORADO, KS

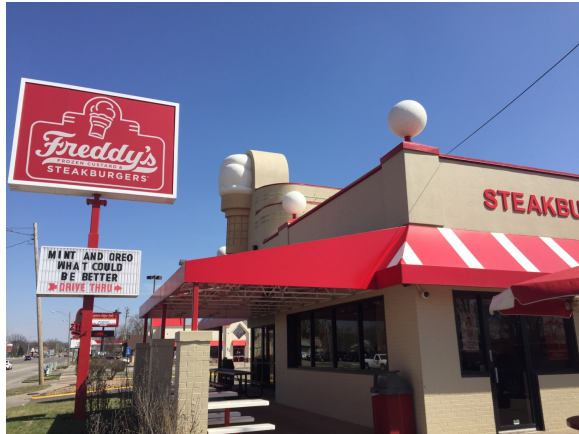
RTU 1

Notes: Starting rpm 849. This is a 10 ton unit running with the sheave maximized.

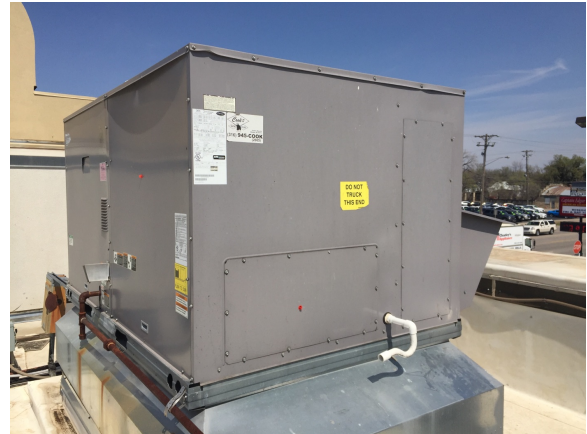
RTU 2 manual damper. EF 1 bad belt needs replacment. EF 2 missing grease cup EF 1 and EF 2 are Running in SFA. The MUA is not a heated unit.

Notes: Starting rpm 846. This is a 10 ton unit running with the sheave maximized.

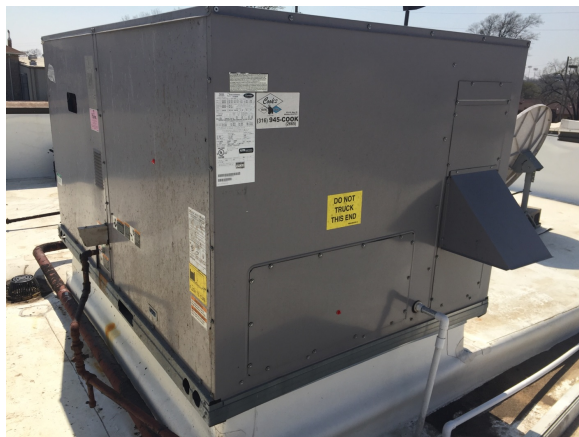
EF1

- Notes:
- Wiring inside Curb
  - Belt badly needs replaced
  - Grease cup missing
  - There is not a safe wiring access to get voltage and amperage readings.

Recommendation (Clean/Repair/Replace/Info)	
Repair	EF 1 has a bad belt and needs to be replaced.
Repair	EF 2 is missing the grease cup.
Repair	EF 4 is not running. There is no power to the motor.
Info	The hoods are under performing and smoke is rolling out the front. To improve hood capture, National TAB will turn off the MAU. We will also reduce the supply air around the hood. This will make the localized space negative and improve hood capture.
Info	The RTUs are low on airflow due to restrictions at the curb transition. The size of the transition is not large enough to have the required amount of return air. National TAB will investigate if the transition can be modified during the next Renew cycle with food service. So, we can be above the ceiling during unoccupied hours.

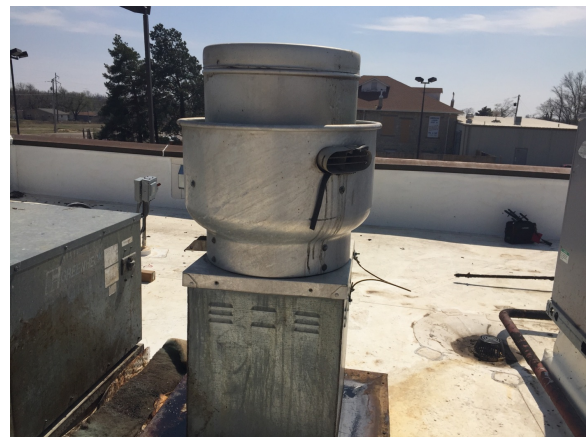
EF 2

Notes: Wiring inside Curb  
Fan is running in SFA

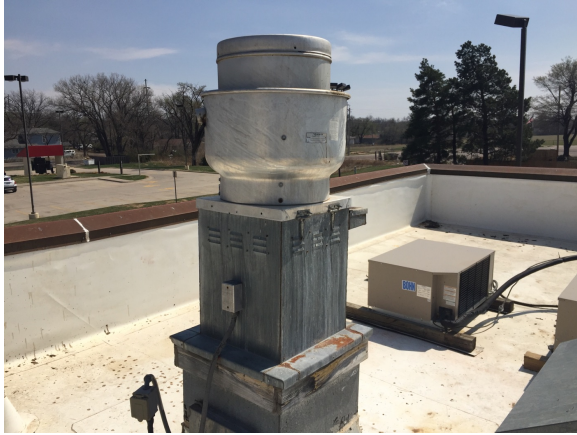
MUA

Notes: Belt needs replacement  
 Sheave is minimized motor is running in SFA.  
 Found shut off at disconnect.  
 Intake size: (2) 13.75 x 23 4.39

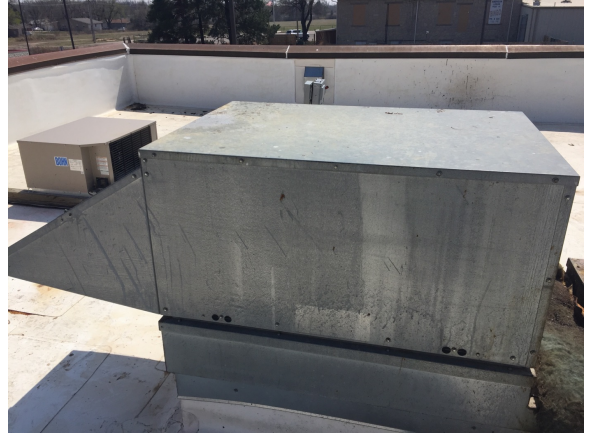
Hood 1

Notes: The smoke is only partially captured when it is held over the front of the griddle. The associated fan performance is weak due to the age and condition of the fan. Please see summary for more details.

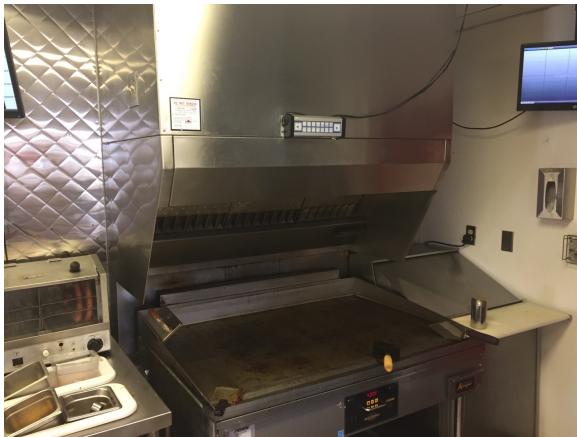
Hood 2

The hood is rolling out at the front of the hood. The associated fan performance is weak due to the age and condition of the fan. Please see summary for more details.

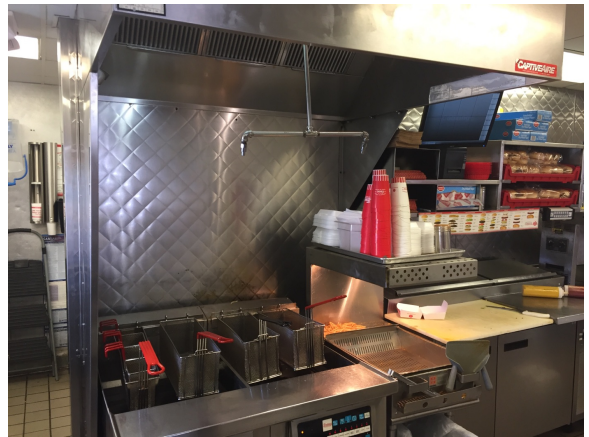
Kitchen Diffusers

The hood capture is a major issue. The first issue is the age and condition of the associated exhaust fans. Both fans are maximized, and EF 2 running in FLA. EF 1 amperage could not be tested because there are wiring access and safety issues. I was not able to get these readings. There are three diffusers on the cookline in front of the hoods. Two of these diffusers are 4-way diffusers that need to be replaced with perforated return diffusers to eliminate cross drafting issues. One diffuser is a perforated supply diffuser it is also recommended to replace it.

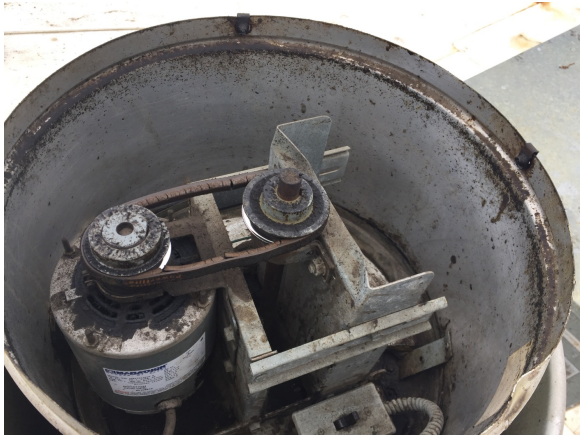
EF 4 (Not Running)

EF 4 was not operational to be measured with a flow hood.

Notes: Fan is not running. There is no power to the motor. This fan does not appear to be operational and the motor housing is covered in cobwebs.
