**Report: TAB Report**  
**Function: Test, Adjust, & Balance**  
**Date: 10/23/2025**  
**Completed By: National TAB**

**PROJECT**  
**02-02-26 QT #1447 LAVEEN, AZ**

QUIKTRIP  
4705 SOUTH 129TH EAST AVENUE  
TULSA, OK 74134

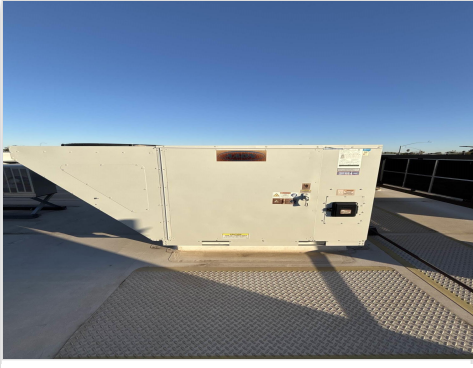
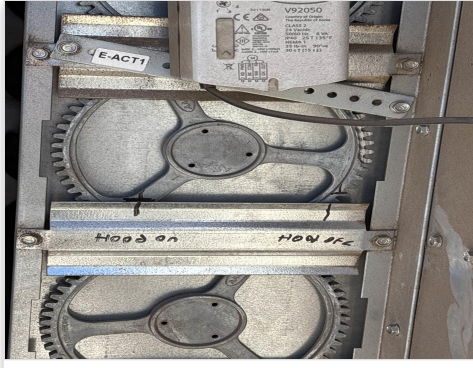
# Unit Data - PHOTO LOG

Asset: RT-1

AREA:SALES FLOOR

Unit Data	
	Actual
MFG	AAON
Serial Num	202304-ANEK27172
Model Num	RN-013-8-0-HA0A-152
Num OA Filters 1	1
OA Filter Size 1	45X22
Num Final Filter 1	2
Final Filter Size 1	44X20

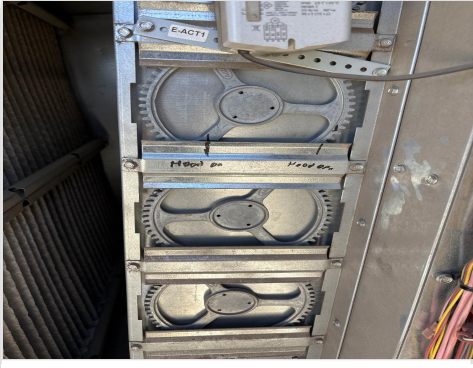
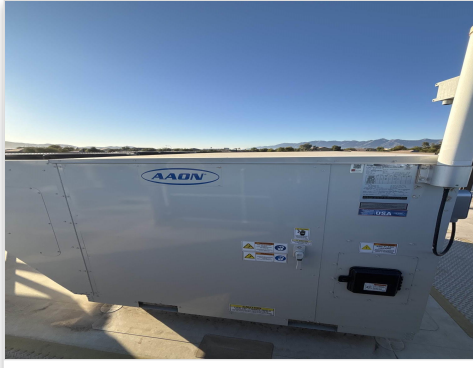
**Unit Data - PHOTO LOG**

Asset: RT-2

AREA:SALES FLOOR

Unit Data	
	Actual
MFG	AAON
Serial Num	202304-ANEK27171
Model Num	RN-013-8-0-HA0A-152
Num OA Filters 1	1
OA Filter Size 1	45X22
Num Final Filter 1	2
Final Filter Size 1	20X44

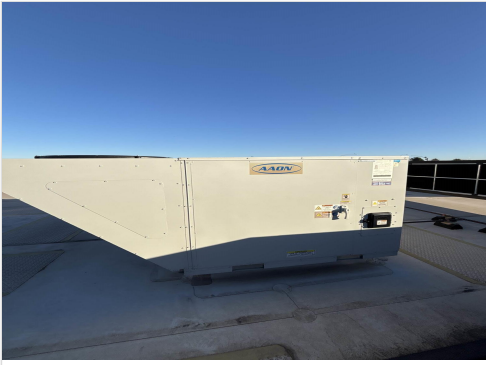
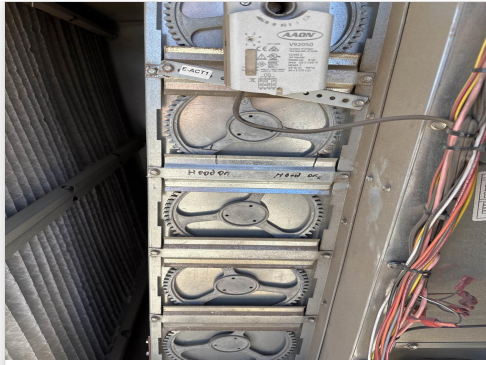
## Unit Data - PHOTO LOG

Asset: RT-3

AREA:BOH/KITCHEN

Unit Data	
	Actual
MFG	AAON
Serial Num	202304-ANEK27170
Model Num	RN-013-8-0-HA0A-152
Num OA Filters 1	1
OA Filter Size 1	45X22
Num Final Filter 1	2
Final Filter Size 1	44X20

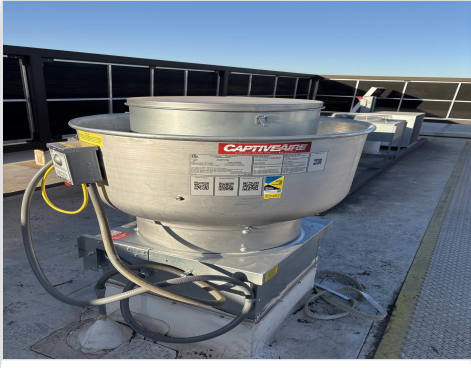
## Unit Data - PHOTO LOG

Asset: EF3

AREA:KITCHEN HD

Actual
MFG	CAPTIVEAIRE
Model Num	DU50HFA
Serial Num	8257480
Type	UPBLAST
Configuration	VERTICAL

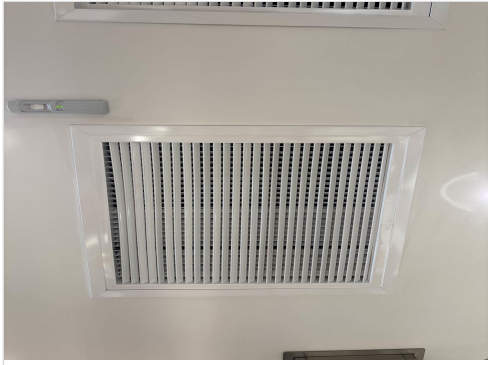
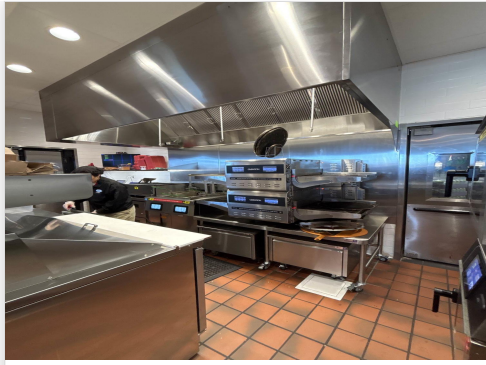
**Unit Data - PHOTO LOG**

Asset: HD1

AREA:GRIDDLE

Unit Data	
	Actual
MFG	CAPTIVEAIRE
Model Num	6030ND-2-F
Job / Serial Num	8257480
Type	TYPE I CANOPY
Hood length	108"
Hood Width	60"
