**Report: TAB Report**  
**Function: Test, Adjust, & Balance**  
**Date: 02/20/2026**  
**Completed By: National TAB**

**PROJECT**  
**02-02-26 QT #1447 LAVEEN, AZ**

Project: 02-02-26 QT #1447 LAVEEN, AZ

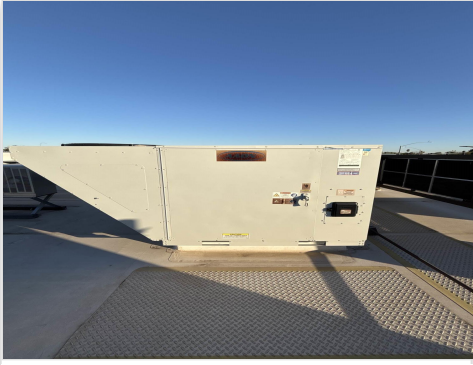
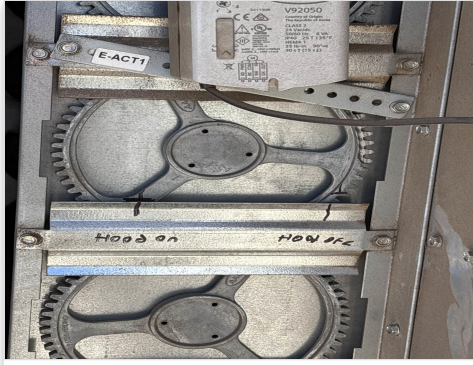
# Unit Data - PHOTO LOG

Asset: RT-1

Unit Data	
	Actual
MFG	AAON
Serial Num	202304-ANEK27172
Model Num	RN-013-8-0-HA0A-152
Num OA Filters 1	1
OA Filter Size 1	45X22
Num Final Filter 1	2
Final Filter Size 1	44X20

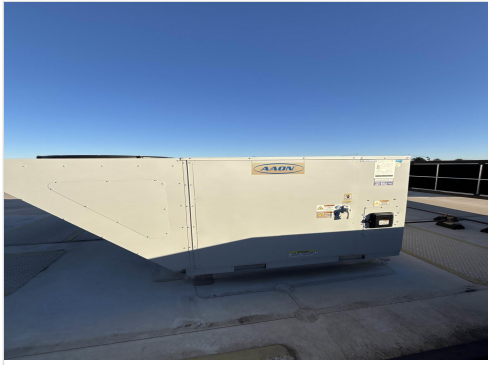
## Unit Data - PHOTO LOG

Asset: RT-3

Unit Data	
	Actual
MFG	AAON
Serial Num	202304-ANEK27170
Model Num	RN-013-8-0-HA0A-152
Num OA Filters 1	1
OA Filter Size 1	45X22
Num Final Filter 1	2
Final Filter Size 1	44X20
