Report: TAB Report
Function: Test, Adjust, & Balance
Date: 12/05/2025
Completed By: National TAB

PROJECT
12-15-25 QT #1405 GILBERT, AZ

Project: 12-15-25 QT #1405 GILBERT, AZ

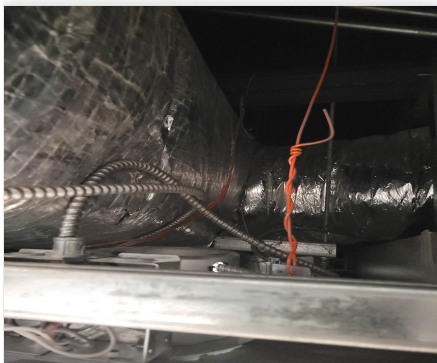
Issue Name : RTU-3 DAMPERS INACCESSIBLE
Description : Dampers are inaccessible. Cannot be properly balanced. Recommend waiting to install kitchen tiles until balance is completed or making them more accessible.
Created By : National TAB **Assigned To :** National TAB - Dan Hertenstein
Status : Open
Priority : High **Asset Tag :** RT-3
Originated Date : 12/17/2025 - Christine Weale - National TAB

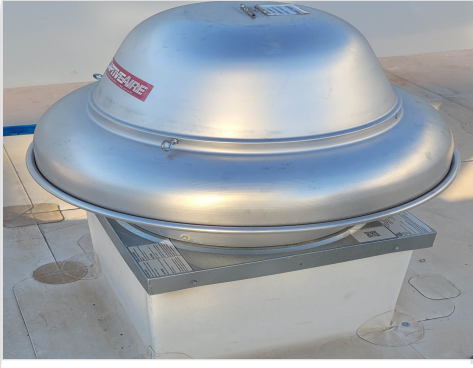
Unit Data - PHOTO LOG

Unit Data		
	Design	Actual
MFG	NA	CAPTIVEAIRE
Model Num	NA	DR50HFA
Serial Num	-	6783229
Type	-	DOWNBLAST
Configuration	-	VERTICAL

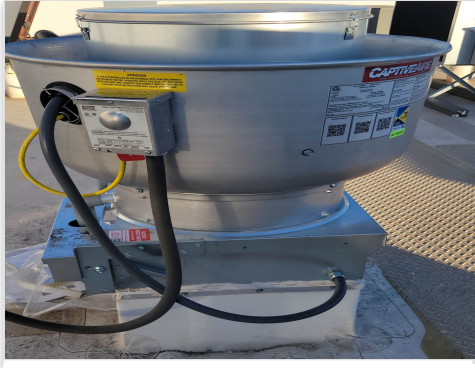
Unit Data - PHOTO LOG

Unit Data		
	Design	Actual
MFG	NA	CAPTIVEAIRE
Model Num	NA	DU50HFA
Serial Num	-	7660158
Type	UPBLAST	UPBLAST
Configuration	VERTICAL	VERTICAL

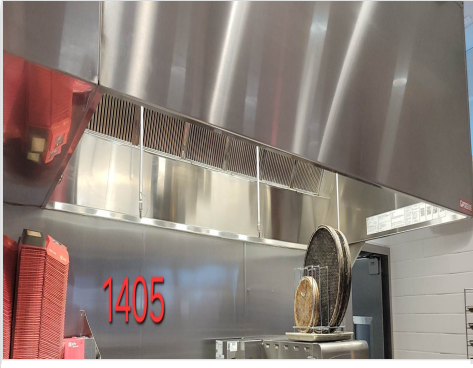
Unit Data - PHOTO LOG

Design	Actual
MFG	CAPTIVEAIRE	CAPTIVEAIRE
Model Num	6030ND-2-F	6030ND-2-F
Job / Serial Num	-	7660158
Type	-	TYPE I CANOPY
Hood length	-	108"
Hood Width	-	60"
