Report: TAB Report
Function: Test, Adjust, & Balance
Date: 10/02/2025
Completed By: National TAB

PROJECT
09-29-25 WAWA #6609 STAUNTON, VA

Project: 09-29-25 WAWA #6609 STAUNTON, VA

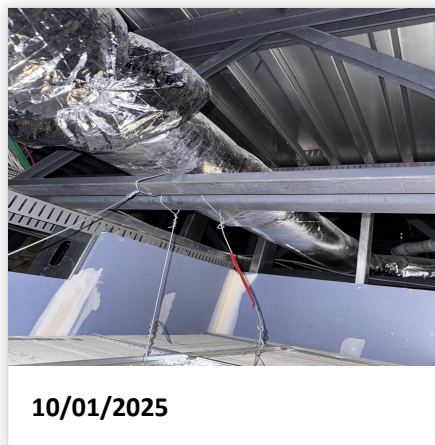
Issue Name : EF2 duct sizing is incorrect
Description : The mechanical plans calls for EF2's ductwork to be 8X8in square duct, while the actual duct is 8in diameter round duct. As a result airflow is 331 CFM out of design of 400 CFM (83% of design). Unable to increase airflow further. Duct should be installed per design.
Created By : National TAB **Assigned To :** National TAB - Ryan Ash
Status : Open
Priority : Medium **Asset Tag :** EF2
Originated Date : 10/01/2025 - Ryan Ash - National TAB

EF2 is below design airflow due to incorrect duct size. The mechanical plans call for 8X8in square duct, but 8in diameter circular duct is installed instead. This reduction in flow area caused the increase in static pressure and less than desired air flow.

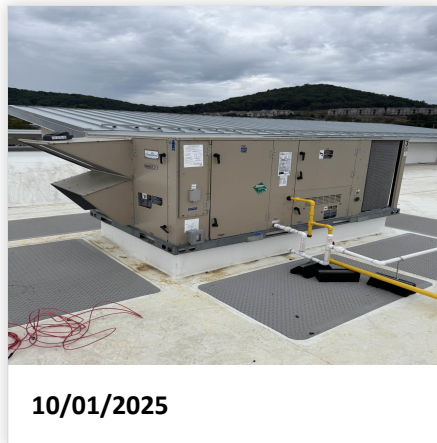
Issue Name : RTU-2 Heating not operational
Description : Heating mode failed for this unit and it was flashing alarm 55. Mechanical contractor needs to service the unit.
Created By : National TAB **Assigned To :** National TAB - Ryan Ash
Status : Open
Priority : High **Asset Tag :** RTU2
Originated Date : 10/01/2025 - Ryan Ash - National TAB

RTU-2 has an Alarm 55 Strike 3 Heat 1 S15 Limit or rollout

RTU-1 NA RTU-2 FAIL: Alarm 55, See Issue RTU-3 EAT:68F/LAT:91F

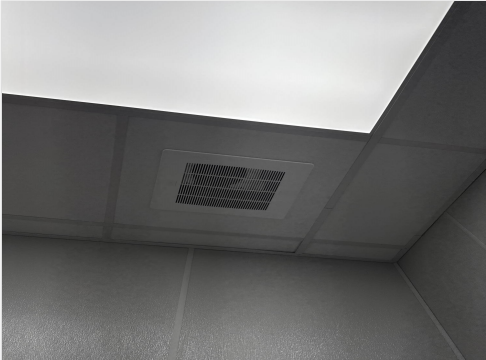
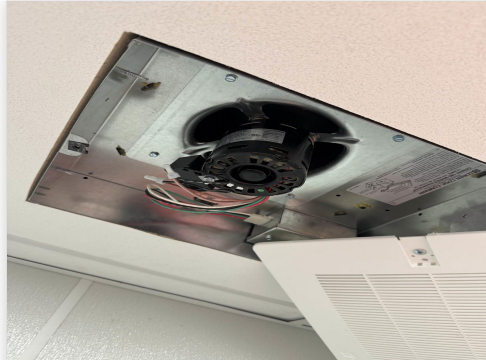
Unit Data - PHOTO LOG

EF3 is technically above design (225 CFM out of 200 CFM), however, it is wired for the lowest possible speed.
