Report: TAB Report
Function: Test, Adjust, & Balance
Date: 10/02/2025
Completed By: National TAB

PROJECT
09-29-25 WAWA #6609 STAUNTON, VA

Project: 09-29-25 WAWA #6609 STAUNTON, VA

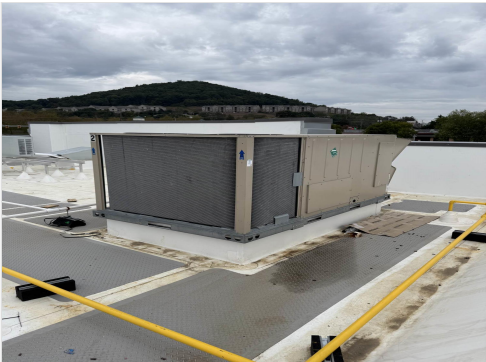
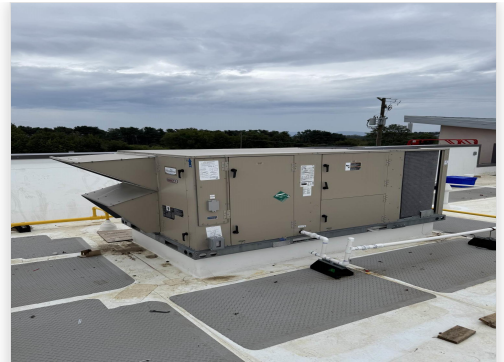
Unit Data - PHOTO LOG

Asset: RTU1

Unit Data		
	Design	Actual
MFG	LENNOX	LENNOX
Serial Num	-	5624L06117
Model Num	LCT150H4E	LCT150H4E
Type	RTU	RTU
Configuration	VERTICAL	VERTICAL
Num OA Filters 1	-	2
OA Filter Size 1	-	14X23
Num Final Filter 1	-	4
Final Filter Size 1	-	20X25X2

Test Data		
	Design	Actual
SF CFM	4500	4556
SF RPM	-	1371
MOTOR RPM	-	1371
RA CFM	3800	3795
OA CFM	700	761
RL Voltage	-	210.3/212.1/213.2
RL Amperage	-	3.8/3.8/3.8
SF System SetPt	-	77%
RA Damper Position	-	MECHANICAL LINKAGE
RA Damper Type	-	MECHANICAL LINKAGE
OA Damper Position	-	26%
OA Damper Type	-	ECONOMIZER

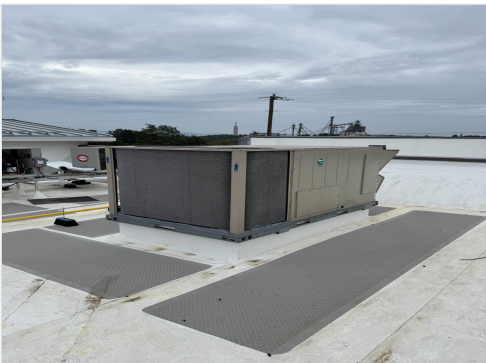
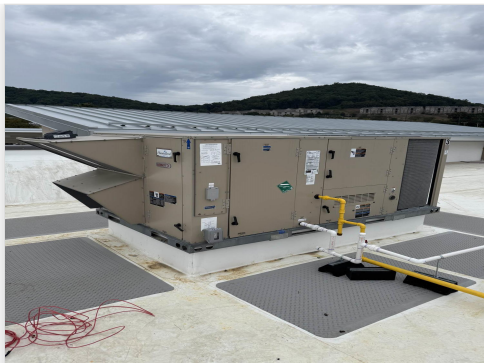
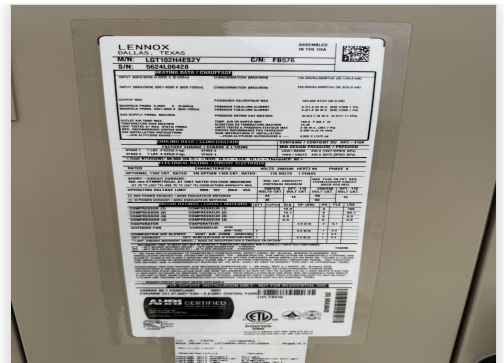
Unit Data - PHOTO LOG

RTU-2 has an Alarm 55 Strike 3 Heat 1 S15 Limit or rollout

RTU-1 NA RTU-2 FAIL: Alarm 55, See Issue RTU-3 EAT:68F/LAT:91F

Asset: RTU2

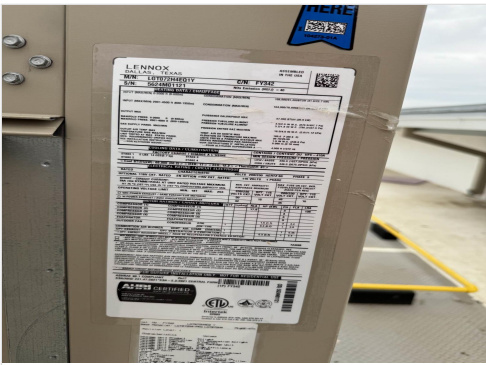
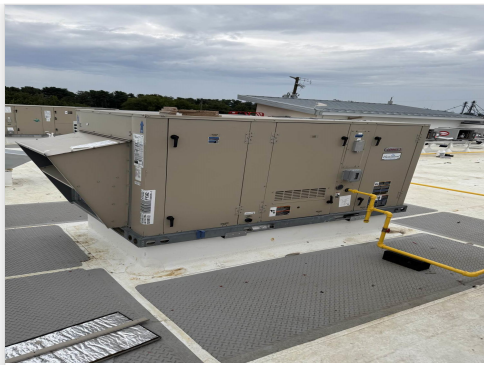
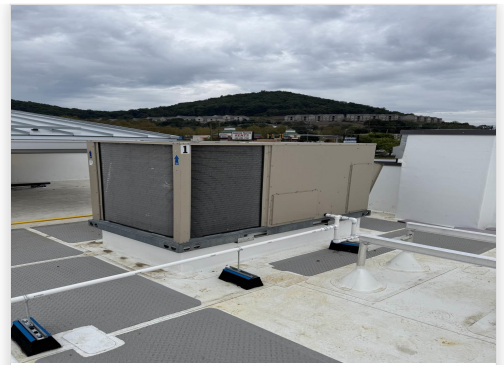
Unit Data - PHOTO LOG

Asset: RTU3

Test Data		
	Design	Actual
SF CFM	2400	2443
SF RPM	-	2937
MOTOR RPM	-	2937
RA CFM	2200	2228
OA CFM	200	215
RL Voltage	-	209.0/210.4/211.2
RL Amperage	-	3.2/3.2/3.1
SF System SetPt	-	89%
RA Damper Position	-	MECHANICAL LINKAGE
RA Damper Type	-	MECHANICAL LINKAGE
OA Damper Position	-	20%
OA Damper Type	-	ECONOMIZER

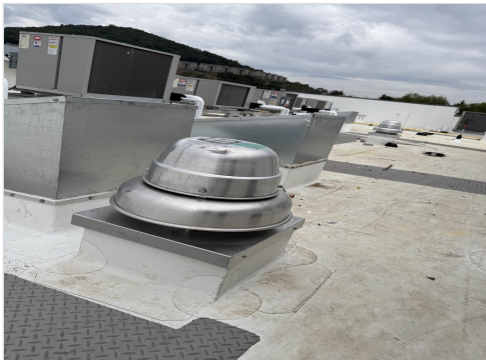
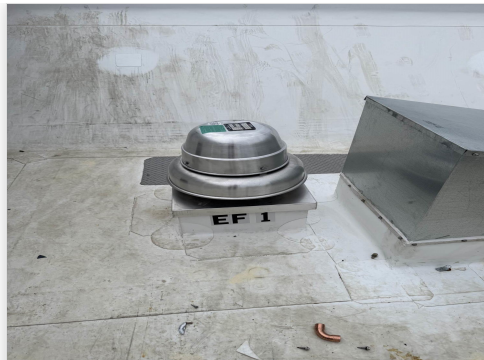
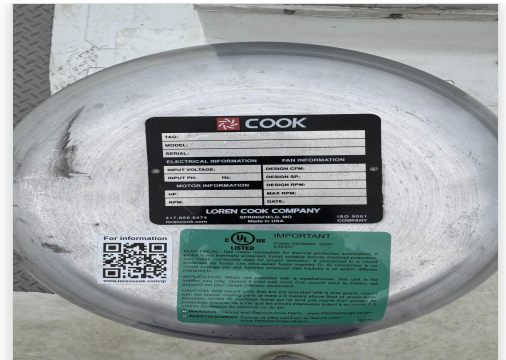
Unit Data - PHOTO LOG

Asset: EF1

Test Data		
	Design	Actual
CFM	375	377
Fan RPM	-	NA
Fan Rotation	-	CCW
Motor RPM	-	NA
System SetPt	-	33%
RL Voltage	-	NA
RL Amperage	-	NA
Total ESP	0.38"	0.20"
Fan Inlet SP	-	-0.20"
Fan Discharge SP	-	ATM

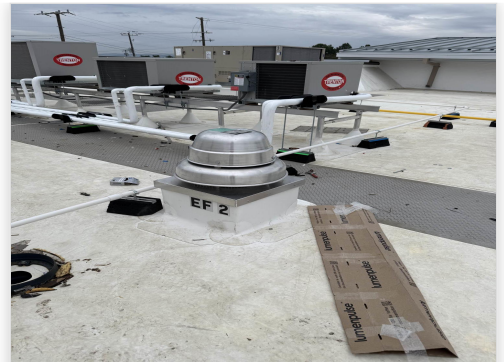
Unit Data - PHOTO LOG

Test Data		
	Design	Actual
CFM	400	331
Fan RPM	-	NA
Fan Rotation	-	CCW
Motor RPM	-	NA
System SetPt	-	100%
RL Voltage	-	NA
RL Amperage	-	NA
Total ESP	0.38"	0.48"
Fan Inlet SP	-	-0.48"
Fan Discharge SP	-	ATM

EF2 is below design airflow due to incorrect duct size. The mechanical plans call for 8X8in square duct, but 8in diameter circular duct is installed instead. This reduction in flow area caused the increase in static pressure and less than desired air flow.

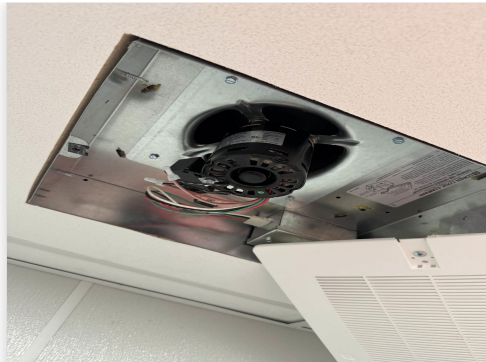
Unit Data - PHOTO LOG

EF3 is technically above design (225 CFM out of 200 CFM), however, it is wired for the lowest possible speed.
