Report: TAB Report
Function: Test, Adjust, & Balance
Date: 10/02/2025
Completed By: National TAB

PROJECT
09-29-25 WAWA #6609 STAUNTON, VA

Project: 09-29-25 WAWA #6609 STAUNTON, VA

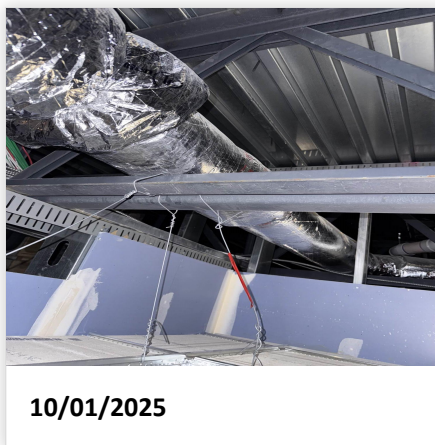
Issue Name : EF2 duct sizing is incorrect
Description : The mechanical plans calls for EF2's ductwork to be 8X8in square duct, while the actual duct is 8in diameter round duct. This reduction in flow area caused the exhaust fan to not meet CFM requirements and exceed static pressure expectations.
Created By : National TAB **Assigned To :** National TAB - Ryan Ash
Status : Open
Priority : InfoOnly **Asset Tag :**
Originated Date : 10/01/2025 - Ryan Ash - National TAB

EF2 is below design airflow due to incorrect duct size. The mechanical plans call for 8X8in square duct, but 8in diameter circular duct is installed instead. This reduction in flow area caused the increase in static pressure and less than desired air flow.

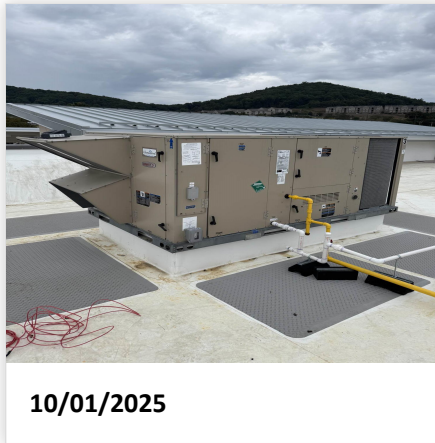
Issue Name : RTU-2 Alarm 55
Description : When setting up the RTU, Alarm 55 presented itself when the unit was in heating mode, this caused heating mode to fail. Recommend that the Mechanical or a Lennox technician sees to service it.
Created By : National TAB **Assigned To :** National TAB - Ryan Ash
Status : Open
Priority : Urgent **Asset Tag :**
Originated Date : 10/01/2025 - Ryan Ash - National TAB

RTU-2 has an Alarm 55 Strike 3 Heat 1 S15 Limit or rollout

RTU-1 NA RTU-2 FAIL: Alarm 55, See Issue RTU-3 EAT:68F/LAT:91F

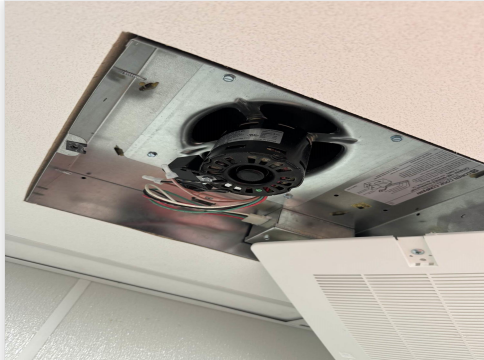
EF3 is technically above design (225 CFM out of 200 CFM), however, it is wired for the lowest possible speed.
