**Report: TAB Report**  
**Function: Test, Adjust, & Balance**  
**Date: 10/02/2025**  
**Completed By: National TAB**

**PROJECT**  
**09-29-25 WAWA #6609 STAUNTON, VA**

1031 RICHMOND AVENUE

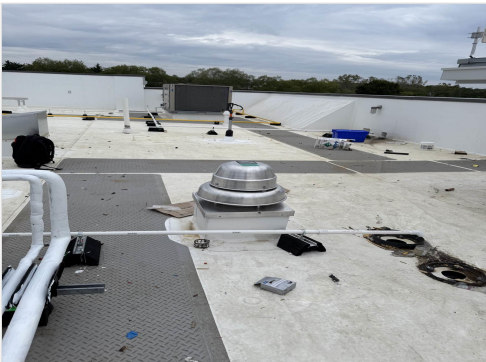
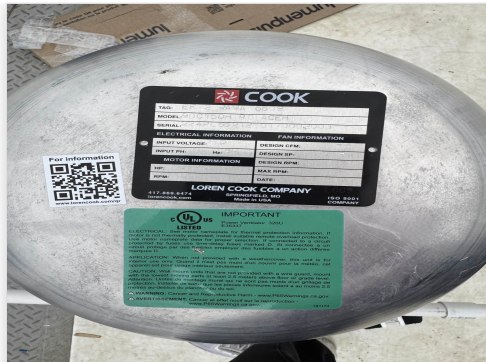
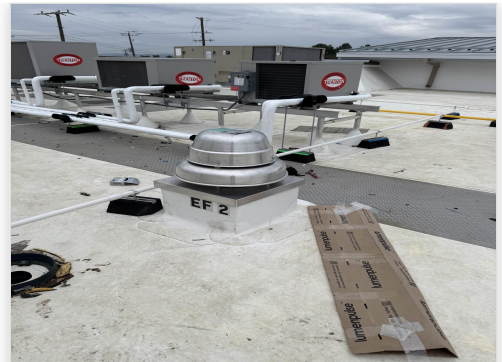
Asset: EF2

EF2 is below design airflow due to incorrect duct size. The mechanical plans call for 8X8in square duct, but 8in diameter circular duct is installed instead. This reduction in flow area caused the increase in static pressure and less than desired air flow.

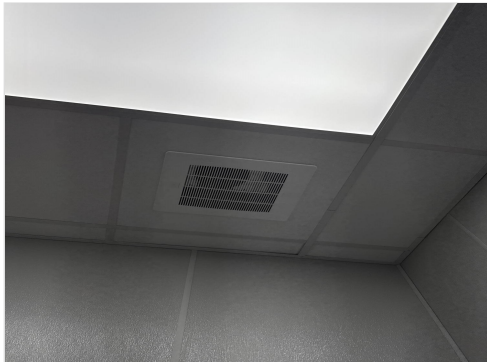
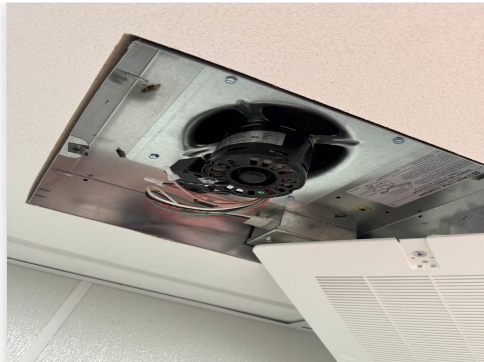
Asset: EF3

EF3 is technically above design (225 CFM out of 200 CFM), however, it is wired for the lowest possible speed.

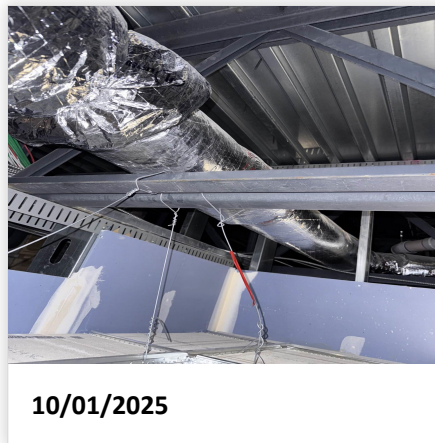
**Issue Name :** EF2 duct sizing is incorrect  
**Description :** The mechanical plans calls for EF2's ductwork to be 8X8in square duct, while the actual duct is 8in diameter round duct. This reduction in flow area caused the exhaust fan to not meet CFM requirements and exceed static pressure expectations.  
**Created By :** National TAB                      **Assigned To :** National TAB - Ryan Ash  
**Status :** Open  
**Priority :** InfoOnly                                      **Asset Tag :**  
**Originated Date :** 10/01/2025 - Ryan Ash - National TAB

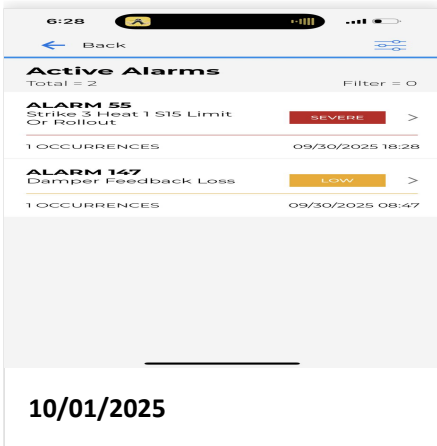
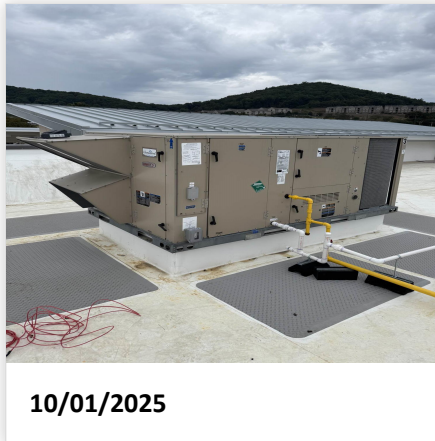
RTU-2 has an Alarm 55 Strike 3 Heat 1 S15 Limit or rollout

RTU-1 NA RTU-2 FAIL: Alarm 55, See Issue RTU-3 EAT:68F/LAT:91F

**Issue Name :** RTU-2 Alarm 55  
**Description :** When setting up the RTU, Alarm 55 presented itself when the unit was in heating mode, this caused heating mode to fail. Recommend that the Mechanical or a Lennox technician sees to service it.  
**Created By :** National TAB                      **Assigned To :** National TAB - Ryan Ash  
**Status :** Open  
**Priority :** Urgent                                      **Asset Tag :**  
**Originated Date :** 10/01/2025 - Ryan Ash - National TAB
