Report: TAB Report
Function: Test, Adjust, & Balance
Date: 03/04/2026
Completed By: National TAB

PROJECT
03-23-26 QT #0448 PHOENIX, AZ

9910 W CAMELBACK RD

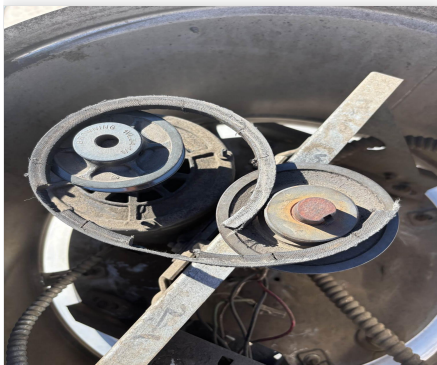
Issue Name : EF-1 Restroom Belt Broken
Description : The Belt for EF-1 is broken couldn't balance
Created By : National TAB **Assigned To :** National TAB - Dan Hertenstein
Status : Open
Priority : Urgent **Asset Tag :** EF-1
Originated Date : 03/24/2026 - Ethan Van Orden - National TAB

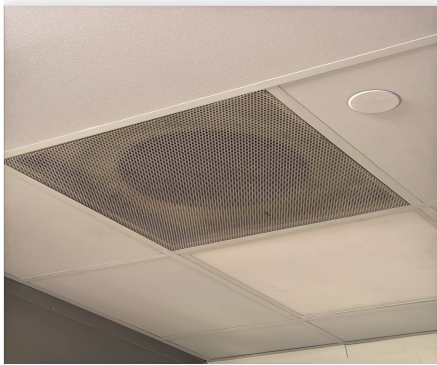
Issue Name : Kitchen Diffusers
Description : Kitchen diffusers installed are perforated diffusers not sure if those are the correct diffusers
Created By : National TAB **Assigned To :** National TAB - Dan Hertenstein
Status : Open
Priority : InfoOnly **Asset Tag :** RT-3
Originated Date : 03/24/2026 - Ethan Van Orden - National TAB

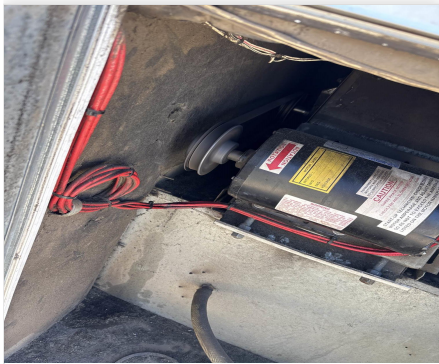
Issue Name : RTU-1 pulley won't turn
Description : Pulley needs to be broken free so it can be adjusted
Created By : National TAB **Assigned To :** National TAB - Dan Hertenstein
Status : Open
Priority : Medium **Asset Tag :** RT-1
Originated Date : 03/24/2026 - Ethan Van Orden - National TAB

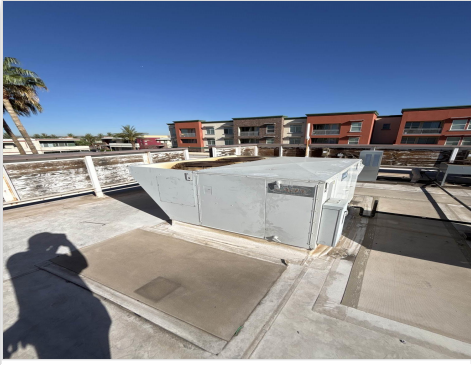
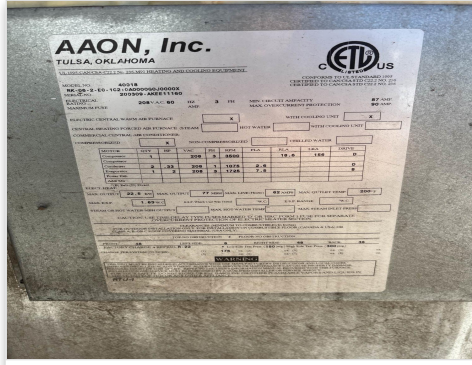
Unit Data - PHOTO LOG

Unit Data	
	Actual
MFG	AAON
Serial Num	200309-AKEE11160
Model Num	RK-06-2-E0- 1C2:0A0000G0J0000X
Num OA Filters 1	0
Num Final Filter 1	2
Final Filter Size 1	40X16

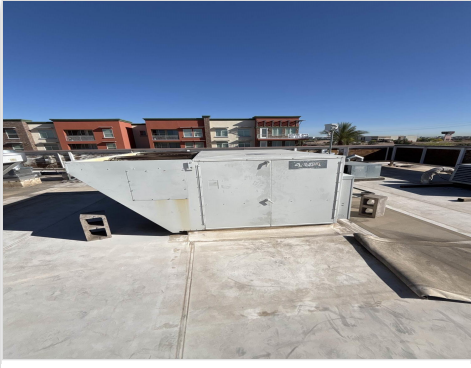
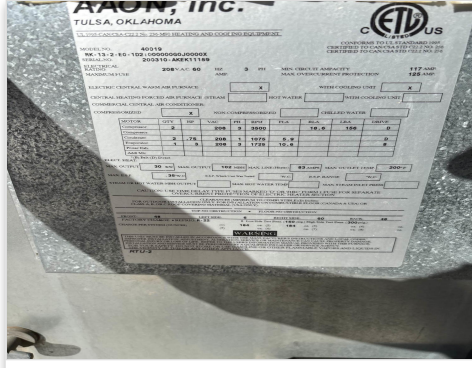
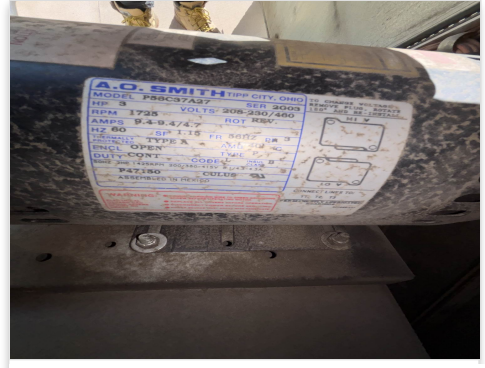
Unit Data - PHOTO LOG

Unit Data	
	Actual
MFG	AAON
Serial Num	200310-AKEK11159
Model Num	RK-13-2-E0- 1D2:000000G0J0000X
Num OA Filters 1	0
Num Final Filter 1	2
Final Filter Size 1	47X20

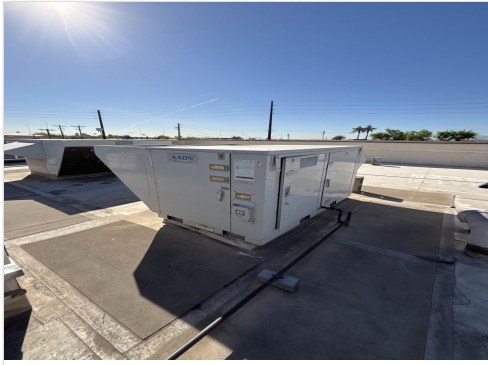
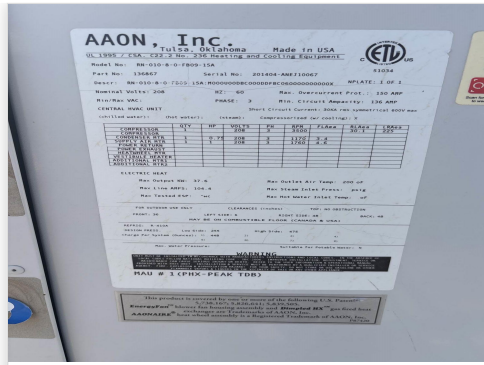
Unit Data - PHOTO LOG

Unit Data	
	Actual
MFG	AAON
Serial Num	201404-ANEJ10067
Model Num	RN-010-8-0-FB09-15A
Num OA Filters 1	1
OA Filter Size 1	35X19
Num Final Filter 1	2
Final Filter Size 1	40X16

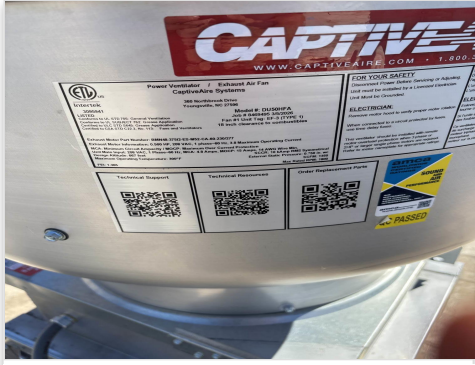
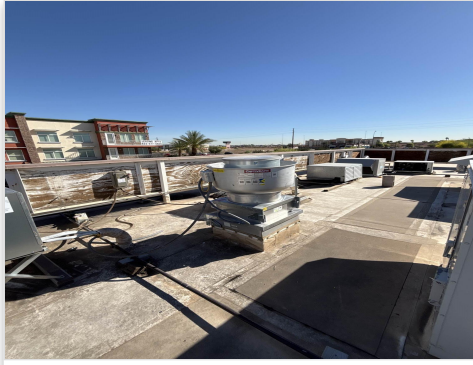
Unit Data - PHOTO LOG

Unit Data		
	Design	Actual
MFG	NA	CAPTIVEAIRE
Model Num	NA	DU50HFA
Serial Num	-	8469495
Type	UPBLAST	UPBLAST
Configuration	VERTICAL	VERTICAL

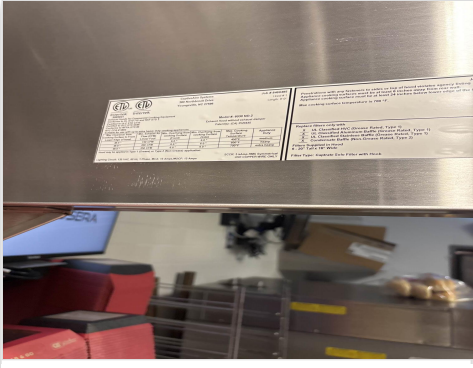
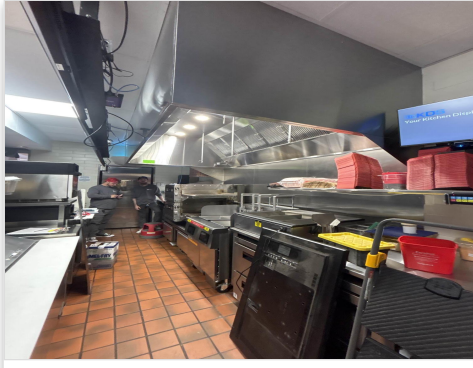
Unit Data - PHOTO LOG

Design	Actual
MFG	CAPTIVEAIRE	CAPTIVEAIRE
Model Num	6030ND-2-F	6030ND-2-F
Job / Serial Num	-	8469495
Type	TYPE I CANOPY	TYPE I CANOPY
Hood length	108"	108"
Hood Width	60"	60"

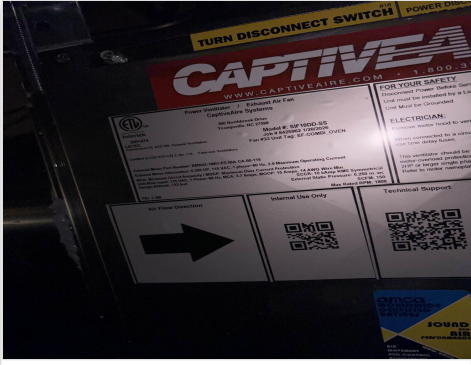
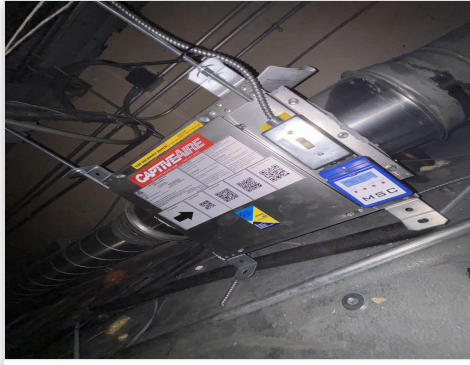
Unit Data - PHOTO LOG

Unit Data		
	Design	Actual
MFG	NA	CAPTIVEAIRE
Model Num	NA	SIFIODD-SS
Serial Num	-	8425962
Type	INLINE	INLINE
Configuration	VERTICAL	HORIZONTAL
