Report: Renew - 1122
Function: Test, Adjust, & Balance
Date: 11/09/2022

**09-12 FIVE GUYS #1932 - LAKEWOOD, CO
(RENEW)**

Name : 5 GUYS HVAC PERFORMANCE EVALUATION **Status :** NotSubmitted
Assigned Organization : National TAB **Asset :**
Requesting Organization : National TAB

Name :	RENEW SITE PICTURES & FINAL BUILDING PERFORMANCE	Status :	NotSubmitted
Assigned Organization :	National TAB	Asset :	
Requesting Organization :	National TAB

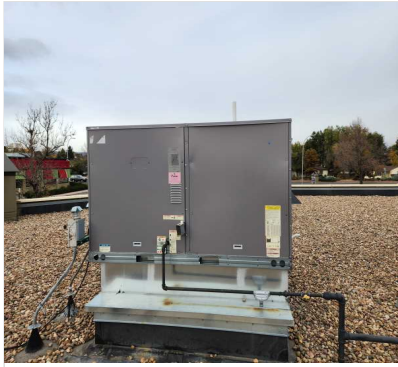
RTU1 (TAKE PICTURE OF UNIT)

MFG & MODEL NUMBER	CARRIER 48TCFD09A2A5A0A0
OA CFM	157 CFM
OA DAMPER POSITION	0% OPEN NO POWER TO HONEYWELL CONTROLLER
FAN SUCTION AND DISHCHARGE PRESSURE	-0.9" FAN SUCTION 0.51" FAN DISCHARGE
BLOWER MOTOR RLA / FLA	5.0/4.66/4.98 FLA 6.9

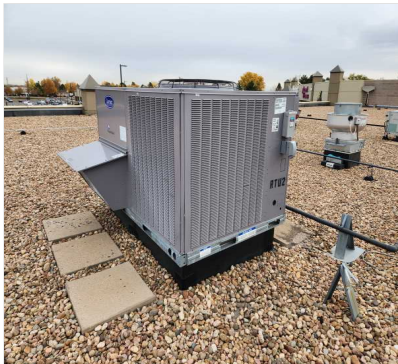
RTU2 (TAKE PICTURE OF UNIT)

MFG & MODEL NUMBER	CARRIER 48HCFD12K2M5A6U0G0
OA CFM	835 CFM
OA DAMPER POSITION	4.4 DCV
FAN SUCTION AND DISHCHARGE PRESSURE	-1.1" FAN SUCTION 0.86" FAN DISCHARGE

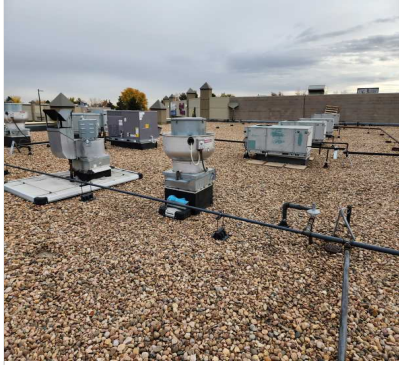
KEF1 - HOOD 1 (TAKE PICTURE OF UNIT)

MFG & MODEL NUMBER

CAPTIVEAIRE DU180HFA

EXH-CFM

1542 CFM

MOTOR RLA / FLA

4.3/4.4/4.35 FLA 9.5 3 HP

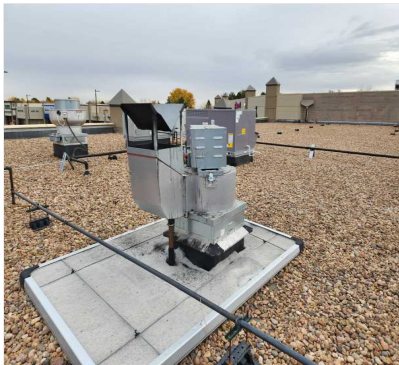
KEF2 - HOOD 2 (TAKE PICTURE OF UNIT)

MFG & MODEL NUMBER

CAPTIVEAIRE CASRE15DD

EXH-CFM

1331 CFM

MOTOR RLA / FLA

4.06/4.1/4.2 FLA 8.7 3 HP

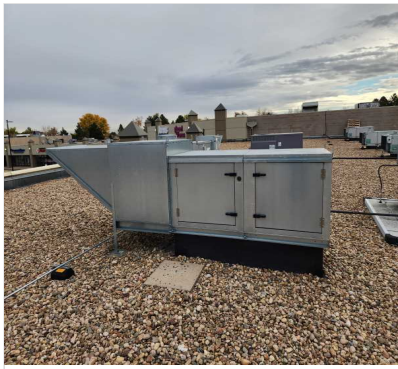
MUA - ALL HOODS (TAKE PICTURE OF UNIT)

MFG & MODEL NUMBER	CAPTIVEAIRE A2-D.500-20D
MUA-CFM	2323 CFM
MOTOR RLA/FLA	4.68/4.7/4.6 FLA 8.6 3 HP

MUA HAS COOLING

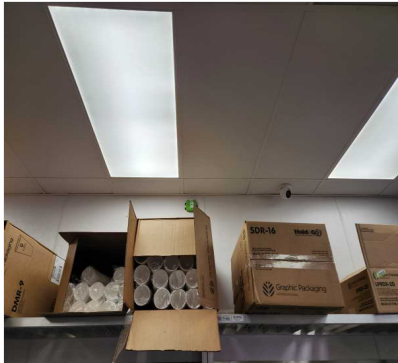
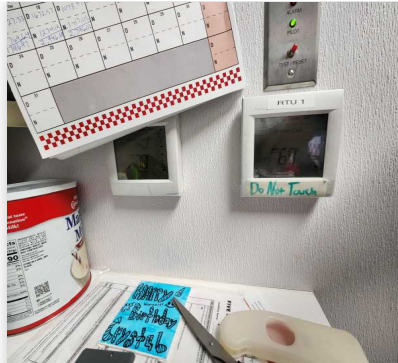
TAKE PICTURE OF THERMOSTATS AND WALL SENSORS

ARE THERMOSTATS PROGRAMMED FOR OCCUPIED HOURS AND IS THE FAN IN "ON" MODE DURING OCCUPIED TIMES	YES
BUILDING PRESSURE (FINAL)	-0.0123"
HOOD CAPTURE (WITNESS COOKING OR SMOKE TEST)	100% CRYSTAL

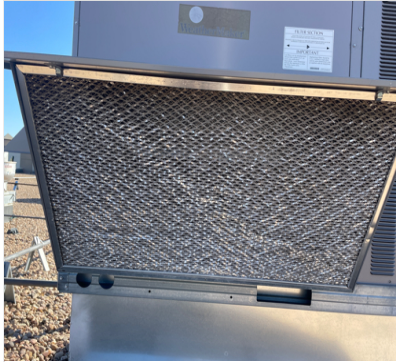
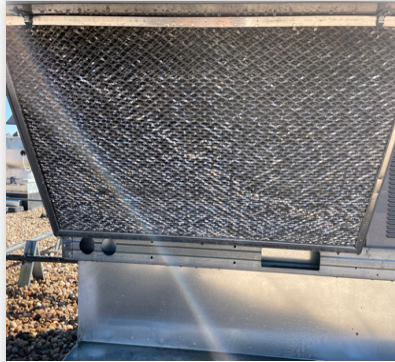
RTU 1 O.A. MESH FILTER (BEFORE AND AFTER)

Dirty(1).jpeg

Clean.jpeg

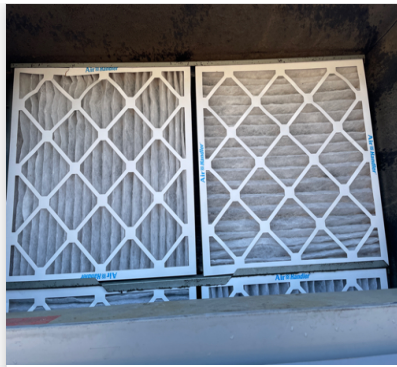
RTU 1 FINAL FILTER (BEFORE AND AFTER)

Dirty(1).jpeg

Clean.jpeg

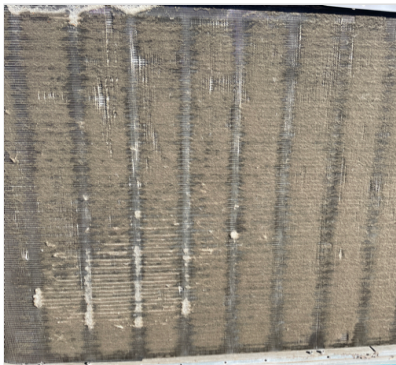
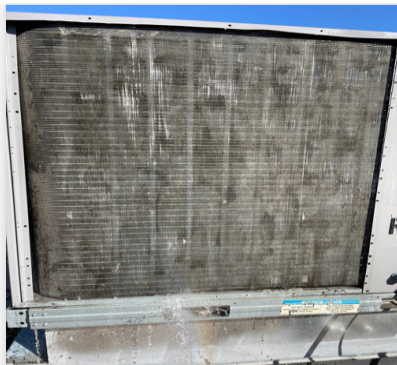
RTU 1 CONDENSER COIL (BEFORE AND AFTER)

Dirty(1).jpeg

Clean.jpeg

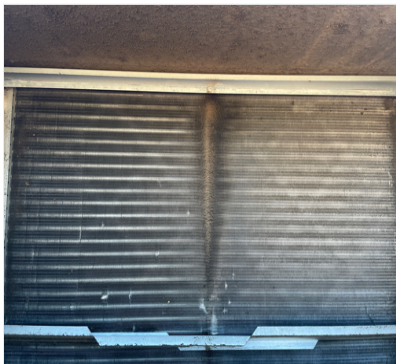
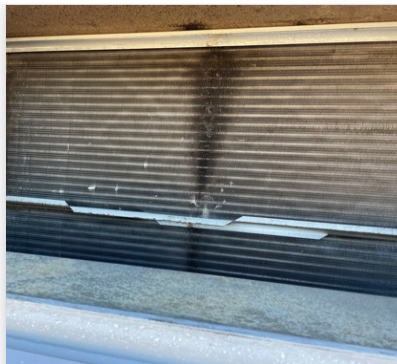
RTU 1 EVAPORATOR COIL (BEFORE AND AFTER)

Dirty(1).jpeg

Clean.jpeg

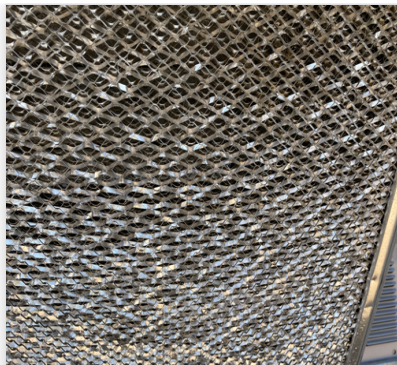
RTU 2 OA FILTER (BEFORE AND AFTER)

Dirty(1).jpeg

Clean.jpeg

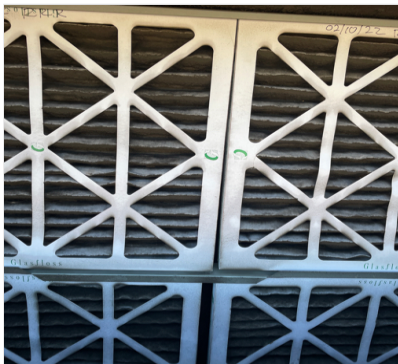
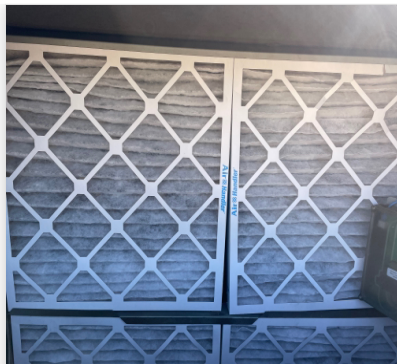
RTU 2 FINAL FILTER (BEFORE AND AFTER)

Dirty(1).jpeg

Clean.jpeg

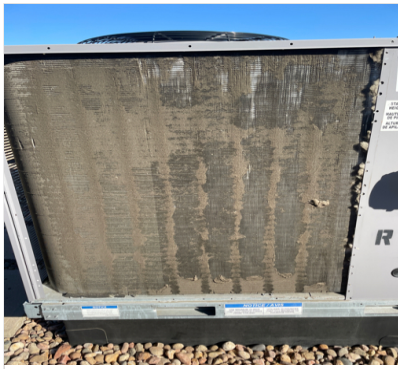
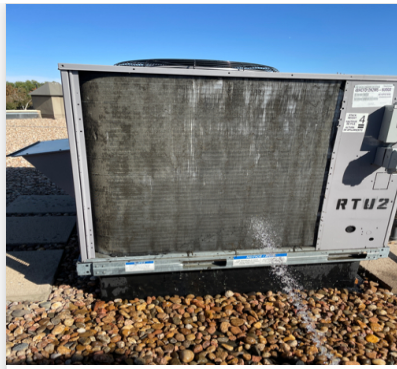
RTU 2 CONDENSER COIL (BEFORE AND AFTER)

Dirty(1).jpeg

Clean.jpeg

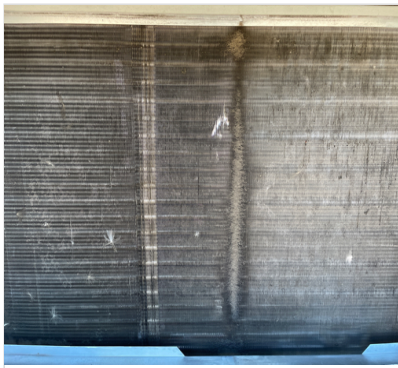
RTU 2 EVAPORATOR COIL (BEFORE AND AFTER)

Dirty(1).jpeg

Clean.jpeg

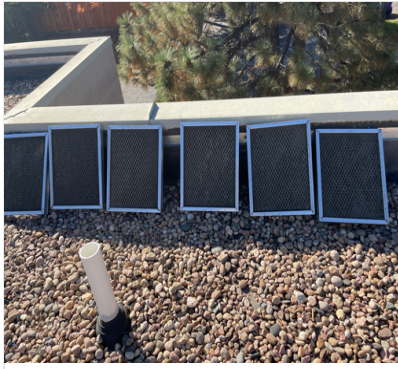
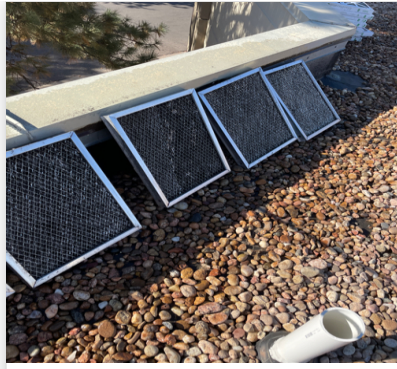
MUA OA MESH FILTERS

Dirty(1).jpeg

Clean.jpeg

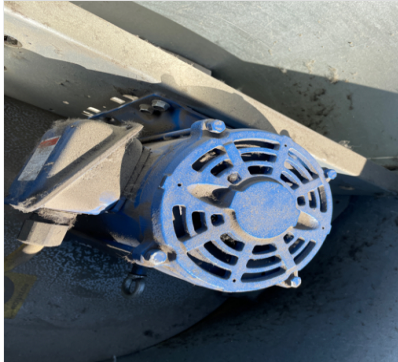
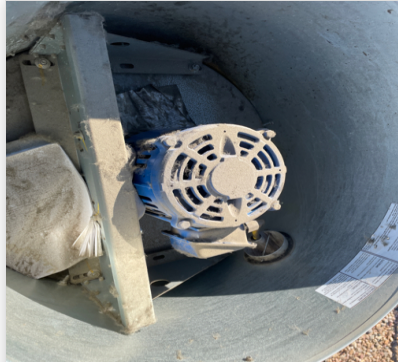
EXHAUST FAN KEF1 MOTOR HOUSING CLEANED

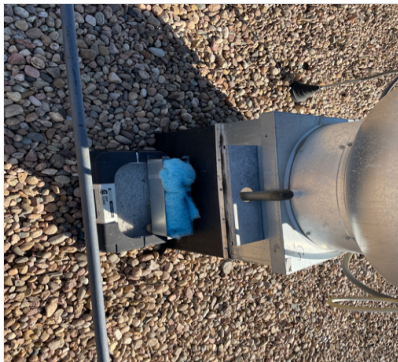
EXHAUST FAN KEF1 GREASE CUP PROPERLY INSTALLED

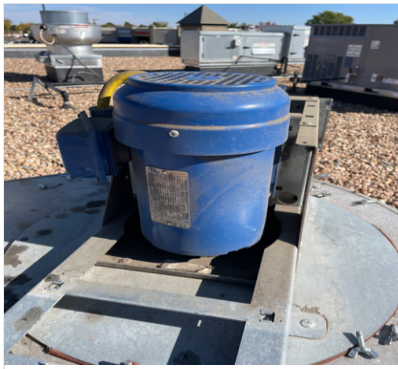
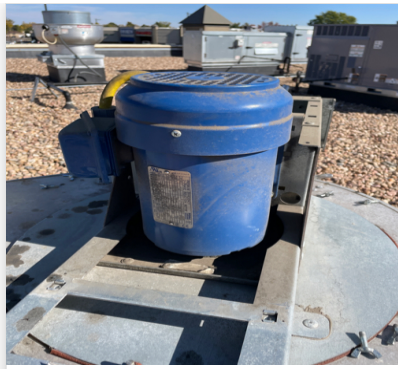
EXHAUST FAN KEF2 MOTOR HOUSING CLEANED

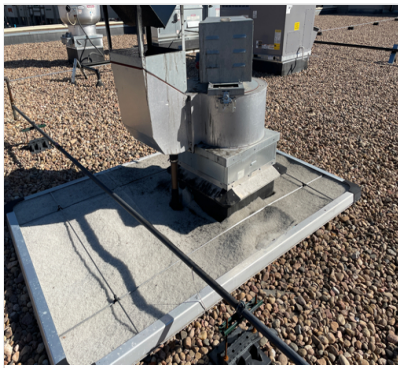
EXHAUST FAN KEF2 GREASE CUP PROPERLY INSTALLED
