**Report: TAB Report**  
**Function: Test, Adjust, & Balance**  
**Date: 02/06/2025**  
**Completed By: National TAB**

**PROJECT**  
**02-03-25 WAWA #5804 FAIRHOPE, AL**

22148 STATE HWY 181

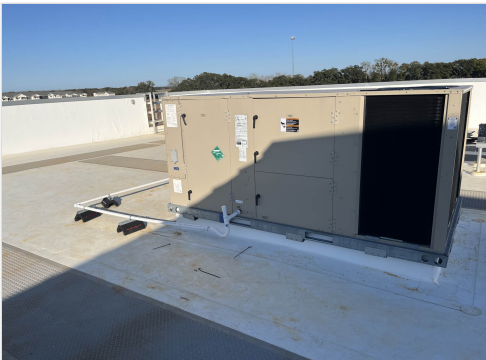
## Unit Data - PHOTO LOG

Asset: RTU1

Unit Data		
	Design	Actual
MFG	LENNOX ENLIGHT	LENNOX ENLIGHT
Serial Num	-	5624H04580
Model Num	LCT102H4E	LCT102H4EG1Y
Type	RTU	RTU
Configuration	VERTICAL	VERTICAL
Num OA Filters 1	-	1
OA Filter Size 1	-	24X16
Num Final Filter 1	-	4
Final Filter Size 1	-	20X25X2

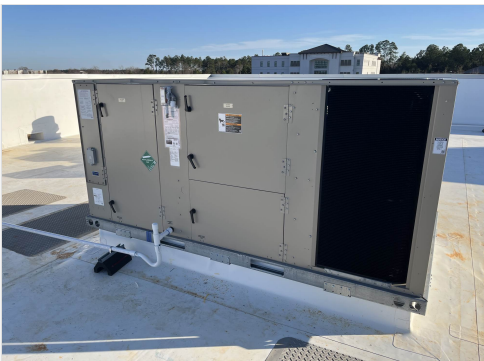
## Unit Data - PHOTO LOG

Asset: RTU2

Unit Data		
	Design	Actual
MFG	LENNOX ENLIGHT	LENNOX ENLIGHT
Serial Num	-	5624HO4161
Model Num	LCT150H4E	LCT150H4EG1Y
Type	RTU	RTU
Configuration	VERTICAL	VERTICAL
Num OA Filters 1	-	1
OA Filter Size 1	-	24X16
Num Final Filter 1	-	4
Final Filter Size 1	-	20X25X2

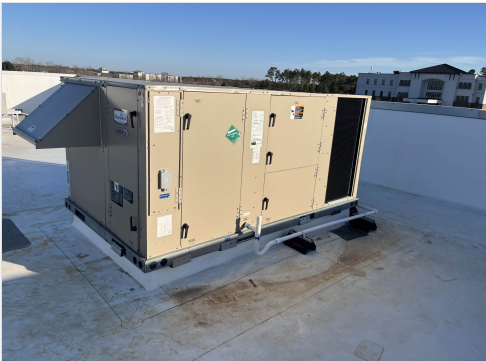
## Unit Data - PHOTO LOG

Asset: RTU3

Unit Data		
	Design	Actual
MFG	LENNOX ENLIGHT	LENNOX ENLIGHT
Serial Num	-	5624H04156
Model Num	LCT092H4E	LCT092H4EG1Y
Type	RTU	RTU
Configuration	VERTICAL	VERTICAL
Num OA Filters 1	-	1
OA Filter Size 1	-	24X16
Num Final Filter 1	-	4
Final Filter Size 1	-	20X25X2

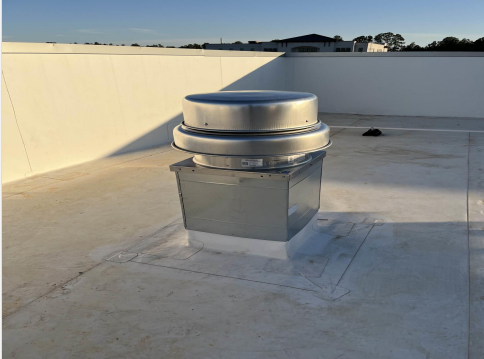
## Unit Data - PHOTO LOG

Asset: EF1

Unit Data		
	Design	Actual
MFG	GREENHECK	GREENHECK
Model Num	G-120	G-120-4-VG-19-X
Serial Num	-	2S4S9467
Type	DOWNBLAST	DOWNBLAST
Configuration	VERTICAL	VERTICAL

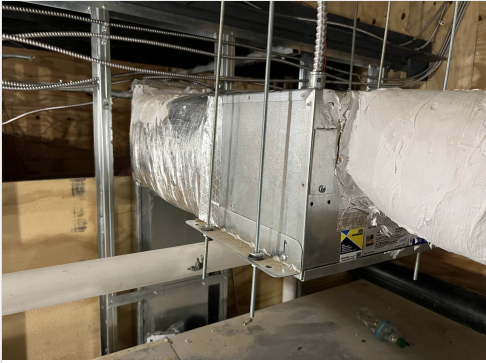
## Unit Data - PHOTO LOG

Asset: EF2

Unit Data		
	Design	Actual
MFG	GREENHECK	GREENHECK
Model Num	CSP-B110	CSP-B110
Serial Num	-	-
Type	INLINE	INLINE
Configuration	HORIZONTAL	HORIZONTAL

Notes:  
 (1). MOTOR DATA IS NOT ACCESSIBLE. MOTOR IS ENCLOSED IN METAL CASING.
