Report: TAB Report
Function: Test, Adjust, & Balance
Date: 02/06/2025
Completed By: National TAB

PROJECT
02-03-25 WAWA #5804 FAIRHOPE, AL

Project: 02-03-25 WAWA #5804 FAIRHOPE, AL

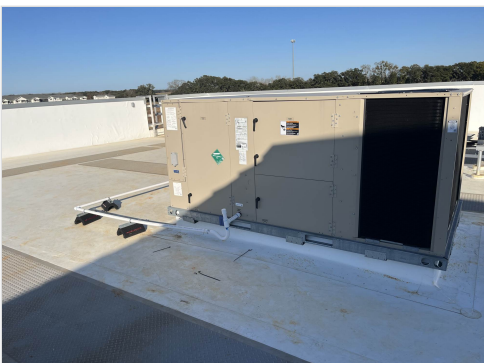
Unit Data - PHOTO LOG

Asset: RTU1

AREA:RETAIL

Unit Data		
	Design	Actual
MFG	LENNOX ENLIGHT	LENNOX ENLIGHT
Serial Num	-	5624H04580
Model Num	LCT102H4E	LCT102H4EG1Y
Type	RTU	RTU
Configuration	VERTICAL	VERTICAL
Num OA Filters 1	-	1
OA Filter Size 1	-	24X16
Num Final Filter 1	-	4
Final Filter Size 1	-	20X25X2

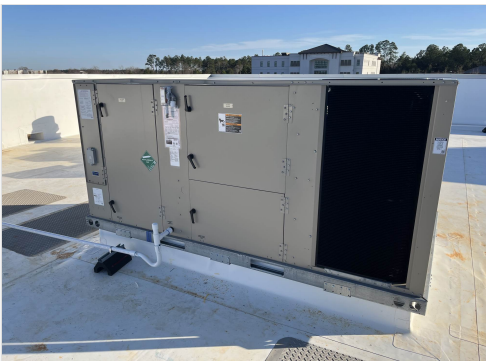
Unit Data - PHOTO LOG

Asset: RTU2

AREA:FOOD SERVICE

Unit Data		
	Design	Actual
MFG	LENNOX ENLIGHT	LENNOX ENLIGHT
Serial Num	-	5624HO4161
Model Num	LCT150H4E	LCT150H4EG1Y
Type	RTU	RTU
Configuration	VERTICAL	VERTICAL
Num OA Filters 1	-	1
OA Filter Size 1	-	24X16
Num Final Filter 1	-	4
Final Filter Size 1	-	20X25X2

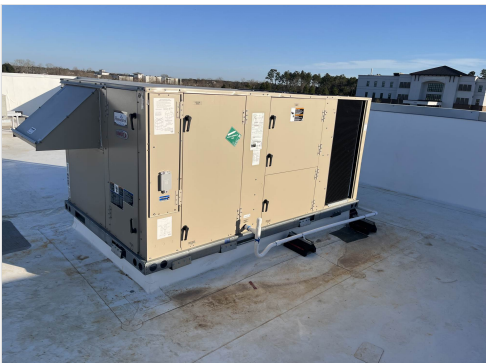
Unit Data - PHOTO LOG

Asset: RTU3

AREA:RETAIL

Unit Data		
	Design	Actual
MFG	LENNOX ENLIGHT	LENNOX ENLIGHT
Serial Num	-	5624H04156
Model Num	LCT092H4E	LCT092H4EG1Y
Type	RTU	RTU
Configuration	VERTICAL	VERTICAL
Num OA Filters 1	-	1
OA Filter Size 1	-	24X16
Num Final Filter 1	-	4
Final Filter Size 1	-	20X25X2

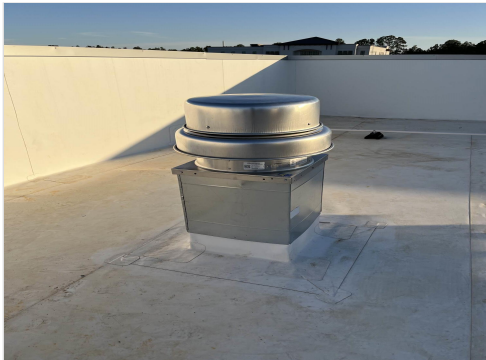
Unit Data - PHOTO LOG

Asset: EF1

AREA:FOOD SERVICE

Unit Data		
	Design	Actual
MFG	GREENHECK	GREENHECK
Model Num	G-120	G-120-4-VG-19-X
Serial Num	-	2S4S9467
Type	DOWNBLAST	DOWNBLAST
Configuration	VERTICAL	VERTICAL
