Report: TAB Report
Function: Test, Adjust, & Balance
Date: 04/02/2026
Completed By: National TAB

PROJECT
01-26-26 QT #1406 PHOENIX, AZ

QUIKTRIP
4705 SOUTH 129TH EAST AVENUE
TULSA, OK 74134

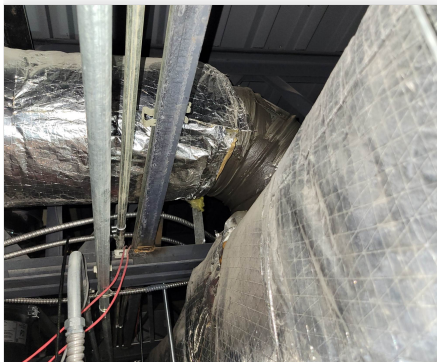
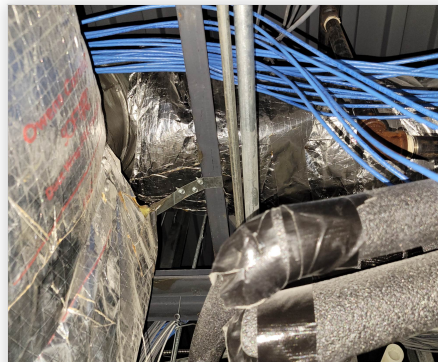
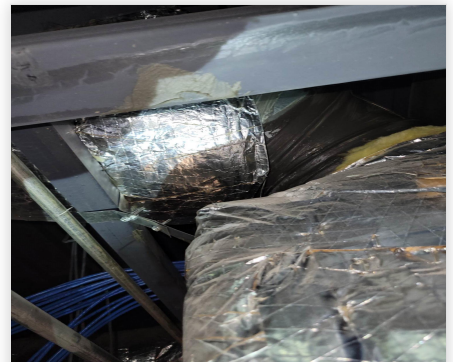
Issue Name : DAMPERS NONEXISTENT/INACCESSIBLE
Description : Dampers for RTU3-5&6 either not installed or inaccessible.
Created By : National TAB **Assigned To :** National TAB - Dan Hertenstein
Status : Open
Priority : Medium **Asset Tag :** SGRD5
Originated Date : 04/04/2026 - Christine Weale - National TAB

Notes:
DAMPERS INACCESSIBLE, MALFUNCTIONING, SEE 'REMARKS'.

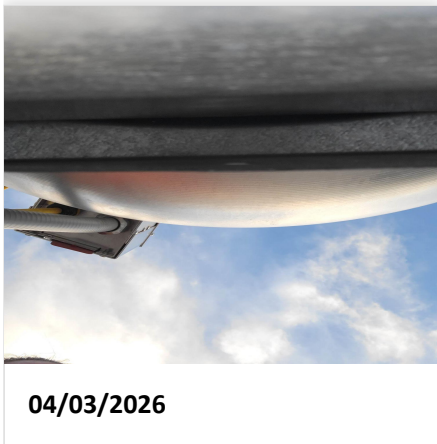
Issue Name : EF3 CURB LEAK
Description : EF3 fan is not installed correctly, leak at curb. BP is high enough the extra exhaust will not make building negative, once fixed.
Created By : National TAB **Assigned To :** National TAB - Dan Hertenstein
Status : Open
Priority : High **Asset Tag :** EF3
Originated Date : 04/03/2026 - Christine Weale - National TAB

No major leakage around the fan base Fail

90 - due to air leak at curb, smoke did not sufficiently clear from hood edge.

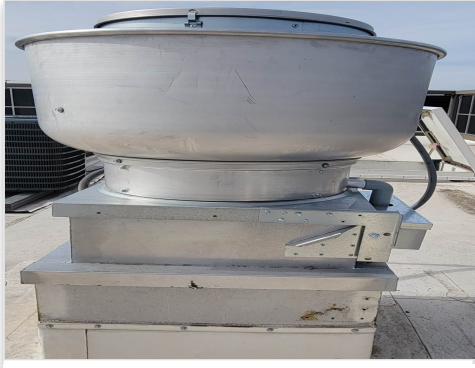
Asset: EF3

Yes, but on wrong side. Should be opposite of the grease cup.
