Report: TAB REPORT
Function: Test, Adjust, & Balance
Date: 10/31/2025
Completed By: National TAB

PROJECT
10-20-25 WAWA #7611 GEORGETOWN, KY

Project: 10-20-25 WAWA #7611 GEORGETOWN, KY

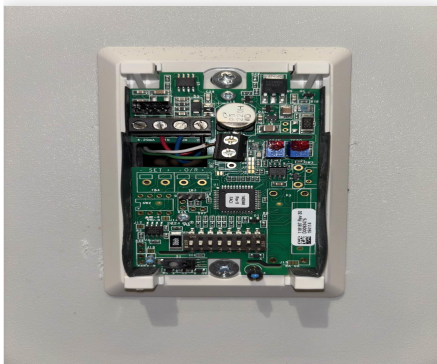
Issue Name : Incorrect sensor wiring
Description : The wiring for the temp/humidity sensors should use two separate shielded twisted pairs per Lennox specification. This was not done on any unit. Current wiring can cause false humidity readings due to signal interference.
Created By : National TAB **Assigned To :** National TAB - Will Turnbough
Status : Open
Priority : High **Asset Tag :**
Originated Date : 10/21/2025 - Corey Dick - National TAB

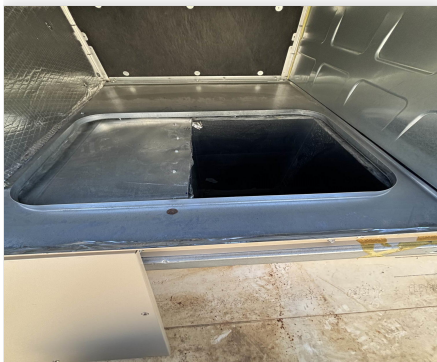
Issue Name : RTU-1 Supply Ductwork
Description : The unit connection to the duct work is blocked off and is creating a choke point at the unit. This point is creating high supply side pressures. The size of the opening is 20"x16". ($20 \times 16 = 2.22 \text{ SF}$, $4500 \text{ CFM} / 2.22 = 2027 \text{ FPM}$). Airflow is within design so no further action is necessary but noting since static pressure is elevated (0.98" on supply)
Created By : National TAB **Assigned To :** National TAB - Will Turnbough
Status : Open
Priority : Medium **Asset Tag :** RTU1
Originated Date : 10/21/2025 - Corey Dick - National TAB

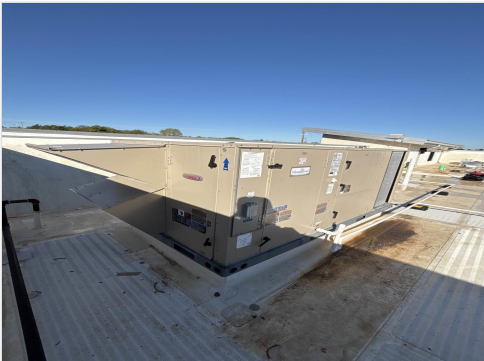
Unit Data - PHOTO LOG

Asset: RTU1

Unit Data		
	Design	Actual
MFG	LENNOX	LENNOX
Serial Num	-	5625D05814
Model Num	LCT150H5E	LCT150H5E
Type	RTU	RTU
Configuration	VERTICAL	VERTICAL
Num OA Filters 1	-	2
OA Filter Size 1	-	14.25"x23"
Num Final Filter 1	-	4
Final Filter Size 1	-	20"x25"x2"

Test Data		
	Design	Actual
SF CFM	4500	4544
RA CFM	3800	3839
OA CFM	700	728
RL Voltage	-	208
RL Amperage	-	5.7
SF System SetPt	-	88%
RA Damper Position	-	77%
RA Damper Type	-	MECHANICALLY LINKED
OA Damper Position	-	23%
OA Damper Type	-	ECONOMIZER

Performance Data		
	Design	Actual
MA Plenum SP	-	-0.62"
Fan Suction SP	-	-0.91"
Fan Discharge SP	-	0.98"
Total ESP	0.70"	1.60"
Fan Total SP	-	1.89"

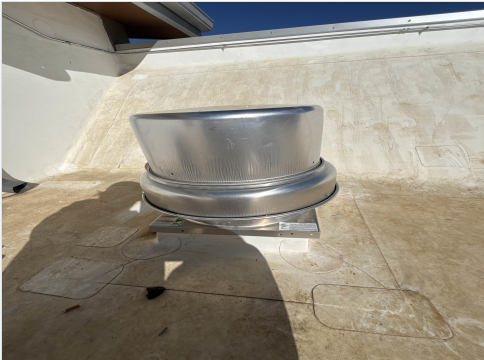
Unit Data - PHOTO LOG

Asset: EF1

Unit Data		
	Design	Actual
MFG	GREENHECK	GREENHECK
Model Num	GB-098-6	GB-098-6
Serial Num	-	26918738
Type	DOWNBLAST	DOWNBLAST
Configuration	VERTICAL	VERTICAL

Test Data		
	Design	Actual
CFM	375	357
Fan Rotation	-	CW
System SetPt	-	3 TURNS OUT
RL Voltage	-	INACCESSIBLE
RL Amperage	-	3.6
Total ESP	0.38"	0.22"
Fan Inlet SP	-	-0.22"
Fan Discharge SP	-	ATM

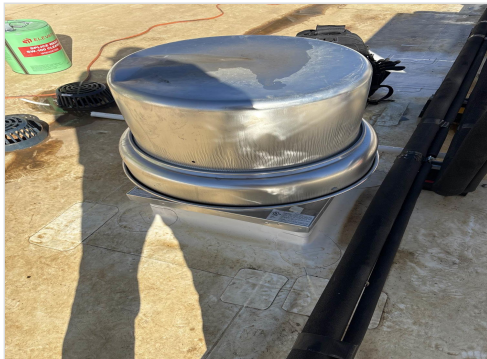
Unit Data - PHOTO LOG

Asset: EF2

Unit Data		
	Design	Actual
MFG	GREENHECK	GREENHECK
Model Num	GB-098-6	GB-098-6
Serial Num	-	26918739
Type	DOWNBLAST	DOWNBLAST
Configuration	VERTICAL	VERTICAL

Test Data		
	Design	Actual
CFM	400	373
Fan Rotation	-	CORRECT
System SetPt	-	3 TURNS OUT
RL Voltage	-	INACCESSIBLE
RL Amperage	-	3.6
Total ESP	0.38"	0.18"
Fan Inlet SP	-	-0.18"
Fan Discharge SP	-	ATM
