Report: TAB REPORT
Function: Test, Adjust, & Balance
Date: 10/23/2025
Completed By: National TAB

PROJECT
10-20-25 WAWA #7611 GEORGETOWN, KY

Project: 10-20-25 WAWA #7611 GEORGETOWN, KY

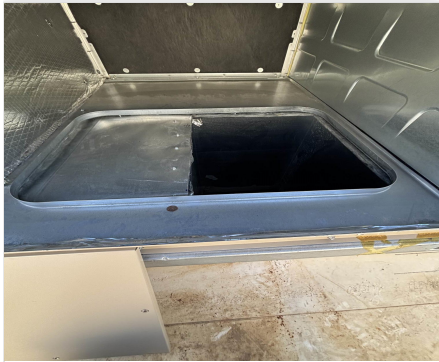
Project Issue File Details

Issue Name : RTU-1 Pressures
Description : The unit connection to the duct work is blocked off and is creating a choke point at the unit. This point is creating high supply side pressures.
Created By : National TAB **Assigned To :** National TAB - Will Turnbough
Status : Open
Priority : Medium **Asset Tag :**
Originated Date : 10/21/2025 - Corey Dick - National TAB

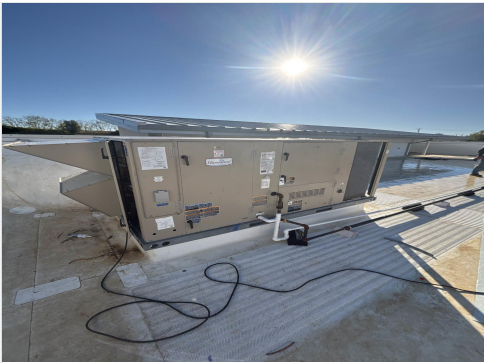
Unit Data - PHOTO LOG

Unit Data		
	Design	Actual
MFG	LENNOX	LENNOX
Serial Num	-	5625D03924
Model Num	LGT102H5E	LGT102H5E
Type	RTU	RTU
Configuration	VERTICAL	VERTICAL
Num OA Filters 1	-	2
OA Filter Size 1	-	14.25"x23"
Num Final Filter 1	-	4
Final Filter Size 1	-	20"x25"x2"

Test Data		
	Design	Actual
SF CFM	3400	3429
SF RPM	-	1227
MOTOR RPM	-	1227
RA CFM	3020	3038
OA CFM	380	391
RL Voltage	-	208
RL Amperage	-	3.0
SF System SetPt	-	69%
RA Damper Position	-	87%
RA Damper Type	-	MECHANICALLY LINKED
OA Damper Position	-	13%
OA Damper Type	-	ECONOMIZER

Performance Data		
	Design	Actual
MA Plenum SP	-	-0.53"
Fan Suction SP	-	-0.78"
Fan Discharge SP	-	0.45"
Total ESP	1.00"	0.98"
Fan Total SP	-	1.23"

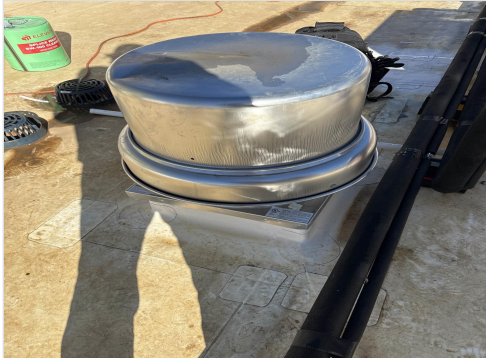
Unit Data - PHOTO LOG

Unit Data		
	Design	Actual
MFG	GREENHECK	GREENHECK
Model Num	GB-098-6	GB-098-6
Serial Num	-	26918739
Type	DOWNBLAST	DOWNBLAST
Configuration	VERTICAL	VERTICAL

Test Data		
	Design	Actual
CFM	400	373
Fan Rotation	-	CORRECT
System SetPt	-	3 TURNS OUT
RL Voltage	-	INACCESSIBLE
RL Amperage	-	3.6
Total ESP	0.38"	0.18"
Fan Inlet SP	-	-0.18"
Fan Discharge SP	-	ATM

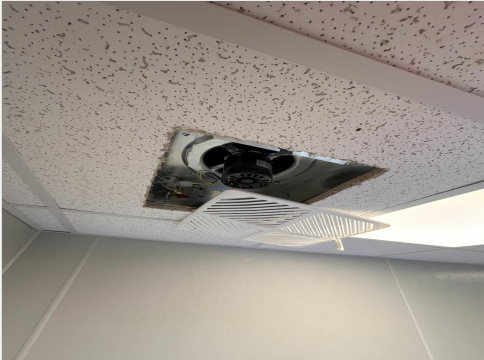
Unit Data - PHOTO LOG

Unit Data		
	Design	Actual
MFG	GREENHECK	GREENHECK
Model Num	SP-B200	SP-B200
Serial Num	-	182561453-0034
Type	CEILING	CEILING
Configuration	VERTICAL	VERTICAL

Test Data		
	Design	Actual
CFM	200	205
Fan Rotation	-	CORRECT
System SetPt	-	SINGLE SPEED
