Report: TAB REPORT
Function: Test, Adjust, & Balance
Date: 10/31/2025
Completed By: National TAB

PROJECT
10-20-25 WAWA #7611 GEORGETOWN, KY

Project: 10-20-25 WAWA #7611 GEORGETOWN, KY

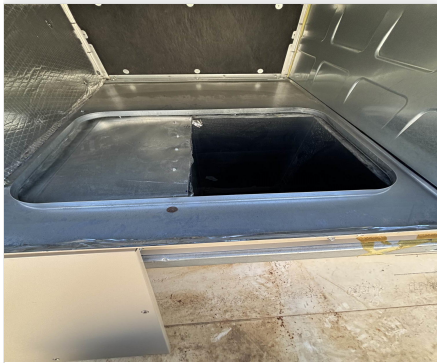
Issue Name : RTU-1 Pressures
Description : The unit connection to the duct work is blocked off and is creating a choke point at the unit. This point is creating high supply side pressures. The size of the opening is 20"x16". $20 \times 16 = 2.22 \text{ SF}$, $4500 \text{ CFM} / 2.22 = 2027 \text{ FPM}$. This is well beyond the typical design of 1200 FPM.
Created By : National TAB **Assigned To :** National TAB - Will Turnbough
Status : Open
Priority : Medium **Asset Tag :**
Originated Date : 10/21/2025 - Corey Dick - National TAB

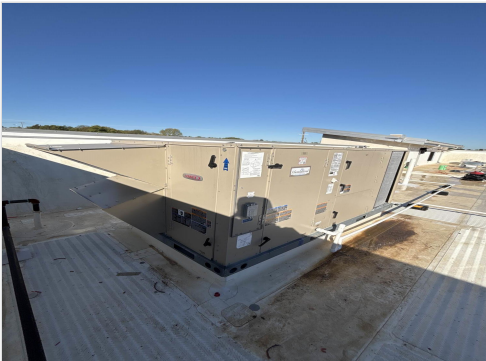
Unit Data - PHOTO LOG

Unit Data		
	Design	Actual
MFG	LENNOX	LENNOX
Serial Num	-	5625D05814
Model Num	LCT150H5E	LCT150H5E
Type	RTU	RTU
Configuration	VERTICAL	VERTICAL
Num OA Filters 1	-	2
OA Filter Size 1	-	14.25"x23"
Num Final Filter 1	-	4
Final Filter Size 1	-	20"x25"x2"

Test Data		
	Design	Actual
SF CFM	4500	4544
RA CFM	3800	3839
OA CFM	700	728
RL Voltage	-	208
RL Amperage	-	5.7
SF System SetPt	-	88%
RA Damper Position	-	77%
RA Damper Type	-	MECHANICALLY LINKED
OA Damper Position	-	23%
OA Damper Type	-	ECONOMIZER

Performance Data		
	Design	Actual
MA Plenum SP	-	-0.62"
Fan Suction SP	-	-0.91"
Fan Discharge SP	-	0.98"
Total ESP	0.70"	1.60"
Fan Total SP	-	1.89"

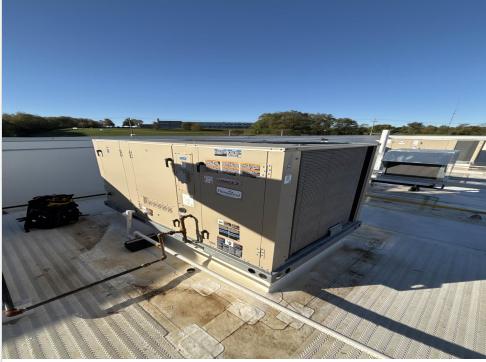
Unit Data - PHOTO LOG

Unit Data		
	Design	Actual
MFG	LENNOX	LENNOX
Serial Num	-	5625E00871
Model Num	LGT072H5E	LGT072H5E
Type	RTU	RTU
Configuration	VERTICAL	VERTICAL
Num OA Filters 1	-	1
OA Filter Size 1	-	14"x29"
Num Final Filter 1	-	4
Final Filter Size 1	-	20"x20"x2"

Test Data		
	Design	Actual
SF CFM	2400	2432
SF RPM	-	3133
MOTOR RPM	-	3133
RA CFM	2200	2218
OA CFM	200	214
RL Voltage	-	208
RL Amperage	-	4.0
SF System SetPt	-	95%
RA Damper Position	-	89%
RA Damper Type	-	MECHANICALLY LINKED
OA Damper Position	-	11%
OA Damper Type	-	ECONOMIZER

Performance Data		
	Design	Actual
MA Plenum SP	-	-0.47"
Fan Suction SP	-	-0.69"
Fan Discharge SP	-	-0.69"
Total ESP	0.50"	1.16"
Fan Total SP	-	1.38"

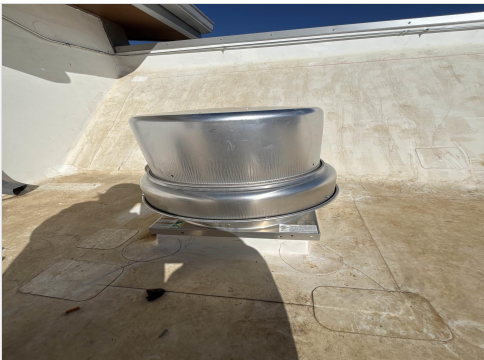
Unit Data - PHOTO LOG

Unit Data		
	Design	Actual
MFG	GREENHECK	GREENHECK
Model Num	GB-098-6	GB-098-6
Serial Num	-	26918738
Type	DOWNBLAST	DOWNBLAST
Configuration	VERTICAL	VERTICAL

Test Data		
	Design	Actual
CFM	375	357
Fan Rotation	-	CW
System SetPt	-	3 TURNS OUT
RL Voltage	-	INACCESSIBLE
RL Amperage	-	3.6
Total ESP	0.38"	0.22"
Fan Inlet SP	-	-0.22"
Fan Discharge SP	-	ATM

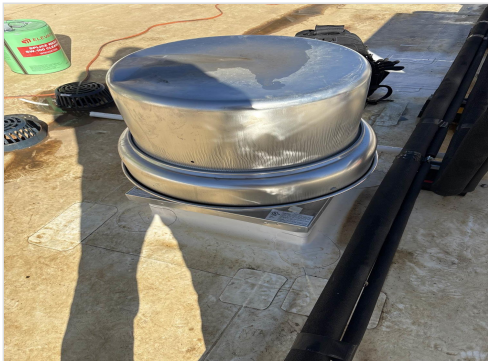
Unit Data - PHOTO LOG

Unit Data		
	Design	Actual
MFG	GREENHECK	GREENHECK
Model Num	GB-098-6	GB-098-6
Serial Num	-	26918739
Type	DOWNBLAST	DOWNBLAST
Configuration	VERTICAL	VERTICAL

Test Data		
	Design	Actual
CFM	400	373
Fan Rotation	-	CORRECT
System SetPt	-	3 TURNS OUT
RL Voltage	-	INACCESSIBLE
RL Amperage	-	3.6
Total ESP	0.38"	0.18"
Fan Inlet SP	-	-0.18"
Fan Discharge SP	-	ATM

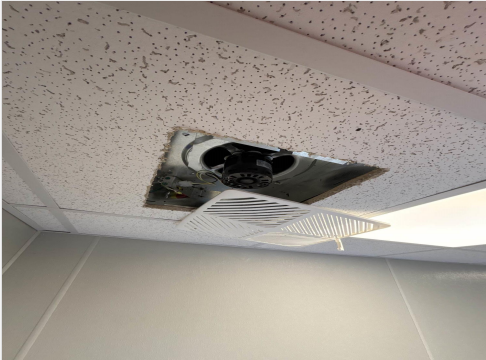
Unit Data - PHOTO LOG

Unit Data		
	Design	Actual
MFG	GREENHECK	GREENHECK
Model Num	SP-B200	SP-B200
Serial Num	-	182561453-0034
Type	CEILING	CEILING
Configuration	VERTICAL	VERTICAL

Test Data		
	Design	Actual
CFM	200	205
Fan Rotation	-	CORRECT
System SetPt	-	SINGLE SPEED
