Report: TAB Report
Function: Test, Adjust, & Balance
Date: 12/02/2025
Completed By: National TAB

PROJECT
12-01-25 WAWA #7614 HEBRON, KY

Project: 12-01-25 WAWA #7614 HEBRON, KY

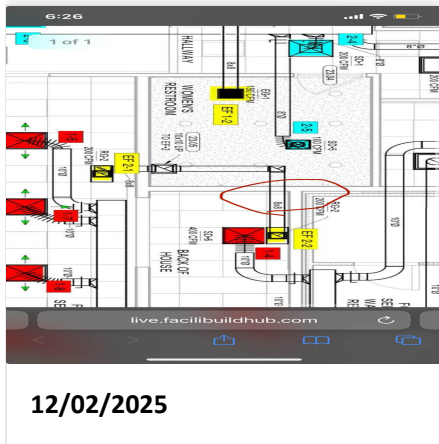
Issue Name : EF-2 Return Grilles
Description : EF-2 return grilles are not in design. In order to balance exhaust evenly, a damper will need to be added to diffuser 2.
Created By : National TAB **Assigned To :** National TAB - Jordan Best
Status : Open
Priority : Medium **Asset Tag :**
Originated Date : 12/02/2025 - Jordan Best - National TAB

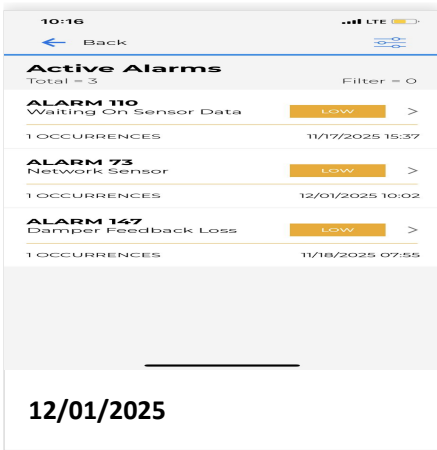
Issue Name : RTU Sensor Alarms
Description : All 3 RTU's are displaying the same sensor alarms, did not have time to troubleshoot yet but will look further tomorrow.
Created By : National TAB **Assigned To :** National TAB - Jordan Best
Status : Open
Priority : Medium **Asset Tag :**
Originated Date : 12/01/2025 - Jordan Best - National TAB

Alarms present, see issue.
