Report: TAB Report
Function: Test, Adjust, & Balance
Date: 07/08/2025
Completed By: National TAB

08-04-25 CHIPOTLE #4722 SPRINGDALE, AR

5761 W. SUNSET AVE

SPRINGDALE, AR 72762

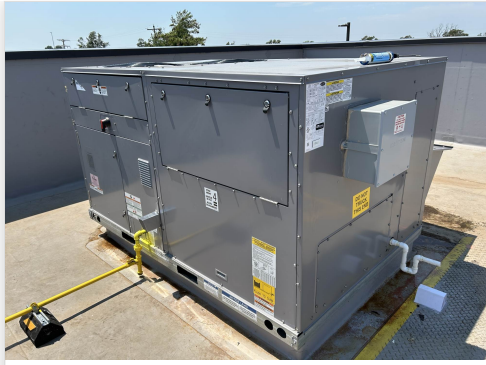
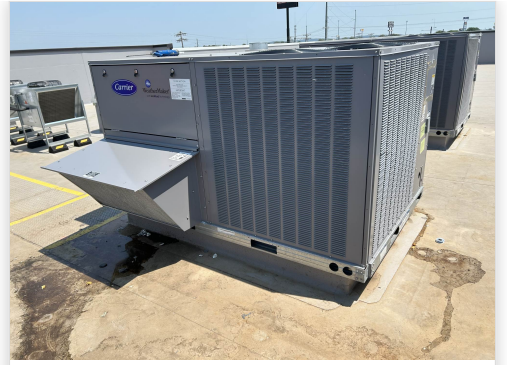
Unit Data - PHOTO LOG

Notes:
Economizer makes a deep rumble noise briefly when opening on unit startup.

Issue Name : RTU-1 Economizer noise
Description : RTU-1 Economizer makes a deep low rumble briefly on unit startup.
Created By : National TAB **Assigned To :** National TAB - Dan Hertenstein
Status : Open
Priority : Low **Asset Tag :** RTU1
Originated Date : 08/08/2025 - Cody Collett - National TAB
