Report: TAB Report

Function: Test, Adjust, & Balance

Date: 07/08/2025

07-07-25 CHIPOTLE #4722 SPRINGDALE, AR

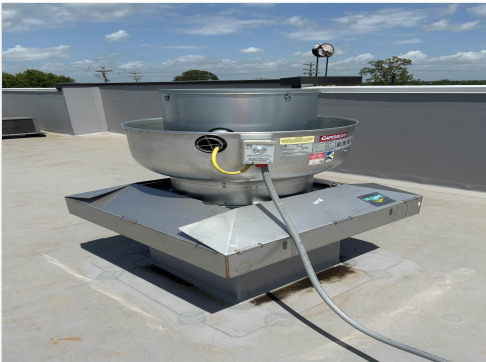
Unit Data - PHOTO LOG

Asset: EF1

AREA: KITCHEN

Unit Data		
	Design	Actual
MFG	CAPTIVEAIRE	CAPTIVEAIRE
Model Num	DU180HFA	DU180HFA
Serial Num	-	6104716
Type	UPBLAST	UPBLAST
Configuration	VERTICAL	VERTICAL

Test Data		
	Design	Actual
CFM	2550	2464
Fan RPM	-	1110
Fan Rotation	-	CCW
Motor RPM	-	1110
System SetPt	-	52.7HZ
RL Voltage	-	103/103/103
RL Amperage	-	5.0/5.0/5.1
Total ESP	1.2"	0.87"
Fan Inlet SP	-	-0.87"
Fan Discharge SP	-	ATM

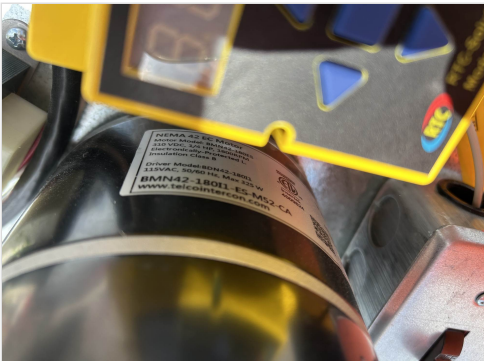
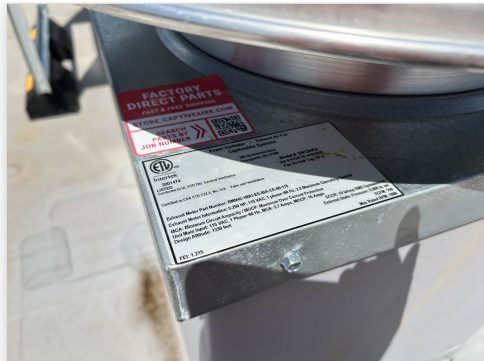
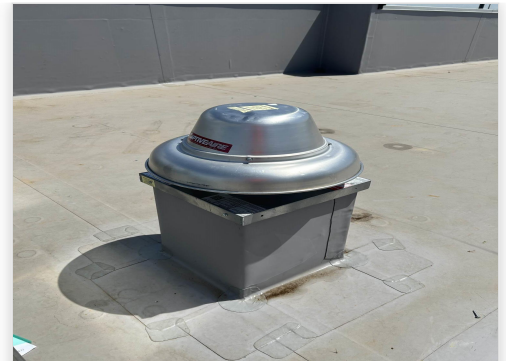
Unit Data - PHOTO LOG

Asset: EF2

AREA:RESTROOMS

Unit Data		
	Design	Actual
MFG	CAPTIVEAIRE	CAPTIVEAIRE
Model Num	DR12HFA	DR12HFA
Serial Num	-	6104716
Type	DOWNBLAST	DOWNBLAST
Configuration	VERTICAL	VERTICAL

Test Data		
	Design	Actual
CFM	150	159
Fan RPM	-	828
Fan Rotation	-	CCW
Motor RPM	-	828
System SetPt	-	46%
RL Voltage	-	118
RL Amperage	-	0.35
Total ESP	.6"	0.17"
Fan Inlet SP	-	-0.17"
Fan Discharge SP	-	ATM

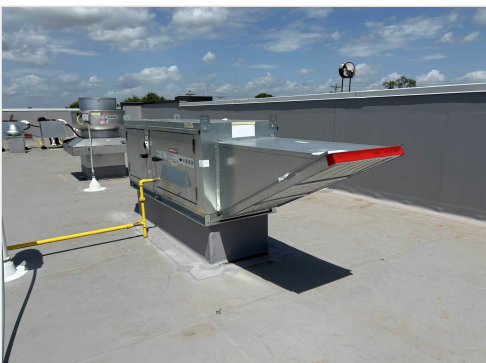
Unit Data - PHOTO LOG

Asset: MAU1

AREA:HOOD

Unit Data		
	Design	Actual
MFG	CAPTIVEAIRE	CAPTIVEAIRE
Model Num	A1-D.250-15D	A1-D.250-15D
Serial Num	-	6104716
Type	MAU	MUA
Configuration	VERTICAL	VERTICAL

Gas Heat		
	Design	Actual
Heater Operates (y/n)	-	YES
Flame Status (pass/fail)	-	PASS
Inlet Air Temp SetPt	-	55
Discharge Air Temp SetPt	-	65
Air Flow Switch SP Actual	-	0.347"

Test Data		
	Design	Actual
CFM	1300	1386
SF RPM	-	1380
Motor RPM	-	1380
SF System SetPt	-	47.6HZ
RL Voltage	208	112/112/112
RL Amperage	-	2.2/2.2/2.3
