**Report: TAB Report**  
**Function: Test, Adjust, & Balance**  
**Date: 07/08/2025**  
**Completed By: National TAB**

**07-07-25 CHIPOTLE #4722 SPRINGDALE, AR**

5761 W. SUNSET AVE

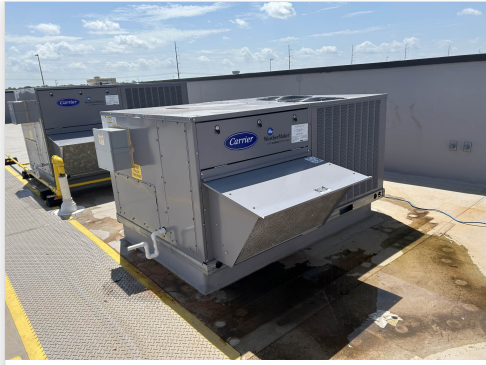
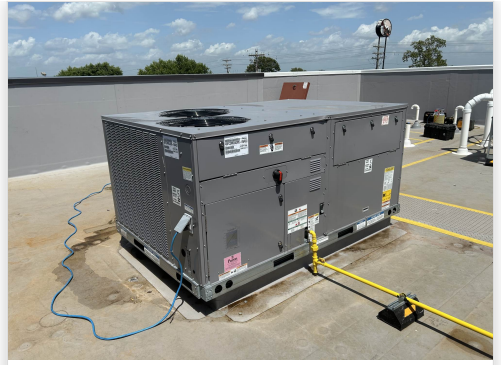
Asset: RTU1

Unit undersized (explained further in issues.). Unit balanced proportionally at 75% of design with exception of office (Diffuser 1-1) was balanced at design due to room size.

Construction grade filters installed.

**Issue Name :** RTU-1 Undersized unit.  
**Description :** RTU-1 is undersized, design unit is a 10 ton model 48FCDM12, actual installed unit is a 7.5 ton model 48FCDM08. Unit is not rated to meet 4000 CFM; Unit balanced proportionally to the units capabilities (3000CFM 75% of design) with exception of office diffuser (1-1) which was balanced at design due to the small nature of the space served.

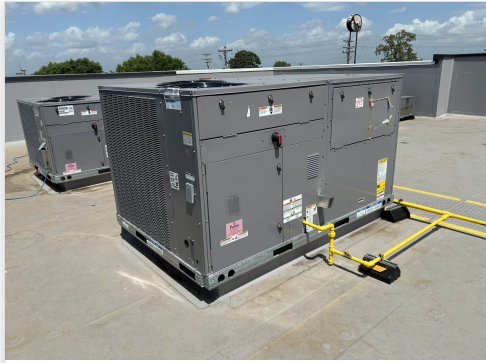
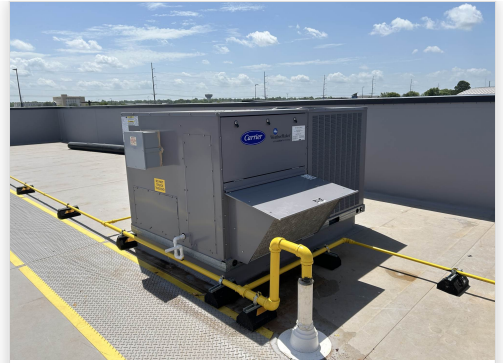
Asset: RTU2

Notes:  
Construction grade filters installed.

**Issue Name :** RTU-1 and RTU-2 Final filters.  
**Description :** RTU-1 and RTU-2 still have construction grade final filters and should be replaced with pleated filters.  
**Created By :** National TAB                      **Assigned To :** National TAB - Dan Hertenstein  
**Status :** Open  
**Priority :** [Medium](#)                      **Asset Tag :**  
**Originated Date :** 07/08/2025 - Cody Collett - National TAB
