Report: TAB Report
Function: Test, Adjust, & Balance
Date: 09/19/2024

09-16-24 WAWA #8440 BYRAM, NJ

Project: 09-16-24 WAWA #8440 BYRAM, NJ

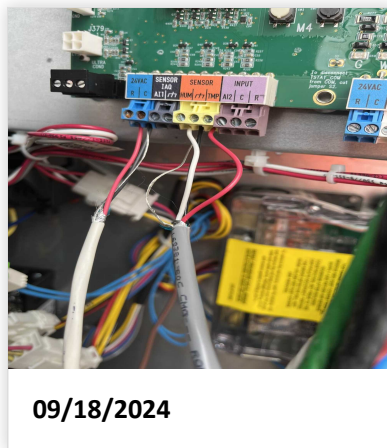
Issue Name : Humidity sensor wiring
Description : All AC humidity sensors are not wired per the manufacturers recommendation. The humidity sensor alone needs two separate strands of two wire shielded to avoid signal interference. Recommend running another strand if shielded wire to meet specifications.
Created By : National TAB **Assigned To :** National TAB - Will Turnbough
Status : Open
Priority : High **Asset Tag :**
Originated Date : 09/18/2024 - Tyler Youells - National TAB

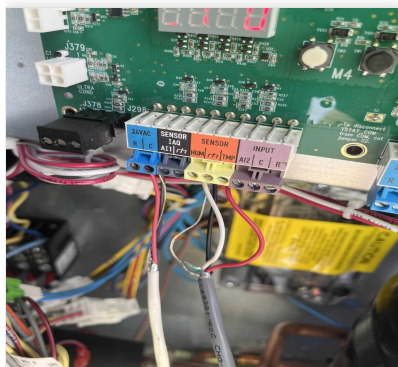
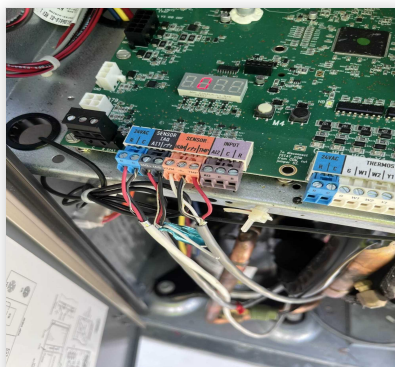
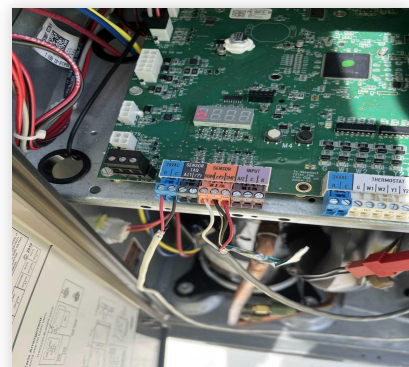
2 conductor shielded cable has one wire landed to Vin, one to GND, and the shield wire is not connected. Fail

SUPERINTENDENT NOTIFIED THAT WIRING NEEDS TO BE CORRECTED. PICTURES INDICATE AS INSTALLED.

For second shielded cable, one wire is landed to Vout and the shield wire is not connected. Fail

SUPERINTENDENT NOTIFIED THAT WIRING NEEDS TO BE CORRECTED

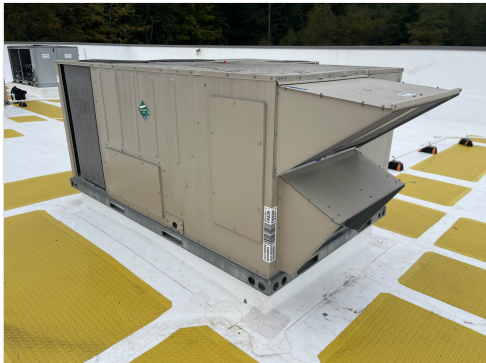
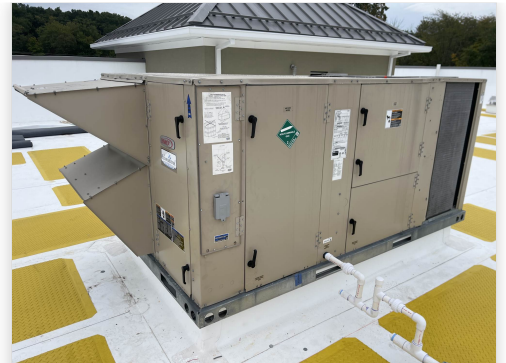
Asset: RTU1

Unit Data		
	Design	Actual
MFG	LENNOX ENLIGHT	LENNOX ENLIGHT
Serial Num	-	5623H08959
Model Num	LCT102H4E	LCT102H4EE1Y
Type	RTU	RTU
Configuration	VERTICAL	VERTICAL
Num OA Filters 1	-	2
OA Filter Size 1	-	16X25
Num Final Filter 1	-	4
Final Filter Size 1	-	20x25x2

Test Data		
	Design	Actual
SF CFM	3400	3426
SF RPM	-	1430
MOTOR RPM	-	1430
RA CFM	2855	2887
OA CFM	545	539
RL Voltage	-	212.5/212.9/212.7
RL Amperage	-	3.05/3.02/3.04
SF System SetPt	-	65%
RA Damper Position	-	MECHANICAL LINKAGE
OA Damper Position	-	28%
OA Damper Type	-	ECONOMIZER

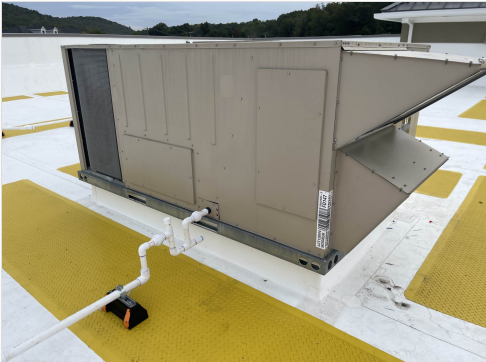
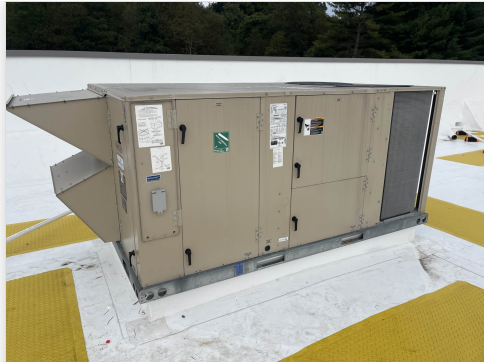
Asset: RTU2

Unit Data		
	Design	Actual
MFG	LENNOX ENLIGHT	LENNOX ENLIGHT
Serial Num	-	5623G06246
Model Num	LCT120H4E	LCT120H4EN1Y
Type	RTU	RTU
Configuration	VERTICAL	VERTICAL
Num OA Filters 1	-	2
OA Filter Size 1	-	25X16
Num Final Filter 1	-	4
Final Filter Size 1	-	20X25X2

Test Data		
	Design	Actual
SF CFM	4000	3968
SF RPM	-	1540
MOTOR RPM	-	1540
RA CFM	3350	3308
OA CFM	650	660
RL Voltage	-	212.7/213.1/212.9
RL Amperage	-	3.38/3.4/3.44
SF System SetPt	-	70%
RA Damper Position	-	MECHANICAL LINKAGE
OA Damper Position	-	29%
OA Damper Type	-	ECONOMIZER

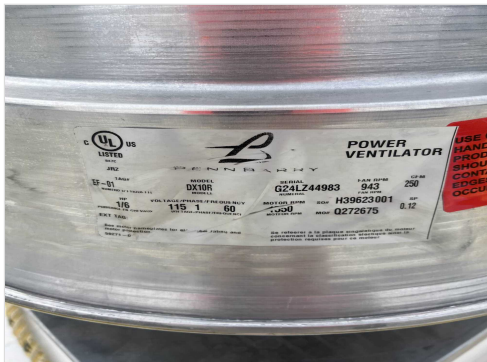
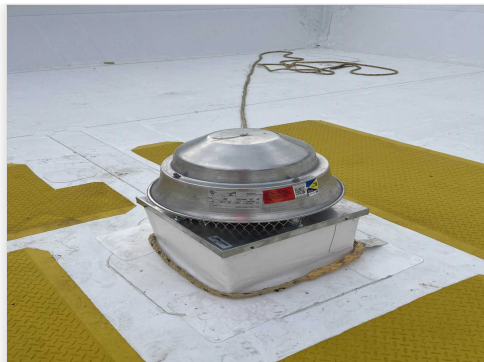
Asset: EF1

Unit Data		
	Design	Actual
MFG	PENNBARRY	PENNBARRY
Model Num	DX10R	DX10R
Serial Num	-	G24LZ44983
Type	DOWNBLAST	DOWNBLAST
Configuration	VERTICAL	VERTICAL

Test Data		
	Design	Actual
CFM	300	312
Fan RPM	1550	NA
Fan Rotation	-	CW
Motor RPM	-	NA
System SetPt	-	MARKED ON DIAL
RL Voltage	-	99.4V
RL Amperage	-	1.54
Total ESP	0.125"	0.48"
Fan Inlet SP	-	-0.48"
Fan Discharge SP	-	ATM

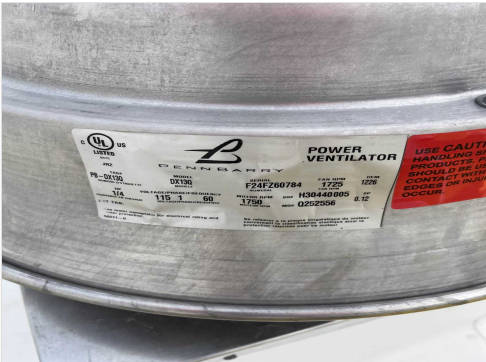
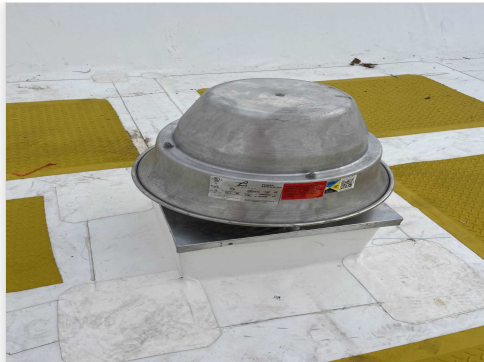
Asset: EF2

Unit Data		
	Design	Actual
MFG	PENNBARRY	PENNBARRY
Model Num	DX13Q	DX13Q
Serial Num	-	F24FZ60784
Type	DOWNBLAST	DOWNBLAST
Configuration	VERTICAL	VERTICAL

Test Data		
	Design	Actual
CFM	900	893
Fan RPM	1725	NA
Fan Rotation	-	CW
Motor RPM	-	NA
System SetPt	-	MARKED ON DIAL
RL Voltage	-	111.1
RL Amperage	-	3.70
Total ESP	0.250"	0.56"
Fan Inlet SP	-	-0.56"
Fan Discharge SP	-	ATM

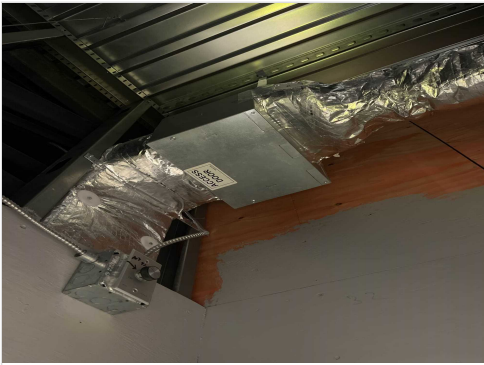
Asset: EF3

Unit Data		
	Design	Actual
MFG	PENNBARRY	PENNBARRY
Model Num	Z3H	Z3HTDA
Serial Num	-	L23AG68580
Type	INLINE	INLINE
Configuration	HORIZONTAL	HORIZONTAL

Test Data		
	Design	Actual
CFM	60	62
