Report: TAB REPORT
Function: Test, Adjust, & Balance
Date: 01/28/2026
Completed By: National TAB

**01-26-26 CHIPOTLE #5455 MARTINSVILLE,
VA**

Project: 01-26-26 CHIPOTLE #5455 MARTINSVILLE, VA

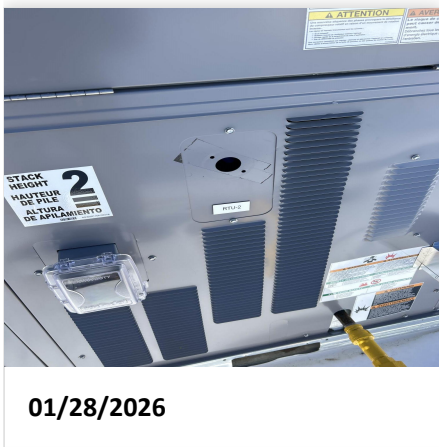
Issue Name : RTU 2 power switch
Description : RTU 2 power switch not installed. If you have to service the unit, it can only be shutoff at the breaker.
Created By : National TAB **Assigned To :** National TAB - Dan Hertenstein
Status : Open
Priority : InfoOnly **Asset Tag :** RTU2
Originated Date : 01/28/2026 - Jearod Ferrette - National TAB

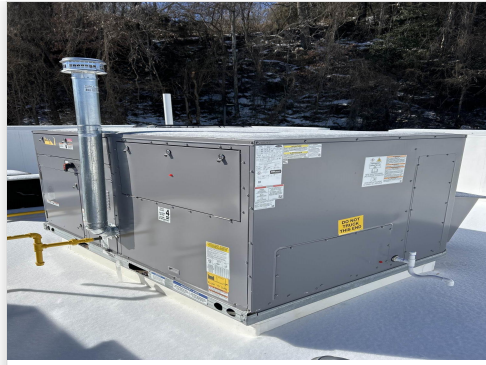
Unit Data - PHOTO LOG

Asset: RTU1

Unit Data		
	Design	Actual
MFG	CARRIER	CARRIER
Serial Num	-	3625P63839
Model Num	48GE_N12	48GE_N12
Type	RTU	RTU
Configuration	VERTICAL	VERTICAL
Num OA Filters 1	-	1
OA Filter Size 1	-	35X19.25
Num Final Filter 1	-	4
Final Filter Size 1	-	20X20X2

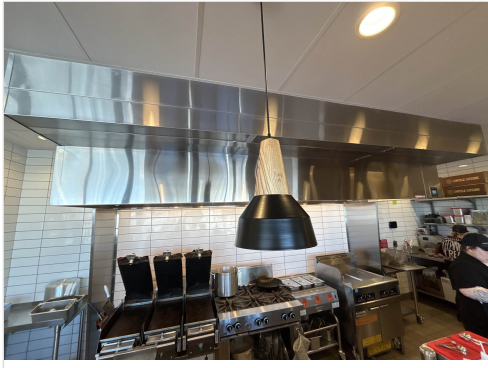
Unit Data - PHOTO LOG

Asset: HD1

Unit Data		
	Design	Actual
MFG	CAPTIVEAIRE	CAPTIVEAIRE
Model Num	5424 ND-2-ACPSP-F	5424 ND-2-ACPSP-F
Job / Serial Num	-	7623172
Type	TYPE I CANOPY	TYPE I CANOPY
Hood length	153"	153"
Hood Width	54"	54"
Supply Plenum Type	-	ACPSP
Supply Plenum Width	9"	9"
Supply Plenum Length	165"	165"
