Report: TAB Report
Function: Test, Adjust, & Balance
Date: 01/28/2026
Completed By: National TAB

**01-26-26 CHIPOTLE #5455 MARTINSVILLE,
VA**

Project: 01-26-26 CHIPOTLE #5455 MARTINSVILLE, VA

Project: 01-26-26 CHIPOTLE #5455 MARTINSVILLE, VA
Function: Test, Adjust, & Balance

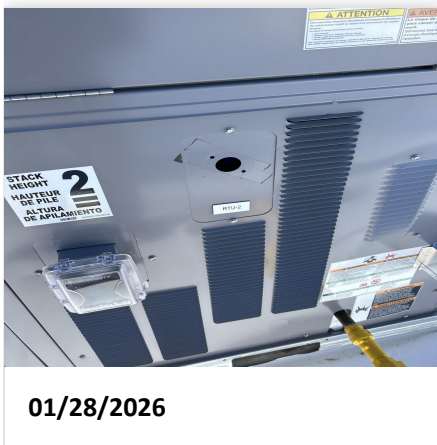
Issue Name : RTU 2 power switch
Description : RTU 2 power switch not installed. If you have to service the unit, it can only be shutoff at the breaker.
Created By : National TAB **Assigned To :** National TAB - Dan Hertenstein
Status : Open
Priority : InfoOnly **Asset Tag :** RTU2
Originated Date : 01/28/2026 - Jearod Ferrette - National TAB

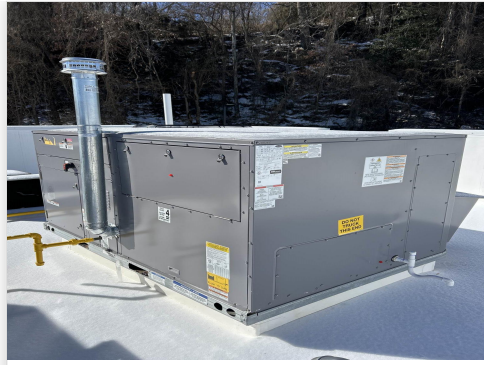
Unit Data - PHOTO LOG

Asset: RTU1

AREA:KITCHEN

Unit Data		
	Design	Actual
MFG	CARRIER	CARRIER
Serial Num	-	3625P63839
Model Num	48GE_N12	48GE_N12
Type	RTU	RTU
Configuration	VERTICAL	VERTICAL
Num OA Filters 1	-	1
OA Filter Size 1	-	35X19.25
Num Final Filter 1	-	4
Final Filter Size 1	-	20X20X2

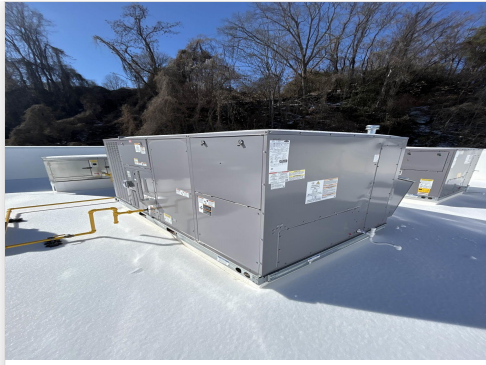
Unit Data - PHOTO LOG

Asset: RTU2

AREA:DINING

Unit Data		
	Design	Actual
MFG	CARRIER	CARRIER
Serial Num	-	3525P07071
Model Num	48GE_N14	48GE_N14
Type	RTU	RTU
Configuration	VERTICAL	VERTICAL
Num OA Filters 1	-	2
OA Filter Size 1	-	22.5X25.5
Num Final Filter 1	-	4
Final Filter Size 1	-	16X20X4
Num Final Filter 2	-	2
Final Filter Size 2	-	20X20X4

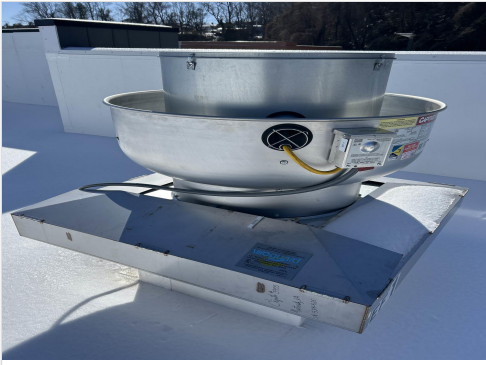
Unit Data - PHOTO LOG

Asset: EF1

AREA:HOOD

Unit Data		
	Design	Actual
MFG	CAPTIVEAIRE	CAPTIVEAIRE
Model Num	DU180HFA	DU180HFA
Serial Num	-	7623172
Type	UPBLAST	UPBLAST
Configuration	VERTICAL	VERTICAL

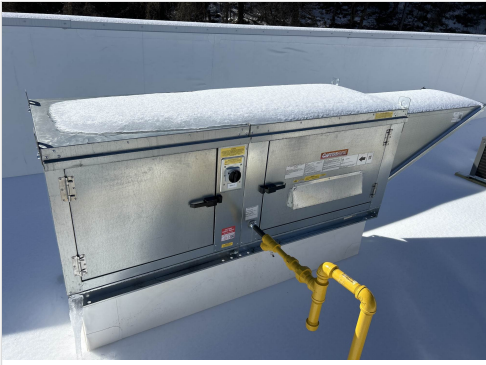
Unit Data - PHOTO LOG

Asset: MAU1

AREA:HOOD

Unit Data		
	Design	Actual
MFG	CAPTIVEAIRE	CAPTIVEAIRE
Model Num	A1-D.250-15D	A1-D.250-15D
Serial Num	-	7623172
Type	MAU	MAU
Configuration	VERTICAL	VERTICAL

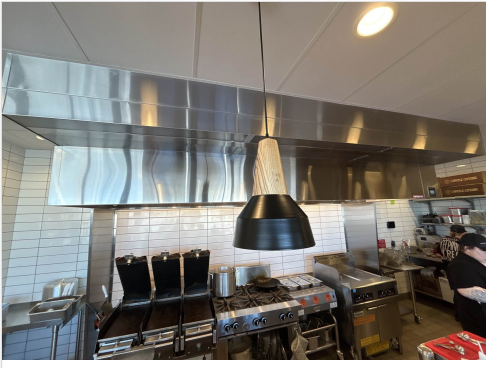
Unit Data - PHOTO LOG

Asset: HD1

AREA:COOKLINE

Unit Data		
	Design	Actual
MFG	CAPTIVEAIRE	CAPTIVEAIRE
Model Num	5424 ND-2-ACPSP-F	5424 ND-2-ACPSP-F
Job / Serial Num	-	7623172
Type	TYPE I CANOPY	TYPE I CANOPY
Hood length	153"	153"
Hood Width	54"	54"
Supply Plenum Type	-	ACPSP
Supply Plenum Width	9"	9"
Supply Plenum Length	165"	165"
