Report: TAB Report Penn Station Brunswick

Function: Test, Adjust, & Balance

Date: 12/01/2023

11-27-23 PENN STATION - BRUNSWICK, OH

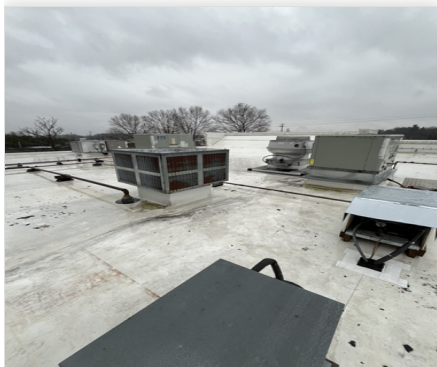
Neighboringequipment...
12/01/2023

Issue Name : Building Pressure
Description : Note: Net building pressure is designed to be positive. Actual building pressure is Net negative after TAB. The neighboring suite is a Chinese restaurant that does not have MUA running. Penn station space pressure test with all systems off: -0.021" AVG showing neighbor is causing net negative pressure.

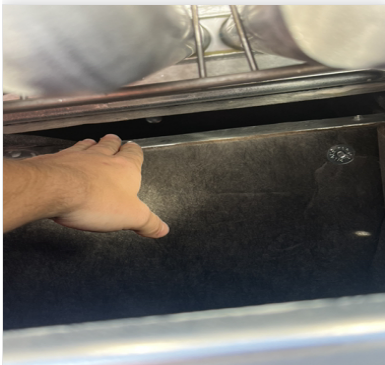
Supplygap
12/01/2023

Issue Name : CRITICAL: RTU-3 Leakage issue
Description : RTU-3 Curb adapter is preventing the unit from sitting flush to the curb/duct connections.
Created By : National TAB **Assigned To :** National TAB - Tyler Youells
Status : Pending
Priority : Urgent **Asset Tag :**
Originated Date : 11/30/2023 - Tyler Youells - National TAB

- Pictures of Gap before taping

- MC temporarily taped the gaps so TAB can be completed. MC stated they will come back for a more permanent solution
