Report: TAB Report
Function: Test, Adjust, & Balance
Date: 10/22/2025
Completed By: National TAB

PROJECT
10-20-25 CULVERS LEESBURG, FL

Project: 10-20-25 CULVERS LEESBURG, FL

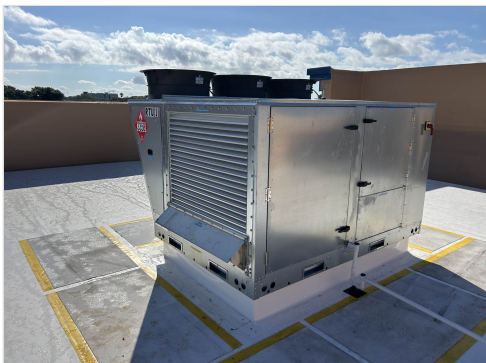
Unit Data - PHOTO LOG

Unit Data		
	Design	Actual
MFG	CAPTIVEAIRE	CAPTIVEAIRE
Serial Num	-	7217510
Model Num	CASRTU3-E.452-24-20T	CAS-HVAC3-E.452-24-20T
Type	RTU	RTU
Configuration	VERTICAL	VERTICAL
Num OA Filters 1	-	4
OA Filter Size 1	-	16x25x2
Num Final Filter 1	-	8
Final Filter Size 1	-	20x25x2

Test Data		
	Design	Actual
SF CFM	5200	5169
SF RPM	-	1379
RA CFM	3200	3113
OA CFM	2000	2056
RL Voltage	-	185V VFD
RL Amperage	-	13.7A VFD
SF Rotation	-	CCW
SF System SetPt	-	71.0Hz
RA Damper Position	-	5.3V
Min OA Damper Position	-	4.7V
Min OA Damper Type	-	ECONOMIZER

Performance Data		
	Design	Actual
Fan Suction SP	-	-1.52"
Fan Discharge SP	-	0.79"
Fan Total SP	-	2.31"

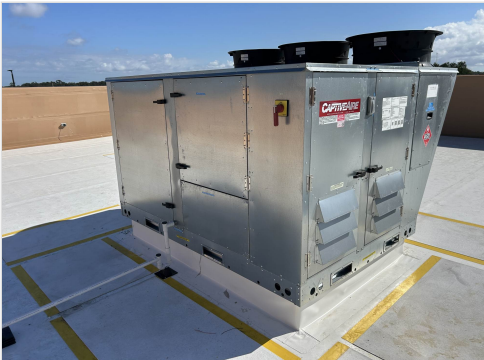
Unit Data - PHOTO LOG

Unit Data		
	Design	Actual
MFG	CAPTIVEAIRE	CAPTIVEAIRE
Serial Num	-	7217510
Model Num	CASRTU3-E.302-24-20T	CAS-HVAC3-E.302-24-20T
Type	RTU	RTU
Configuration	VERTICAL	VERTICAL
Num OA Filters 1	-	4
OA Filter Size 1	-	16x25x2
Num Final Filter 1	-	8
Final Filter Size 1	-	20x25x2

Test Data		
	Design	Actual
SF CFM	5000	4967
SF RPM	-	1359
RA CFM	3000	2990
OA CFM	2000	1977
RL Voltage	-	180V VFD
RL Amperage	-	13.3A VFD
SF Rotation	-	CCW
SF System SetPt	-	70Hz
RA Damper Position	-	5.4V
Min OA Damper Position	-	4.6V
Min OA Damper Type	-	ECONOMIZER

Performance Data		
	Design	Actual
Fan Suction SP	-	-1.57"
Fan Discharge SP	-	0.93"
Fan Total SP	-	2.50"

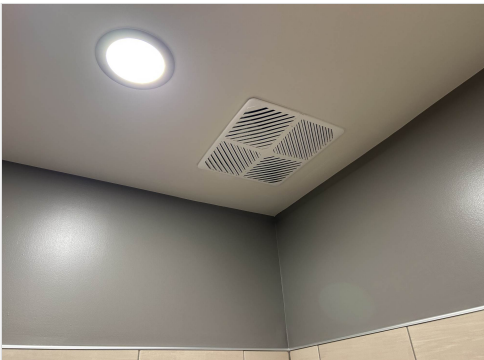
Unit Data - PHOTO LOG

Unit Data		
	Design	Actual
MFG	ACCUREX	GREENHECK
Model Num	XCR-A200	SP-A200
Serial Num	-	27135456
Type	CEILING	CEILING
Configuration	VERTICAL	VERTICAL

Test Data		
	Design	Actual
CFM	220	230
Fan RPM	-	900
Fan Rotation	-	CCW
Motor RPM	-	900
System SetPt	-	MAX
RL Voltage	-	120
RL Amperage	-	0.46

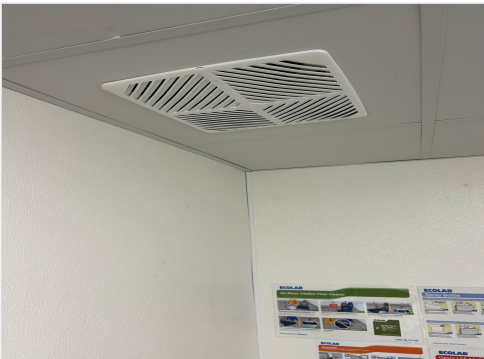
Unit Data - PHOTO LOG

Unit Data		
	Design	Actual
MFG	ACCUREX	GREENHECK
Model Num	XCR-B50	SP-B50
Serial Num	-	27135458
Type	CEILING	CEILING
Configuration	VERTICAL	VERTICAL

Test Data		
	Design	Actual
CFM	50	51
Fan RPM	-	DD
Fan Rotation	-	CCW
Motor RPM	-	DD
System SetPt	-	SPEED CONTROLLER (MARKED)
RL Voltage	-	120
RL Amperage	-	0.11

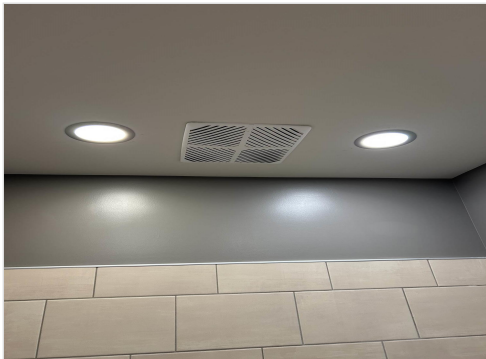
Unit Data - PHOTO LOG

Unit Data		
	Design	Actual
MFG	ACCUREX	GREENHECK
Model Num	XCR-B70	SP-B70
Serial Num	-	27135464
Type	CEILING	CEILING
Configuration	VERTICAL	VERTICAL

Test Data		
	Design	Actual
CFM	70	65
Fan RPM	-	675
Fan Rotation	-	CCW
Motor RPM	-	675
System SetPt	-	MAX
RL Voltage	-	117
RL Amperage	-	0.11

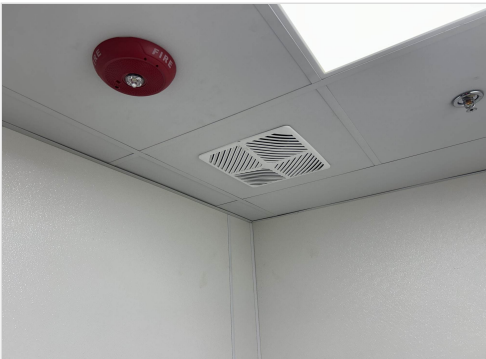
Unit Data - PHOTO LOG

Unit Data		
	Design	Actual
MFG	ACCUREX	GREENHECK
Model Num	XCR-B70	SP-B70
Serial Num	-	27135460
Type	CEILING	CEILING
Configuration	VERTICAL	VERTICAL

Test Data		
	Design	Actual
CFM	70	73
Fan RPM	-	DD
Fan Rotation	-	CCW
Motor RPM	-	DD
System SetPt	-	SPEED CONTROLLER (MARKED)
RL Voltage	-	119
RL Amperage	-	0.13

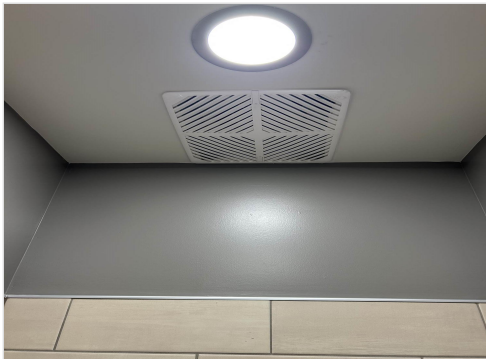
Unit Data - PHOTO LOG

Unit Data		
	Design	Actual
MFG	ACCUREX	GREENHECK
Model Num	XCR-B70	SP-B70
Serial Num	-	27135462
Type	CEILING	CEILING
Configuration	VERTICAL	VERTICAL

Test Data		
	Design	Actual
CFM	70	68
Fan RPM	-	675
Fan Rotation	-	CCW
Motor RPM	-	675
System SetPt	-	MAX
RL Voltage	-	118
RL Amperage	-	0.13

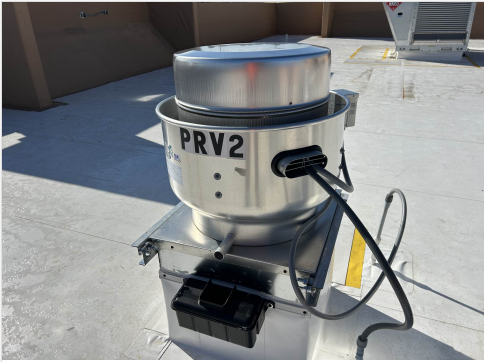
Unit Data - PHOTO LOG

Unit Data		
	Design	Actual
MFG	ACCUREX	ACCUREX
Model Num	XRUB-161XP-15	XCUE-140-10-VG-1-26-G
Serial Num	-	27154640
Type	-	UPBLAST
Configuration	-	VERTICAL

Test Data		
	Design	Actual
CFM	1500	1512
Fan RPM	-	DD
Fan Rotation	-	CW
Motor RPM	-	DD
RL Voltage	-	120
RL Amperage	-	4.2
Suction ESP	-	-0.60"
Discharge ESP	-	ATM
Total ESP	-	0.60"

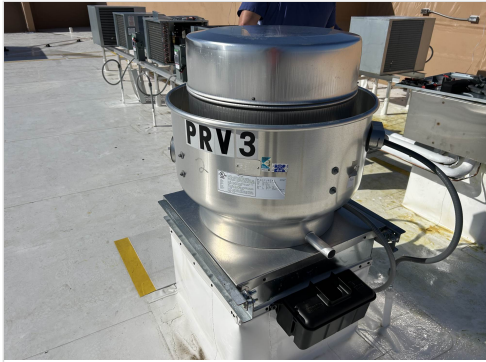
Unit Data - PHOTO LOG

Unit Data		
	Design	Actual
MFG	ACCUREX	ACCUREX
Model Num	XRUB-141-7	XCUE-140-10-VG-1-26-G
Serial Num	-	27154715
Type	-	UPBLAST
Configuration	-	VERTICAL

Test Data		
	Design	Actual
CFM	1500	1522
Fan RPM	-	DD
Fan Rotation	-	CW
Motor RPM	-	DD
RL Voltage	-	120
RL Amperage	-	3.7
Suction ESP	-	-0.52"
Discharge ESP	-	ATM
Total ESP	-	0.52"

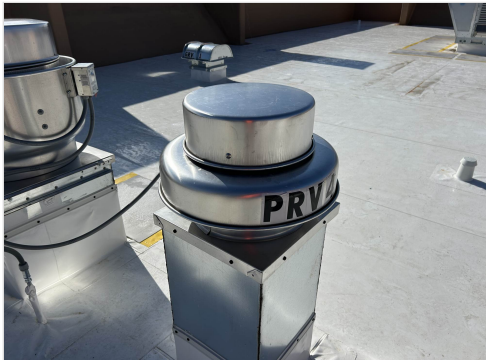
Unit Data - PHOTO LOG

Unit Data		
	Design	Actual
MFG	ACCUREX	ACCUREX
Model Num	XRED-090-D	XRED-095-D-8-1-17-X
Serial Num	-	27135914
Type	-	DOWNBLAST
Configuration	-	VERTICAL

Test Data		
	Design	Actual
CFM	350	332
Fan RPM	-	DD
Fan Rotation	-	CORRECT
Motor RPM	-	DD
System SetPt	-	SPEED CONTROLLER
RL Voltage	-	120
RL Amperage	-	1.2
Total ESP	-	0.34"
Fan Inlet SP	-	-0.34"
Fan Discharge SP	-	ATM

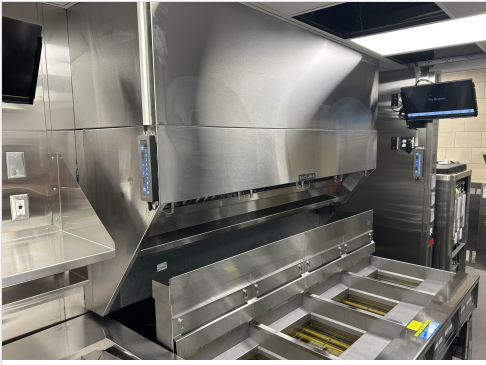
Unit Data - PHOTO LOG

Unit Data		
	Design	Actual
MFG	ACCUREX	ACCUREX
Model Num	XXEP-6.92-S	XXEP-83.00-S
Job / Serial Num	-	27147981
Type	TYPE I LOW PROXIMITY	TYPE I LOW PROXIMITY
Hood length	83"	83"
Hood Width	23"	23"

Test Data Exhaust		
	Design	Actual
Filter Type	X-TRACTOR	X-TRACTOR
Filter Size 1	16X16	16X16
Filter Qty 1	5	5
Filter AK factor size 1	1.53	1.53
Filter Total AK Area	7.65	7.65
Filter1 FPM	-	205
Filter2 FPM	-	186
Filter3 FPM	-	205
Filter4 FPM	-	184
Filter5 FPM	-	217
Filter Ave FPM(corr)	-	199
CFM	1500	1522

Notes:
Setpoint: 6.4 VDC

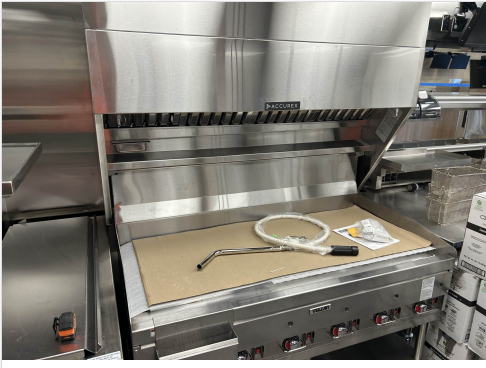
Unit Data - PHOTO LOG

Unit Data		
	Design	Actual
MFG	ACCUREX	ACCUREX
Model Num	XGEP-5.33-S	XXEP-64.00-S
Job / Serial Num	-	27147982
Type	TYPE I LOW PROX	TYPE I LOW PROXIMITY
Hood length	64"	64"
Hood Width	23"	23"

Test Data Exhaust		
	Design	Actual
Filter Type	GREASE GRABBER	X-TRACTOR
Filter Size 1	16X16	16X16
Filter Qty 1	4	4
Filter AK factor size 1	1.53	1.53
Filter Total AK Area	6.12	6.12
Filter1 FPM	-	269
Filter2 FPM	-	233
Filter3 FPM	-	237
Filter4 FPM	-	250
Filter Ave FPM(corr)	-	247
CFM	1500	1512

Notes:
Setpoint: 6.8 VDC

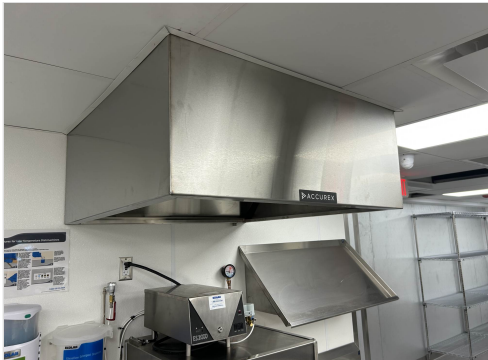
Unit Data - PHOTO LOG

Unit Data		
	Design	Actual
MFG	ACCUREX	ACCUREX
Model Num	XD3-3.5-S	XD3-3.5-S
Serial Num	-	N/A
Type	TYPE II CANOPY	TYPE II
Hood length	42"	42"
Hood Width	42"	42"

Test Data		
	Design	Actual
Exhaust CFM	350	332

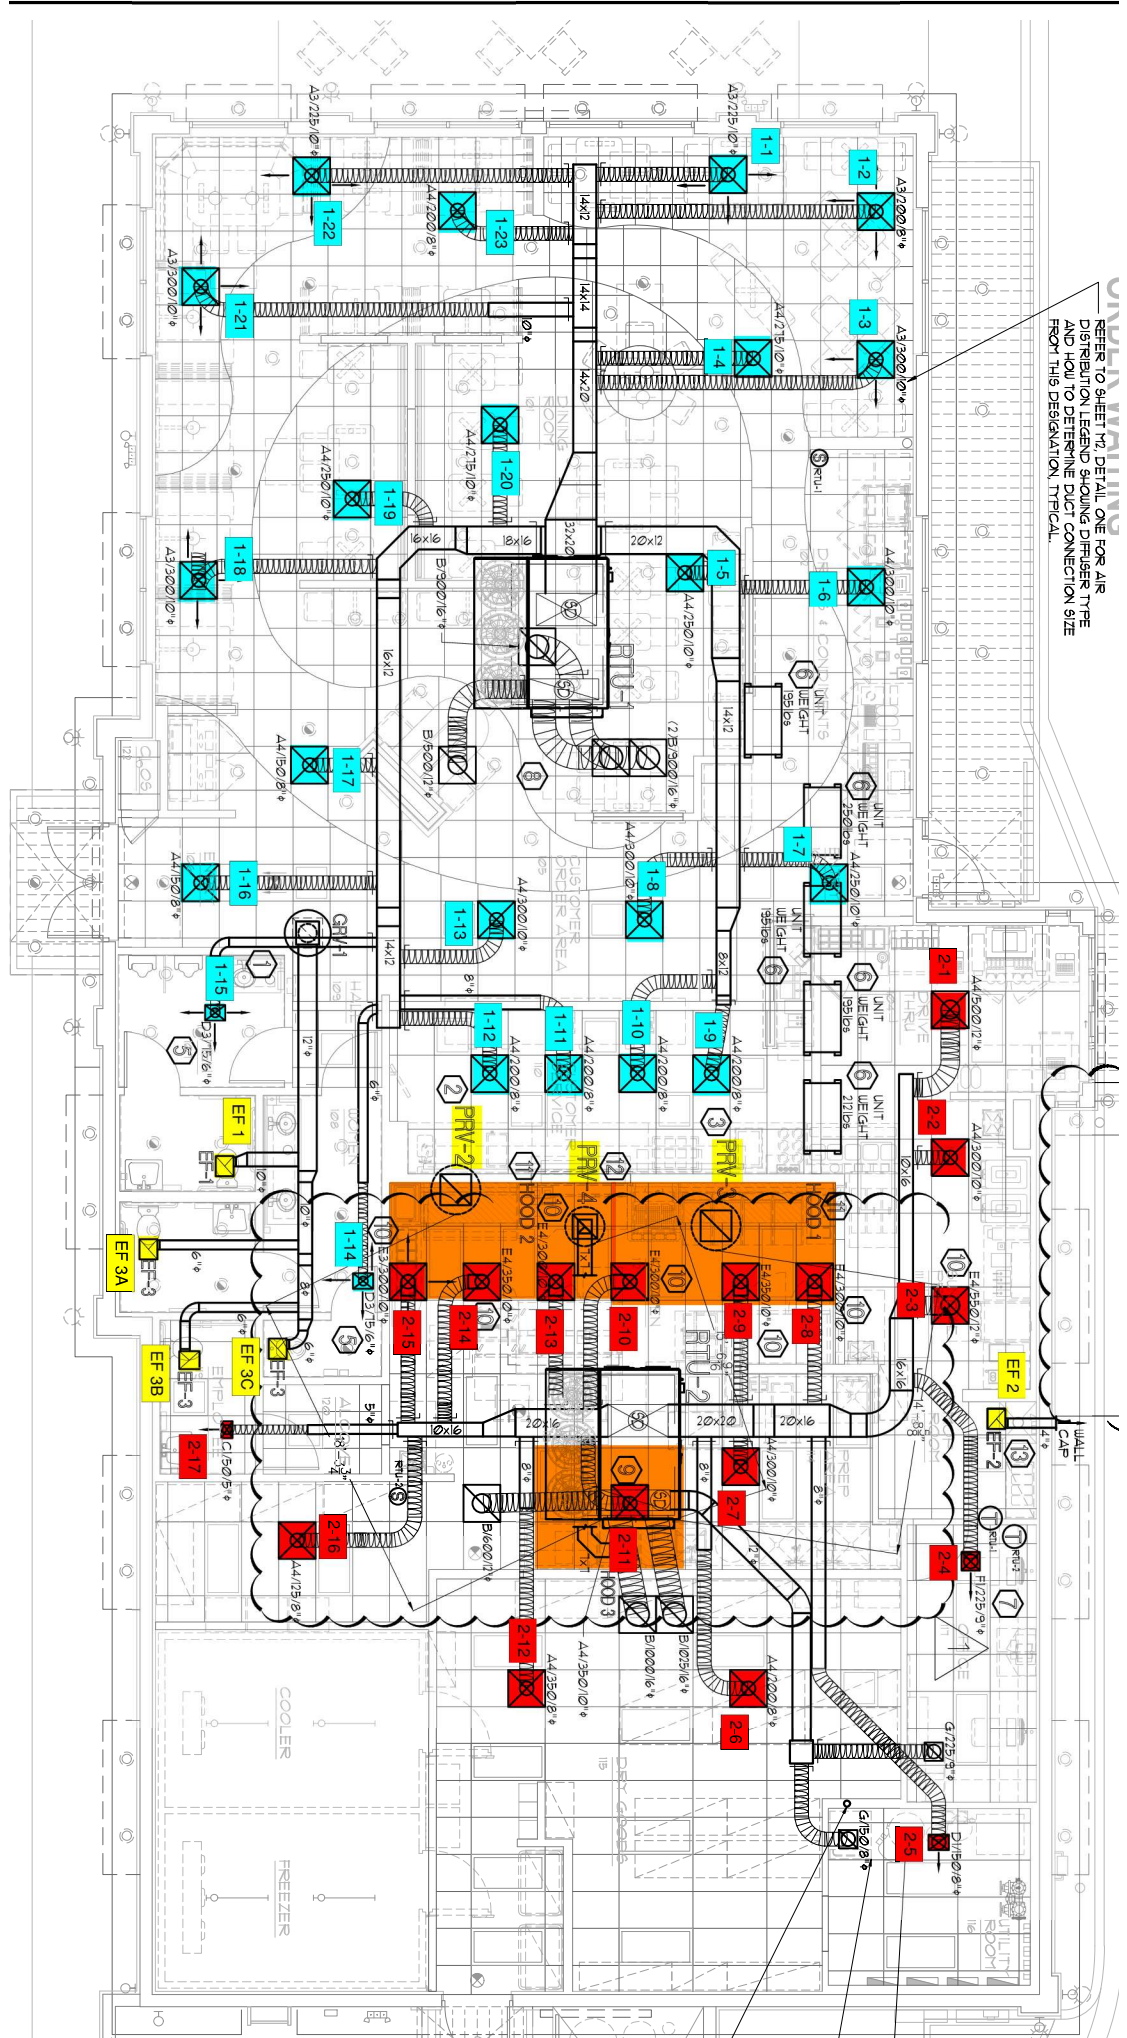
REFER TO SHEET H2 DETAIL ONE FOR AIR DISTRIBUTION LEGEND SHOWING DIFFUSER TYPE AND HOW TO DETERMINE DUCT CONNECTION SIZE FROM THIS DESIGNATION TYPICAL.
