**Report: FINAL TAB REPORT
Function: Test, Adjust, & Balance
Date: 8/15/2022**

**PROJECT
05-09 NIKE LIVE - CARY, NC**

Project: 05-09 NIKE LIVE - CARY, NC

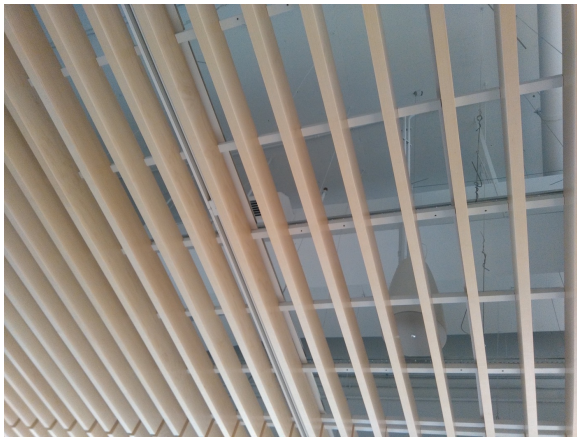
Notes: [1] FCU4 FAN IS RUNNING IN HIGH SPEED. TO PLACE FAN INTO HIGH-SPEED WIRE TAPES WERE ADJUSTED VIA CARRIER TECH SUPPORT OVER THE PHONE AND EMS PLACED UNIT INTO COOLING MODE. UNIT TOTAL IS LOW OF DESIGN CFM. [2] NO SAFE PLACE TO TAKE A VOLT READING [3] SF1 FAN WHEEL WAS GRINDING BADLY, FAN WAS SHUT OFF TO PREVENT DAMAGE. EMS DOES NOT HAVE CONTROL OF SF1 OR OA DAMPER POSITIONS.
