Report: FINAL TAB REPORT
Function: Test, Adjust, & Balance
Date: 07/25/2022

PROJECT
08-29 NIKE LIVE - CARY, NC

Project: 08-29 NIKE LIVE - CARY, NC

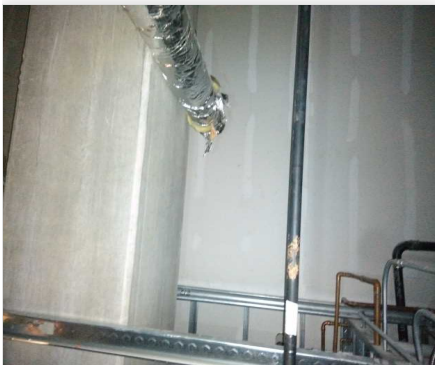
ef1_1_cary_
07/08/2022

Issue Name : EF1
Description : 1.EF1-1 DUCTWORK IS NOT FINISHED OR RUN TO GRILL. UNABLE TO BALANCE THIS GRILL OR FAN TILL DUCTWORK IS COMPLETED.
Created By : National TAB **Assigned To :** National TAB - Brianna Biggs
Status : Closed
Originated Date : 07/07/2022 - Dale Wheeler - National TAB

- **04/27/2023 National TAB - Dale Wheeler**
 - DUCTWORK HAS BEEN COMPLETED GRILL HAS BEEN BALANCED 4/27/23

- **08/31/2022 National TAB - Andrew Loignon**
 - DUCTWORK IS STILL UNCONNECTED. UNABLE TO BALANCE UNTIL DUCTWORK IS CONNECTED.

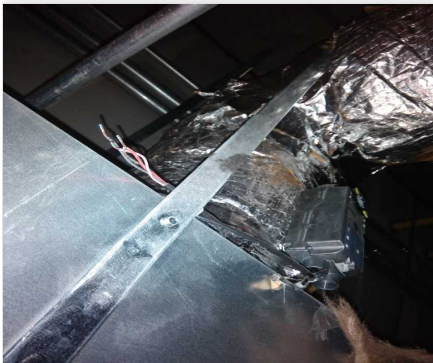
oa_fcu1
07/08/2022

Description : 1. EMS CONTROLS DO NOT HAVE CONTROL OVER OA DAMPERS TO EACH UNIT. OA CANNOT BE SET UNTIL THEY ARE ABLE TO EST. CONTROLS WITH THESE OA DAMPERS. 2. SGRD2 IS CONNECT TO THE SF1 DUCTWORK. IT SHOULD BE CONNECTED TO THE FCU1 SUPPLY DUCT. - FIXED EMS HAS CONTROL OF OA DAMPER, OUTSIDE HAS BEEN TRAVERSED AND DAMPER SET FOR THIS UNIT 4/27/23

- **04/27/2023 National TAB - Dale Wheeler**
 - SGRD2 IS CONNECT TO THE SF1 DUCTWORK. IT SHOULD BE CONNECTED TO THE FCU1 SUPPLY DUCT. - THIS ISSUE HAS BEEN FIXED EMS HAS CONTROL OF OA DAMPER, OUTSIDE HAS BEEN TRAVERSED AND DAMPER SET FOR THIS UNIT 4/27/23

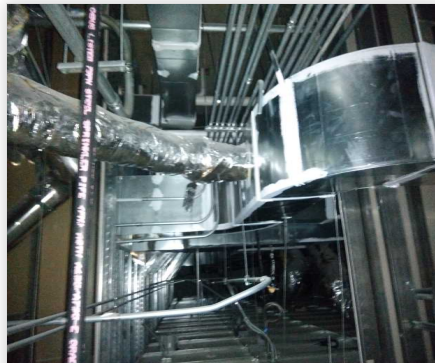
sgrd2_cary_
07/08/2022

- SGRD2 IS CONNECT TO THE SF1 DUCTWORK. IT SHOULD BE CONNECTED TO THE FCU1 SUPPLY DUCT, THIS ISSUE HAS STILL NOT BE ADDRESSED. SF1 CANNOT BE CONTROLLED (REFER TO SF1 ISSUE FOR MORE INFORMATION), RESULTING IN THE INABILITY TO BALANCE OA TO FCU1.
-

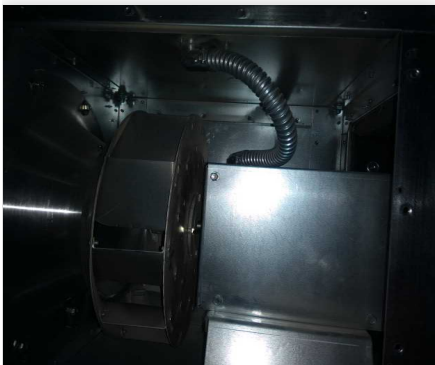
sf1_cary
07/08/2022

SF1 fan was manually shut off due to severe fan wheel grinding on housing

Issue Name : SF1
Description : EMS HAS NO CONTROL OVER FAN SPEED, THEIR SYSTEM SAYS SF1 FAN WAS NOT RUNNING WHEN FAN WAS RUNNING 100%. THERE IS NO SPEED CONTROLLER INSTALLED ON FAN. FAN BLADES ARE ALSO GRINDING REALLY BAD, FAN WAS SHUT OFF TO PREVENT DAMAGE FROM OCCURRING. - FIXED FAN HAS BEEN BALANCED AND SET TO 7.2V
Created By : National TAB **Assigned To :** National TAB - Brianna Biggs
Status : Closed
Originated Date : 07/07/2022 - Dale Wheeler - National TAB

- **08/31/2022 National TAB - Andrew Loignon**
 - SF1 IS OPERATIONAL, HOWEVER COMFORT CONTROL SYSTEMS CAN NOT ADJUST FAN SPEED THROUGH THEIR SYSTEM DUE TO FAULTS, RESULTING IN SF1 NOT BEING ABLE TO BE BALANCED CAUSING THE INABILITY FOR OA OF FCU 1-4 TO BE BALANCED.

Resolution: SF1 - fan controls are installed and operation. fan has been traversed and balanced. Final fan speed setting is 7.2V

Resolution: this issue has been fixed and fan is operating with no grinding noise
