**Report: FINAL TAB REPORT  
Function: Test, Adjust, & Balance  
Date: 8/15/2022**

**PROJECT  
05-09 NIKE LIVE - CARY, NC**

Project: 05-09 NIKE LIVE - CARY, NC

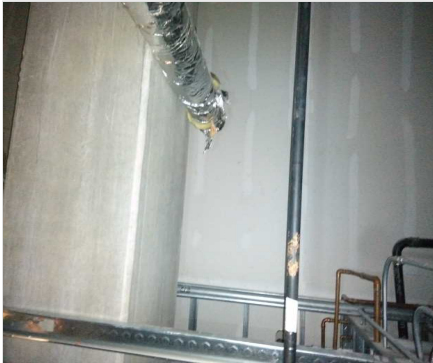
ef1\_1\_cary\_.jpg

**Description :** 1.EF1-1 DUCTWORK IS NOT FINISHED OR RUN TO GRILL. UNABLE TO BALANCE THIS GRILL OR FAN TILL DUCTWORK IS COMPLETED.

EF1 FAN DUCTWORK IS NOT CONNECTED TO EF1-1 FLEX DUCT IS NOT RUN DOWN TO DIFFUSER DUCTWORK LOCATED ABOVE HARD CEILING.

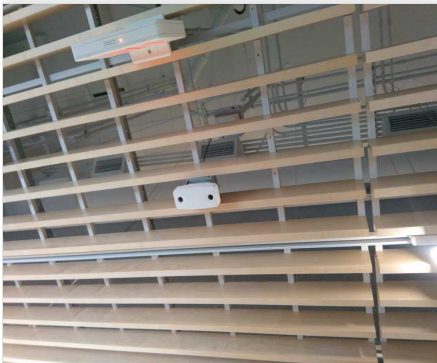
fcu5\_cary\_.jpg

**Description :** 1. FCU5 EMS CONTROLS DO NOT HAVE CONTROL OVER OA DAMPERS TO EACH UNIT. OA CANNOT BE SET UNTIL THEY ARE ABLE TO EST. CONTROLS WITH THESE OA DAMPERS. 2. FCU5 FAN IS RUNNING IN HIGH SPEED. TO PLACE FAN INTO HIGH-SPEED WIRE TAPES WERE ADJUSTED VIA CARRIER TECH SUPPORT OVER THE PHONE AND EMS PLACED UNIT INTO FULL COOLING MODE. UNIT TOTAL IS LOW

Notes: FCU5 FAN IS RUNNING IN HIGH SPEED. TO PLACE FAN INTO HIGH-SPEED WIRE TAPES WERE ADJUSTED VIA CARRIER TECH SUPPORT OVER THE PHONE AND EMS PLACED UNIT INTO COOLING MODE. UNIT TOTAL IS LOW OF DESIGN CFM. STATIC PRESSURES ARE VERY LOW INDICATING UNIT MAY NOT BE RESPONDING TO CALLS FOR HIGH SPEED. [2] NO SAFE PLACE TO TAKE A VOLT READING 3] SF1 FAN WHEEL WAS GRINDING BADLY, FAN WAS SHUT OFF TO PREVENT DAMAGE. EMS DOES NOT HAVE CONTROL OF SF1 OR OA DAMPER POSITIONS.

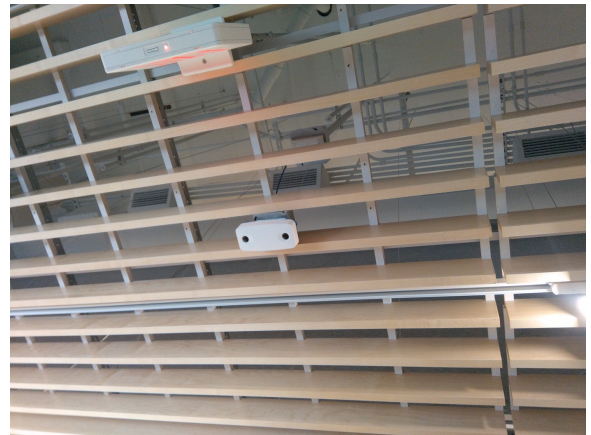
YES / EF1 NO / SF1 FAN WHEEL IS GRINDING UNABLE TO FIX THIS ISSUE. FAN HAS BEEN SHUT OFF TILL THIS ISSUE CAN BE RESOLVED. EMS DOES NOT HAVE COMMUNICATION WITH SF1

| Do actual net building airflow, design net building airflow, and pressure coincide? If not why? (All three should either be positive or negative) | SF1 HAD TO BE TURNED OFF DUE TO FAN GRINDING BADLY. |

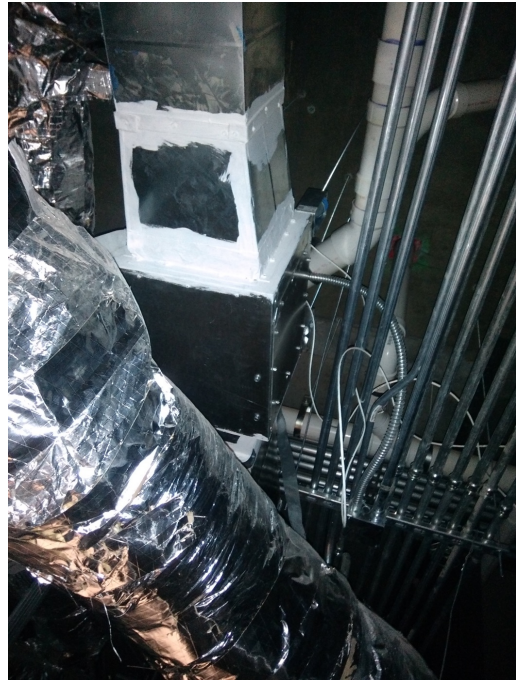
Notes: [1] SGRD2 IS DUCTED INTO THE SF1 DUCT, SHOULD BE DUCTED INTO FCU1 SUPPLY DUCT UNABLE TO BALANCE GRILL TILL THIS IS RESOLVED. SEE PIC [2] EMS COMFORT CONTROLS DO NOT HAVE CONTROLS OVER OA DAMPERS UNABLE TO SET DAMPER POSITIONS UNTIL CONTROLS ISSUE IS RESOLVED. OA DAMPER IS NOT WIRED. [3] UNABLE TO ACCESS AND TAKE RLV

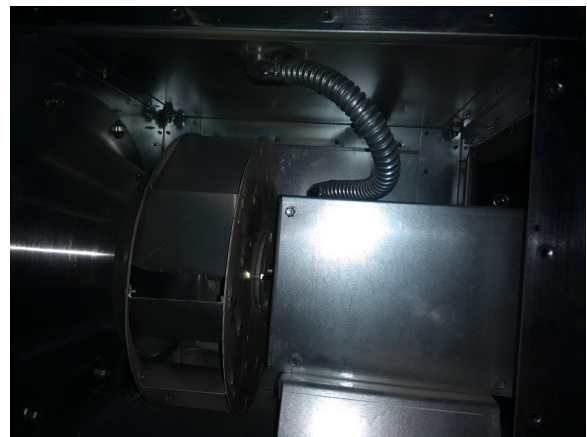
# FCU4

Notes: [1] FCU4 FAN IS RUNNING IN HIGH SPEED. TO PLACE FAN INTO HIGH-SPEED WIRE TAPES WERE ADJUSTED VIA CARRIER TECH SUPPORT OVER THE PHONE AND EMS PLACED UNIT INTO COOLING MODE. UNIT TOTAL IS LOW OF DESIGN CFM. [2] NO SAFE PLACE TO TAKE A VOLT READING [3] SF1 FAN WHEEL WAS GRINDING BADLY, FAN WAS SHUT OFF TO PREVENT DAMAGE. EMS DOES NOT HAVE CONTROL OF SF1 OR OA DAMPER POSITIONS.
