**Report: TAB REPORT**  
**Function: Test, Adjust, & Balance**  
**Date: 01/19/2026**  
**Completed By: National TAB**

**PROJECT**  
**01-19-26 WHATABURGER #1648**  
**LEVELLAND, TX**

Project: 01-19-26 WHATABURGER #1648 LEVELLAND, TX

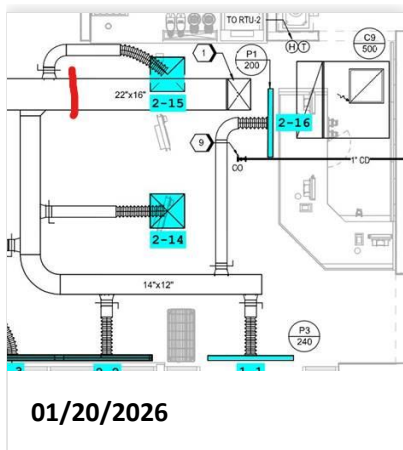
Screenshot of the GRD marked up with supply and return traverse locations for RTU-2 (Add picture here)

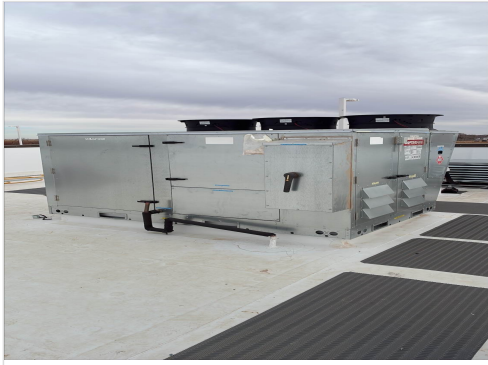
## Unit Data - PHOTO LOG

Notes:  
NO DAMPER FOR DIFFER 1

UNABLE TO RAISE DIFFUSER 11 (BACK DOOR) ANY HIGHER. DUCT AND/OR DIFFUSER MAY BE TOO SMALL TO ACHIEVE 200 CFM.

[1] NO SUITABLE/ACCESSIBLE LOCATION FOR SUPPLY OR RETURN TRAVERSE

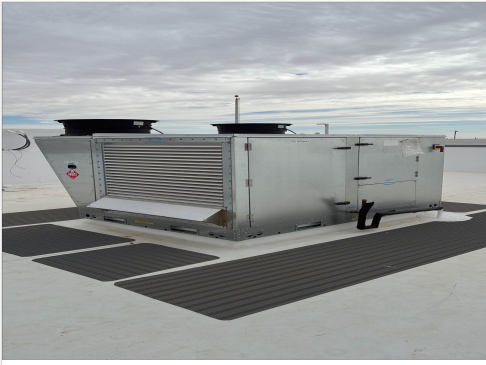
## Unit Data - PHOTO LOG

Notes:  
TOTAL SUPPLY TRAVERSE READING WAS USED WITH AVAILABLE READINGS AND DIVIDED EVENLY TO DETERMINE CFM VALUES FOR LINEAR DIFFERS 2-11 ON THE EDGE OF THE DINING ROOM.

[1] NO SUITABLE/ACCESSIBLE LOCATIONS FOR RETURN TRAVERSE.

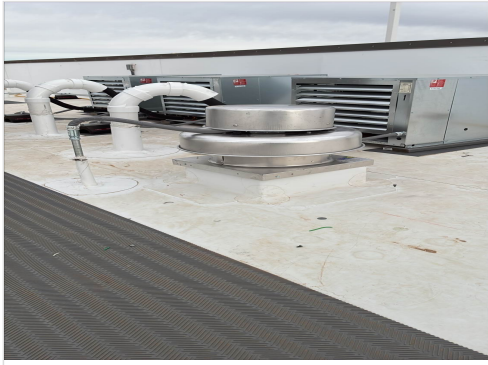
**Unit Data - PHOTO LOG**

NO DAMPER ACCESSIBLE ABOVE RESTROOM CEILINGS. SYSTEM BALANED SUCH THAT BOTH DIFFUSERS AT LEAST REACH DESIGN

**Issue Name :** RESTROOM EXHAUST DAMPERS INACCESSIBLE  
**Description :** DAMPERS FOR BOPTH RESTROOM EXHAUST DAMPERS ARE TOO FAR BEHIND THE DRY WALL CEILING TO BE REACHED. FAN SPEED WAS RAISED UNTIL BOTH WERE AT LEAST IN LOW TOLERANCE OF DESIGN.  
**Created By :** National TAB                      **Assigned To :** National TAB - Dan Hertenstein  
**Status :** Open  
**Priority :** Low                                      **Asset Tag :** EF1  
**Originated Date :** 01/29/2026 - Zack Osborne - National TAB

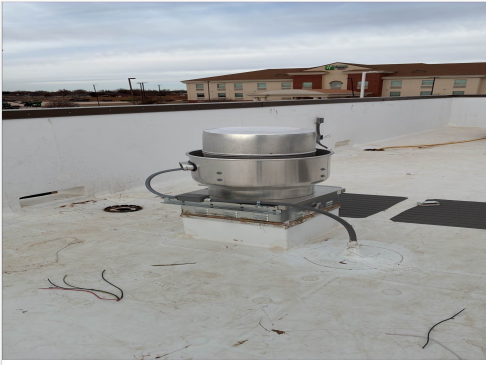
## Unit Data - PHOTO LOG

KEF2 UNABLE TO LEAN FULLY BACK DUE TO CONDUIT BEING TOO SHORT
