**Report: TAB Report**  
**Function: Test, Adjust, & Balance**  
**Date: 10/16/2024**  
**Completed By: National TAB**

**PROJECT**  
**10-14-24 WAWA #5805 MOBILE, AL**

Project: 10-14-24 WAWA #5805 MOBILE, AL

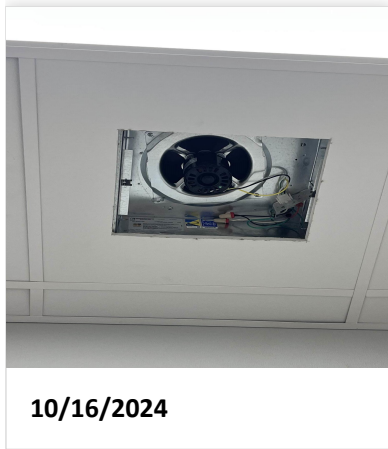
**Issue Name :** EF-3 is missing grille  
**Description :** Unable to locate grille for EF-3. Recommended to install grille once found.  
**Created By :** National TAB                      **Assigned To :** National TAB - Ian Fuller  
**Status :** Open  
**Priority :** High                                      **Asset Tag :**  
**Originated Date :** 10/16/2024 - Ian Fuller - National TAB

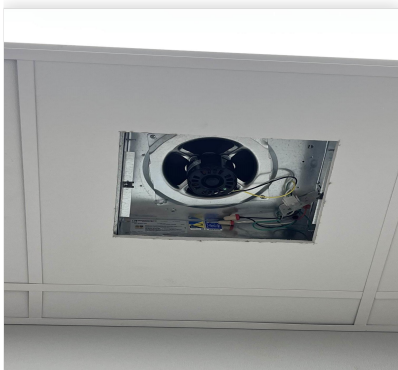
EF-3

Notes:  
GRILLE FACE MISSING
