**Report: FINAL TAB REPORT**  
**Function: Test, Adjust, & Balance**  
**Date: 10/10/2022**

## 10-03 FAMILY DOLLAR - LEWISPORT, KY

Project: 10-03 FAMILY DOLLAR - LEWISPORT, KY

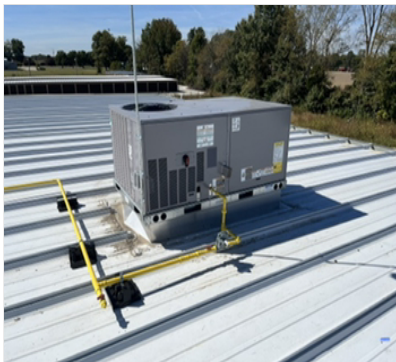
RTU-1

Unit Data		
	Design	Actual
MFG	CARRIER	CARRIER
Serial Num	-	2222C09381
Model Num	HC	48GCEM05A2M5A6W1F0
Type	RTU	RTU
Configuration	VERTICAL	VERTICAL
Num OA Filters 1	-	1
OA Filter Size 1	-	30X16
Num Final Filter 1	-	2
Final Filter Size 1	-	16X24X2

Test Data		
	Design	Actual
SF CFM	1400	1443
SF RPM	-	7.89V
RA CFM	1250	1286
OA CFM	150	157
RL Voltage	-	216.2
RL Amperage	-	5.46
SF Rotation	-	CORRECT
RA Damper Position	-	MECHANICAL LINKAGE
Min OA Damper Position	-	3.15V
Min OA Damper Type	-	ECONOMIZER
OA Enthalpy Setpt	-	ES5

Performance Data		
	Design	Actual
MA Plenum SP	-	-0.49"
Fan Suction SP	-	-0.68"
Fan Discharge SP	-	0.23"
Total ESP	1.00"	0.72"
Fan Total SP	-	0.91

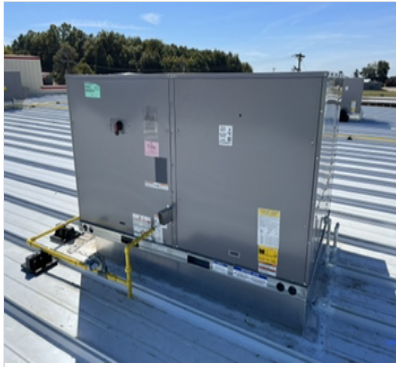
RTU-2

Unit Data		
	Design	Actual
MFG	CARRIER	CARRIER
Serial Num	-	3422P61754
Model Num	HC	48HCED08B2M5A6F1J0
Type	RTU	RTU
Configuration	VERTICAL	VERTICAL
Num OA Filters 1	-	1
OA Filter Size 1	-	36X20
Num Final Filter 1	-	4
Final Filter Size 1	-	20X20X2

Test Data		
	Design	Actual
SF CFM	2800	2953
SF RPM	-	765
RA CFM	2150	2312
OA CFM	650	641
RL Voltage	-	214/214.9/214.1
RL Amperage	-	3.65/4.32/4.16
SF Rotation	-	CCW
RA Damper Position	-	MECHANICAL LINKAGE
Min OA Damper Position	-	4.45V
Min OA Damper Type	-	ECONOMIZER
OA Enthalpy Setpt	-	ES5

Performance Data		
	Design	Actual
MA Plenum SP	-	-0.57"
Fan Suction SP	-	-0.82"
Fan Discharge SP	-	0.54"
Total ESP	1.00"	1.11"
Fan Total SP	-	1.36

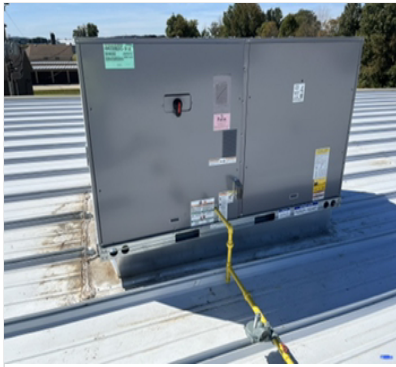
RTU-3

Unit Data		
	Design	Actual
MFG	CARRIER	CARRIER
Serial Num	-	3422P61753
Model Num	HC	48HCED08B2M5A6F1J0
Type	RTU	RTU
Configuration	VERTICAL	VERTICAL
Num OA Filters 1	-	1
OA Filter Size 1	-	36X20
Num Final Filter 1	-	4
Final Filter Size 1	-	20X20X2

Test Data		
	Design	Actual
SF CFM	2800	2987
SF RPM	-	764
RA CFM	2150	2326
OA CFM	650	661
RL Voltage	-	216/216.8/215.7
RL Amperage	-	3.99/3.47/4.49
SF Rotation	-	CCW
RA Damper Position	-	MECHANICAL LINKAGE
Min OA Damper Position	-	4.45V
Min OA Damper Type	-	ECONOMIZER
OA Enthalpy Setpt	-	ES5

Performance Data		
	Design	Actual
MA Plenum SP	-	-0.51"
Fan Suction SP	-	-0.75"
Fan Discharge SP	-	0.43"
Total ESP	1.00"	0.94"
Fan Total SP	-	1.18"

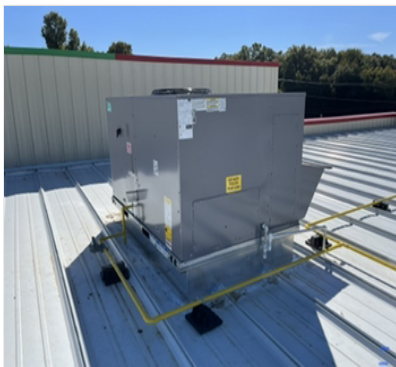
RTU-4

Unit Data		
	Design	Actual
MFG	CARRIER	CARRIER
Serial Num	-	2222P76406
Model Num	HC	48HCED11B2M5A6F1J0
Type	RTU	RTU
Configuration	VERTICAL	VERTICAL
Num OA Filters 1	-	1
OA Filter Size 1	-	36X20
Num Final Filter 1	-	4
Final Filter Size 1	-	20X20X2

Test Data		
	Design	Actual
SF CFM	3500	3728
SF RPM	-	868
RA CFM	2735	2964
OA CFM	775	764
RL Voltage	-	215.4/216.3/215.0
RL Amperage	-	4.99/5.62/6.09
SF Rotation	-	CCW
RA Damper Position	-	MECHANICAL LINKAGW
Min OA Damper Position	-	4.35V
Min OA Damper Type	-	ECONOMIZER
OA Enthalpy Setpt	-	ES5

Performance Data		
	Design	Actual
MA Plenum SP	-	-.71"
Fan Suction SP	-	-1.02"
Fan Discharge SP	-	0.36"
Total ESP	1.00"	1.07"
Fan Total SP	-	1.43"

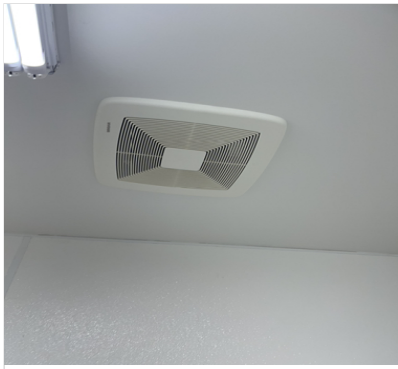
EF-1

Unit Data		
	Design	Actual
<b>MFG</b>	GREENHECK	BROAN
<b>Model Num</b>	SP-B110	LP-80B
<b>Serial Num</b>	-	12H05C1
<b>Type</b>	CEILING	CEILING
<b>Configuration</b>	VERTICAL	HORIZONTAL

Test Data		
	Design	Actual
<b>CFM</b>	75	78
<b>Fan RPM</b>	-	735
<b>Fan Rotation</b>	-	CW
<b>Motor RPM</b>	-	735
<b>System SetPt</b>	-	FULL SPEED
<b>RL Voltage</b>	-	122.1
<b>RL Amperage</b>	-	0.17
<b>Total ESP</b>	0.25"	NA
<b>Fan Inlet SP</b>	-	NA
<b>Fan Discharge SP</b>	-	NA

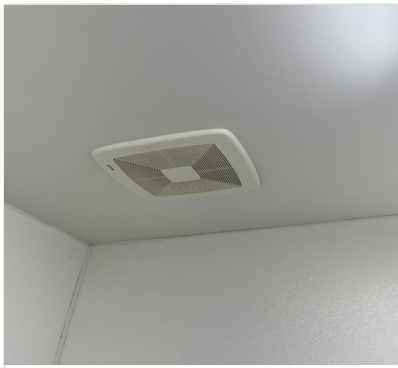
EF-2

Unit Data		
	Design	Actual
MFG	GREENHECK	GREENHECK
Model Num	SP-B110	SP-B110
Serial Num	-	12HO2C1
Type	CEILING	CEILING
Configuration	VERTICAL	HORIZONTAL

Test Data		
	Design	Actual
CFM	75	77
Fan RPM	-	735
Fan Rotation	-	CW
Motor RPM	-	735
System SetPt	-	FULL SPEED
RL Voltage	-	121.4
RL Amperage	-	0.17
Total ESP	0.25"	NA
Fan Inlet SP	-	NA
Fan Discharge SP	-	NA
