**Report: TAB REPORT**  
**Function: Test, Adjust, & Balance**  
**Date: 07/31/2024**

**07-08-24 WAWA #05803 ROBERTSDALE, AL**

21022 HWY 59 BALDWIN

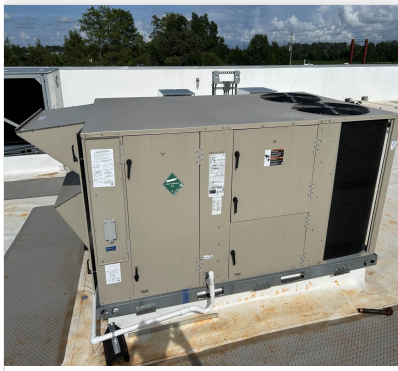
07/11/2024

<b>Is gas piping installed and valves turned on?</b>	N/A
<b>Comment:</b> Electric heating	
<b>Condensate drains are installed?</b>	Pass
<b>Comment:</b>	
<b>Unit free of noticeable noise and vibration</b>	Pass
<b>Comment:</b>	
<b>Final outside air damper position is marked with permanent marker?</b>	Pass
<b>Comment:</b>	
<b>No alarms present?</b>	Pass
<b>Comment:</b>	
<b>Any noticeable duct leakage?</b>	Pass
<b>Comment:</b>	
<b>Total supply and OA flows are balanced within +/-5% and supply &amp; return diffusers within +/-10%?</b>	Fail
<b>Comment:</b> Diffuser 1-3 is at 77% design flow. All other supply diffusers, OA flows, and totals are balanced within tolerance.	
<b>IN TEST MODE, TEST THE FOLLOWING:</b>	
<b>Cooling mode is operational? Record EAT/LAT for each unit:</b>	Pass
<b>Comment:</b> RTU 1: DAT=65°F, RAT=74°F RTU 2: DAT=66°F, RAT=75°F RTU 3: DAT=64°F, RAT=75°F	
<b>Heating mode is operational? Record EAT/LAT for each unit:</b>	Pass

<b>Comment:</b> RTU 1: DAT=79°F, RAT=76°F RTU 2: N/A RTU 3: DAT=80°F, RAT=77°F	
<b>Dehumidification mode is operational? (Feel dehumidification coil with your hand. Is it hot?) Record EAT/LAT for each unit:</b>	Pass

**Comment:**

RTU 1: DAT=75°F, RAT=74°F RTU 2: DAT=79°F, RAT=77°F RTU 3: DAT=74°F, RAT=76°F

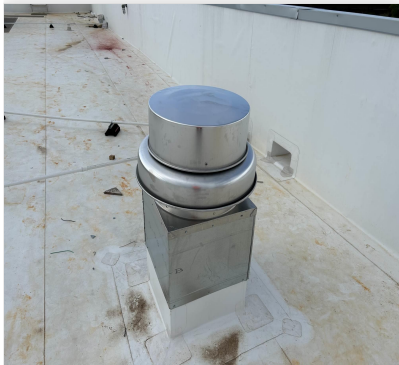
EF-1 is above full load amps at all speeds. Required speed for design flow is marked on the speed controller.

**Issue Name :** EF-1 Over Amps  
**Description :** The motor for EF-1 is overramping at all speeds. At design flow, motor is at 4.3 amps. Recommend inspecting motor for coil damage or other issues. Fan was switched off after balancing and the required speed was marked on the speed controller.  
**Created By :** National TAB                      **Assigned To :** National TAB - Brianna Biggs  
**Status :** Open  
**Priority :** High                                      **Asset Tag :** EF1  
**Originated Date :** 07/11/2024 - Mark Johnson - National TAB

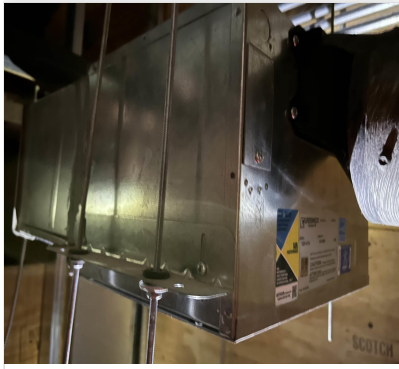
Bathroom exhaust grilles are at -50% (women's), +30% (men's stall), and -28% (men's urinal). EF-2 is at +70% exhaust flow at minimum speed.
