National TAB
1329 E. KEMPER ROAD
SUITE 4210
CINCINNATI, OH 45246

Report: TAB REPORT
Function: Test, Adjust, & Balance
Date: 07/31/2024

07-08-24 WAWA #05803 ROBERTSDALE, AL

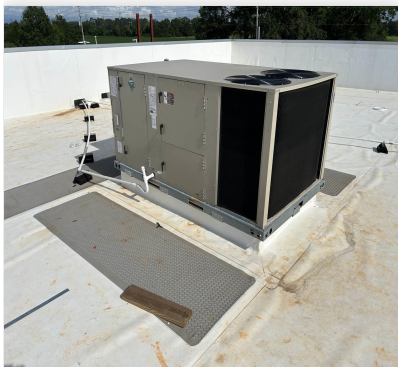
RTU-2

Test Data		
	Design	Actual
SF CFM	4000	4147
RA CFM	3350	3478
OA CFM	650	669
RL Voltage	-	211/212/212
RL Amperage	-	5.5/5.5/5.6
SF System SetPt	-	82%
RA Damper Position	-	75%
RA Damper Type	-	ECONOMIZER
OA Damper Position	-	25%
OA Damper Type	-	ECONOMIZER

Performance Data		
	Design	Actual
MA Plenum SP	-	-1.27"
Fan Suction SP	-	-1.66"
Fan Discharge SP	-	0.55"
Total ESP	0.5"	1.82"
Fan Total SP	-	2.21"

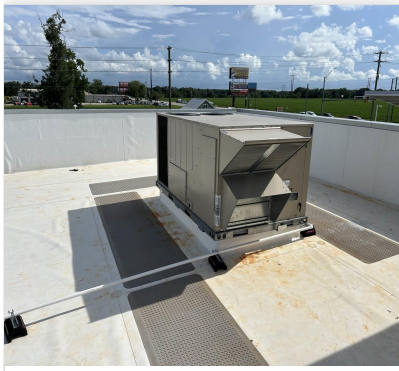
RTU-3

Test Data		
	Design	Actual
SF CFM	3000	3131
RA CFM	2610	2730
OA CFM	390	401
RL Voltage	-	211/212/212
RL Amperage	-	2.9/3.0/3.0
SF System SetPt	-	65%
RA Damper Position	-	77%
RA Damper Type	-	ECONOMIZER
OA Damper Position	-	23%
OA Damper Type	-	ECONOMIZER

Performance Data		
	Design	Actual
MA Plenum SP	-	-0.75"
Fan Suction SP	-	-1.02"
Fan Discharge SP	-	0.46"
Total ESP	0.5"	1.21"
Fan Total SP	-	1.48"
