**Report: TAB REPORT**  
**Function: Test, Adjust, & Balance**  
**Date: 07/31/2024**  
**Completed By: National TAB**

**10-14-24 WAWA #05803 ROBERTSDALE, AL**

21022 HWY 59 BALDWIN

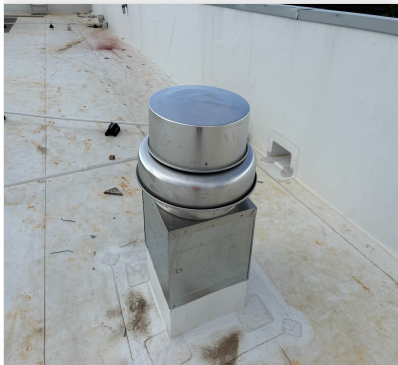
**Issue Name :** EF-1 Over Amps  
**Description :** The motor for EF-1 is overramping at all speeds. At design flow, motor is at 4.3 amps. Recommend inspecting motor for coil damage or other issues. Fan was switched off after balancing and the required speed was marked on the speed controller.  
**Created By :** National TAB                      **Assigned To :** National TAB - Brianna Biggs  
**Status :** Closed  
**Priority :** High                                      **Asset Tag :** EF1  
**Originated Date :** 07/11/2024 - Mark Johnson - National TAB

EF-1 is above full load amps at all speeds. Required speed for design flow is marked on the speed controller.

- **10/17/2024 National TAB - Ian Fuller**
  - ISSUE HAS BEEN RESOLVED MOTOR IS NOW READING AT 3 AMPS AT DESIGN AIR FLOW.
