Report: TAB Report

Function: Test, Adjust, & Balance

Date: 09/30/2025

09-29-25 WAWA #5444 ORLANDO, FL

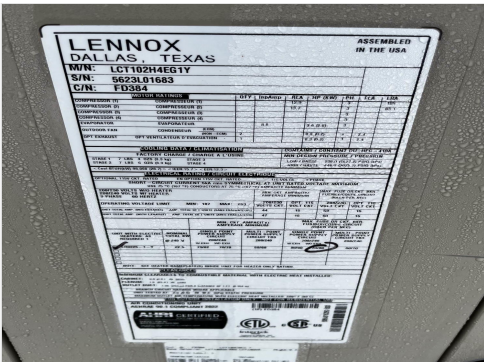
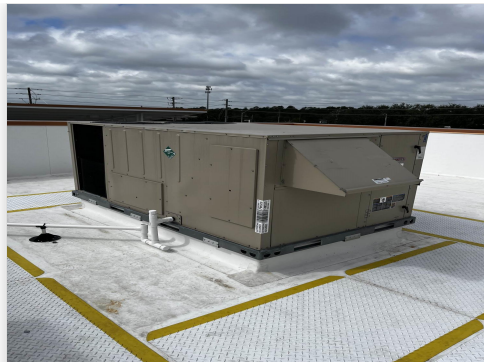
Unit Data - PHOTO LOG

Unit Data		
	Design	Actual
MFG	LENNOX	LENNOX
Serial Num	-	5623L01683
Model Num	LCT102H4E	LCT102H4EG1Y
Type	RTU	RTU
Configuration	VERTICAL	VERTICAL
Num OA Filters 1	-	1
OA Filter Size 1	-	23.25"x14.25"
Num Final Filter 1	-	4
Final Filter Size 1	-	20"x25"x2"

Test Data		
	Design	Actual
SF CFM	3400	3408
SF RPM	-	1298
RA CFM	2900	2929
OA CFM	500	479
RL Voltage	-	210/211/212
RL Amperage	-	2.43/2.56/2.56
SF System SetPt	-	59%
OA Damper Position	-	45%
OA Damper Type	-	MOTORIZED DAMPER

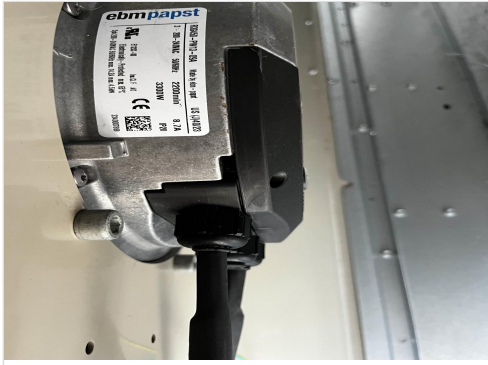
Motor Data - PHOTO LOG

Motor Data		
	Design	Actual
Motor MFG	-	EBMPAPST
Frame	-	NL
Horsepower	3.75	3.7
Motor Rpm	-	2200
Phase	3	3
Rated Voltage	208	200-240VAC
Rated Amperage	-	8.8
Service Factor	-	NL

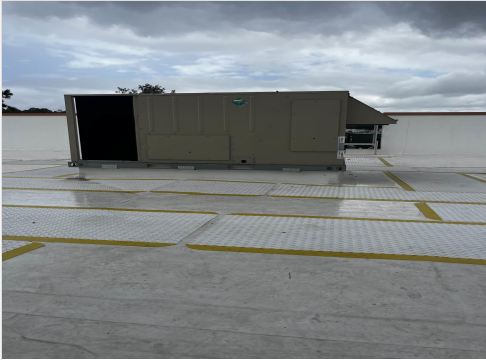
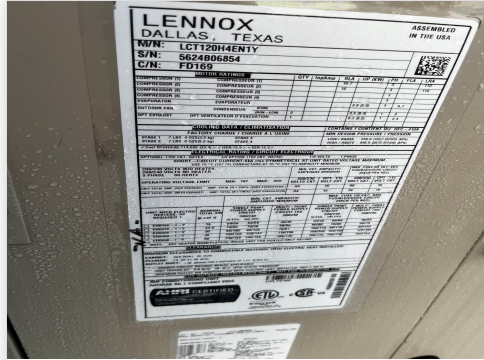
Unit Data - PHOTO LOG

Unit Data		
	Design	Actual
MFG	LENNOX	LENNOX
Serial Num	-	5624B06854
Model Num	LCT120H4E	LCT120H4EN1Y
Type	RTU	RTU
Configuration	VERTICAL	VERTICAL
Num OA Filters 1	-	1
OA Filter Size 1	-	23.25"x14.25"
Num Final Filter 1	-	4
Final Filter Size 1	-	20"x25"x2"

Test Data		
	Design	Actual
SF CFM	4000	3984
SF RPM	-	1540
RA CFM	3225	3223
OA CFM	775	761
RL Voltage	-	210/211/212
RL Amperage	-	3.5/3.6/3.6
SF System SetPt	-	70%
OA Damper Position	-	50%
OA Damper Type	-	MOTORIZED DAMPER

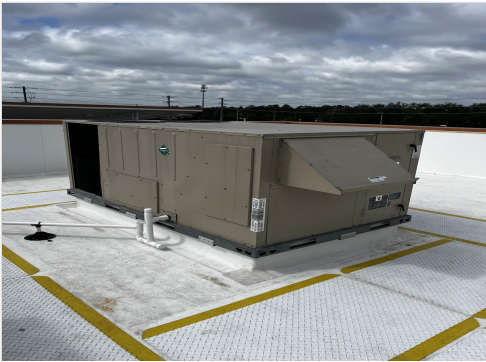
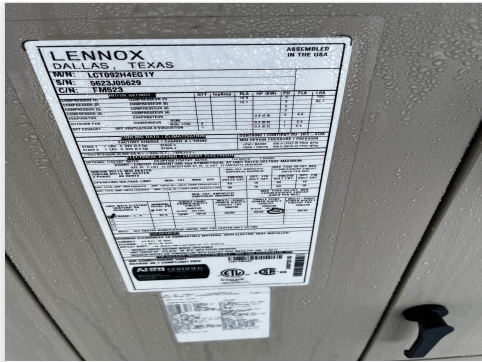
Unit Data - PHOTO LOG

Unit Data		
	Design	Actual
MFG	LENNOX	LENNOX
Serial Num	-	5623J05629
Model Num	LCT092H4E	LCT092H4EG1Y
Type	RTU	RTU
Configuration	VERTICAL	VERTICAL
Num OA Filters 1	-	1
OA Filter Size 1	-	23.25"x14.25"
Num Final Filter 1	-	4
Final Filter Size 1	-	20"x25"x2"

Test Data		
	Design	Actual
SF CFM	3000	3019
SF RPM	-	1298
RA CFM	2650	2679
OA CFM	350	340
RL Voltage	-	210/211/212
RL Amperage	-	2.6/2.6/2.6
SF System SetPt	-	59%
OA Damper Position	-	30%
OA Damper Type	-	MOTORIZED DAMPER

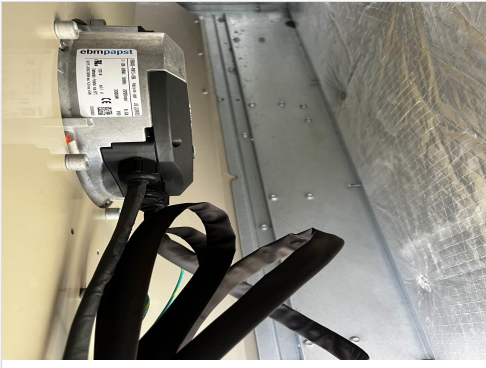
Motor Data - PHOTO LOG

Motor Data		
	Design	Actual
Motor MFG	-	EBMPAPST
Frame	-	NL
Horsepower	3.75	3.8
Motor Rpm	-	2200
Phase	3	3
Rated Voltage	208	200-240
Rated Amperage	-	8.7
Service Factor	-	NL

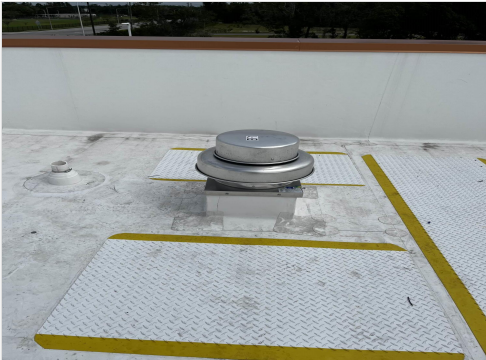
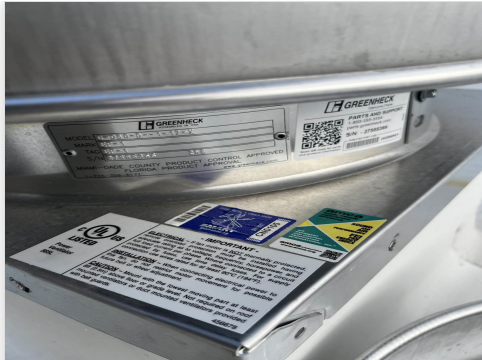
Unit Data - PHOTO LOG

Unit Data		
	Design	Actual
MFG	GREENHECK	GREENHECK
Model Num	G-080	G-080-D— 1-17
Serial Num	-	27444366
Type	DOWNBLAST	CENTRIFUGAL
Configuration	VERTICAL	DOWNBLAST

Test Data		
	Design	Actual
CFM	325	319
Fan RPM	1576	1550
Fan Rotation	-	CORRECT
RL Voltage	-	120
RL Amperage	-	1.1
Total ESP	-	0.30"
Fan Inlet SP	-	-0.30"
Fan Discharge SP	-	ATM

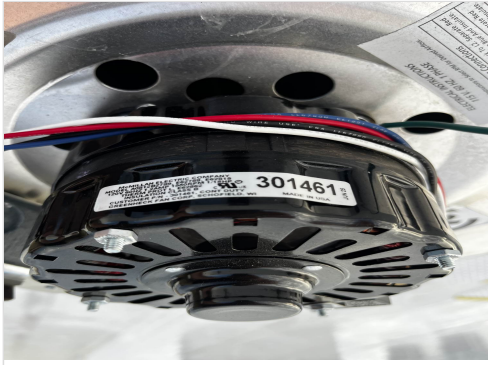
Motor Data - PHOTO LOG

Motor Data		
	Design	Actual
Motor MFG	-	MCMILLIAN
Frame	-	NL
Horsepower	0.1	1/15
Motor Rpm	-	1550
Phase	1	1
Voltage (rated)	120	120
Amperage (rated)	-	1.2
Service Factor	-	NL

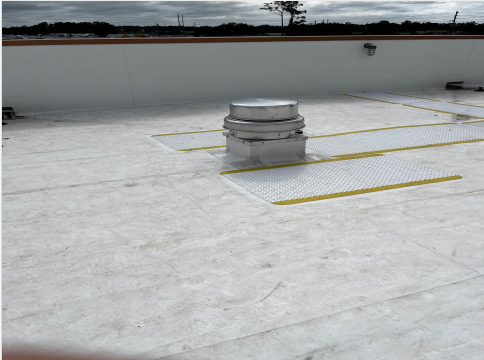
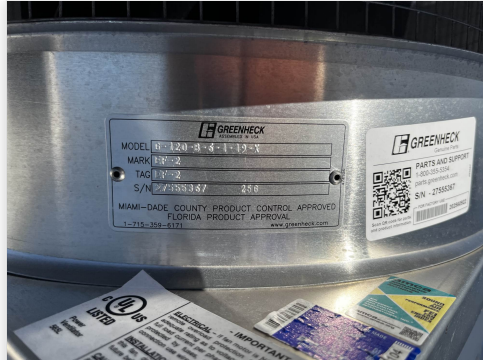
Unit Data - PHOTO LOG

Unit Data		
	Design	Actual
MFG	GREENHECK	GREENHECK
Model Num	G-120	G-120-8-6-19-X
Serial Num	-	27555367
Type	DOWNBLAST	CENTRIFUGAL
Configuration	VERTICAL	DOWNBLAST

Test Data		
	Design	Actual
CFM	800	838
Fan RPM	1390	1456
Fan Rotation	-	CORRECT
Motor RPM	-	DIRECT DRIVE
RL Amperage	-	[1]
Total ESP	-	0.38"
Fan Inlet SP	-	-0.38"
Fan Discharge SP	-	ATM

[1]Unable to gather volts/amps from light switch style disconnect.

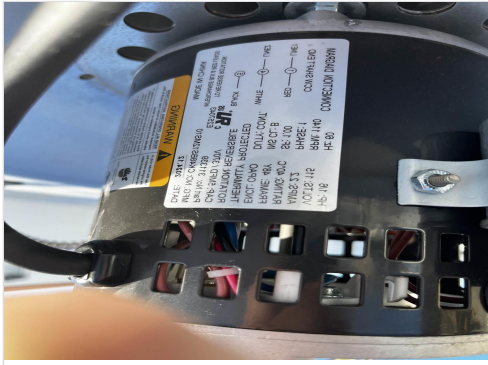
Motor Data - PHOTO LOG

Motor Data		
	Design	Actual
Motor MFG	-	NL
Frame	-	NL
Horsepower	0.5	1/6
Motor Rpm	-	1140
Phase	1	1
Voltage (rated)	120	120
Amperage (rated)	-	2.2
Service Factor	-	1.00
