Report: TAB REPORT
Function: Test, Adjust, & Balance
Date: 10/09/2024
Completed By: National TAB

PROJECT
09-30-24 SWEETGREEN HINGHAM , MA
(TAB, IAQ)

Project: 09-30-24 SWEETGREEN HINGHAM , MA (TAB, IAQ)

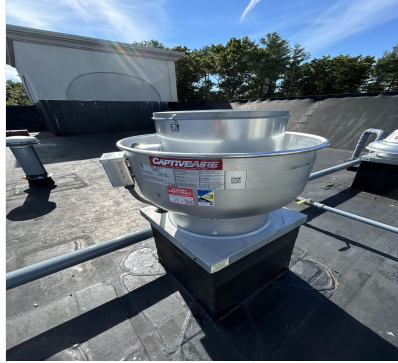
10/01/2024

Identify where the exhaust air is discharged and take pictures

Roof mounted Fan
