Report: Issue Data
Function: Test, Adjust, & Balance
Date: 02/05/2026
Completed By: National TAB

PROJECT
CW 9111 - OCC Expansion (Coppell, TX)

Project: CW 9111 - OCC Expansion (Coppell, TX)

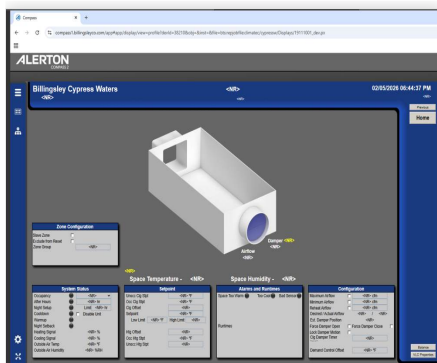
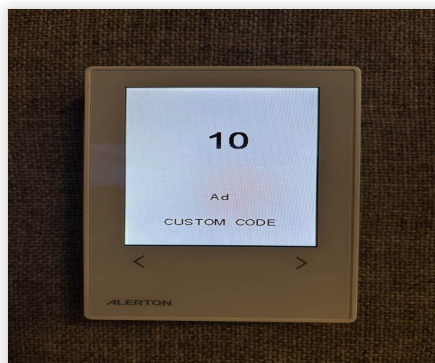
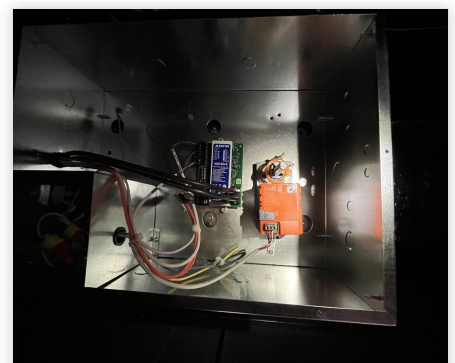
Issue Name : VAV5-10 NOT OPERATIONAL (VAV-2A-10 CONTROLS LABEL)
Description : Unit is assumed to be VAV-2A-10 via controls graphics based on thermostat address. Unit is showing "NR" on controls graphics, unable to calibrate or balance this unit due to that issue.

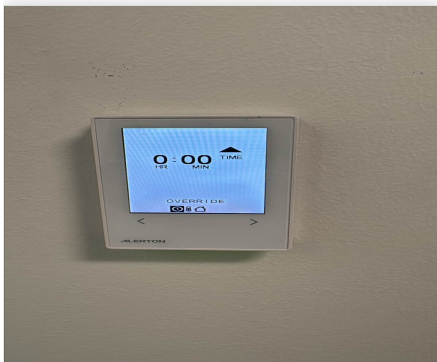
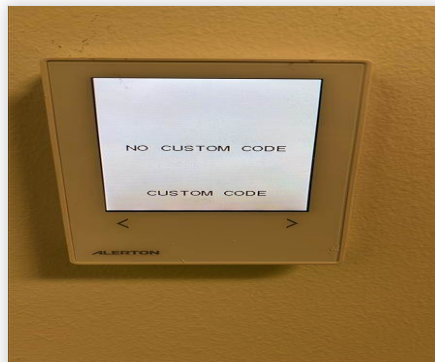
Issue Name : VAV5-3 NOT OPERATIONAL (VAV-2A-30 Controls Label)
Description : Unit is not operational. Unit is showing "NR" on controls graphics. Unit is wired for power and power switch is in ON position. Scrolling through thermostat options and it shows "No Custom Codes". This leads to believe this box has not been programmed. Box shows up on controls graphics matrix for the floor but not on the floor layout page.
