Report: TAB REPORT
Function: Test, Adjust, & Balance
Date: 7/22/2022

PROJECT
SWEETGREEN #MIA - MIAMI, FL (THE
FALLS) TAB, IAQ

US Construction Corp.
6355 NORTHWEST 36TH ST
SUITE 608
MIAMI, FL

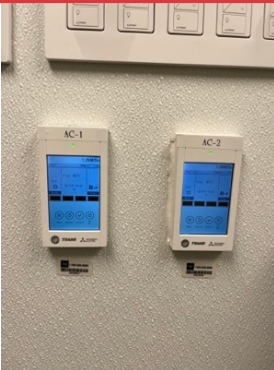
AC 2 & 3 LOW FLOW. FANS IN HIGH SPEED.

NTAB discussed with Trane tech and MC regarding AC 2 and 3 being low on flow. NTAB was informed that the only speed control is via the thermostats, in which both units are currently in high speed. Store was comfortable in current conditions, but it is still suggested to increase fan speeds if at all possible on these units.
