Report: TAB REPORT
Function: Test, Adjust, & Balance
Date: 7/22/2022

PROJECT
SWEETGREEN #MIA - MIAMI, FL (THE
FALLS) TAB, IAQ

Project: SWEETGREEN #MIA - MIAMI, FL (THE FALLS) TAB, IAQ

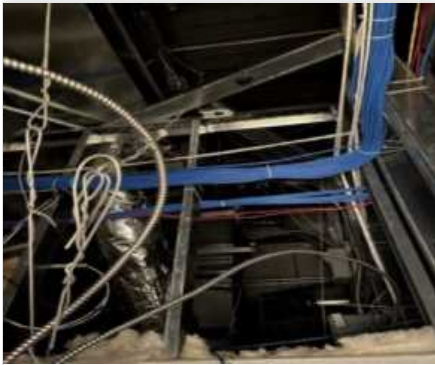
Screenshot_2022_07_22_13403
5.png

Issue Name : AC Units are Inaccessible

Description : AC units are 5 feet above ceiling and are inaccessible for access. Unable to gather all data off the equipment or troubleshoot units with low flow. May also present issues for maintenance.

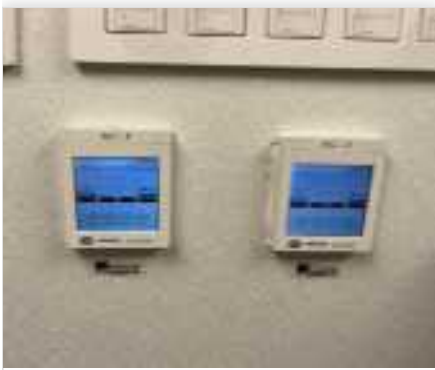
Screenshot_2022_07_22_13412
4.png

Issue Name : AC-2 and 3 are low on flow

Description : AC-2 airflow is 71% of design and AC-3 is 64% of design. Spoke with Trane technician and they said that the unit fan speed is balanced via the thermostat and currently set for the highest speed. Unable to access equipment to troubleshoot further. Recommend verifying that the filters are clean and speaking with Trane for further guidance.

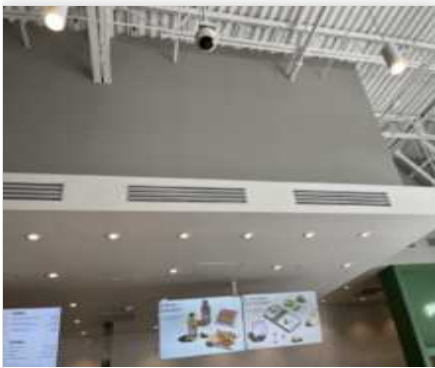
Screenshot_2022_07_22_13392
3.png

Issue Name : AC5 dampers are not accessible.
Description : Balanced the equipment to total flow but unable to balance the individual air devices.
Created By : National TAB **Assigned To :** National TAB - Will Turnbough
Status : Open
Originated Date : 07/22/2022 - Will Turnbough - National TAB

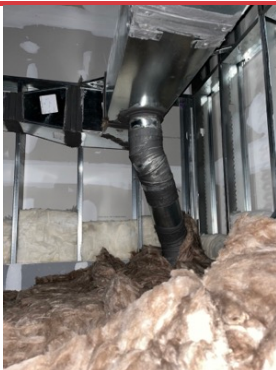
RESTROOM EXHAUST DAMPERS NOT PRESENT

Fan total balanced.
