HVAC Findings

Prepared by David Annan

Sep 17, 2024

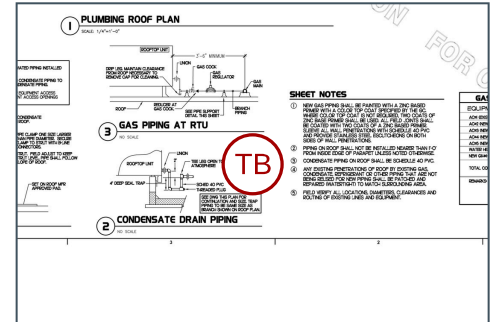
Sheet
P3.1

All condensates drains for the RTUs only have 1 union. The plans show 2 unions between the P-traps. Refer to page P3.1 "detail 2" for specifications.

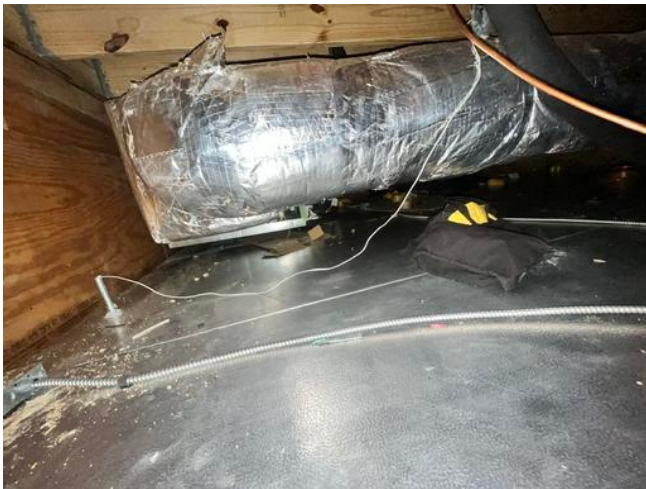
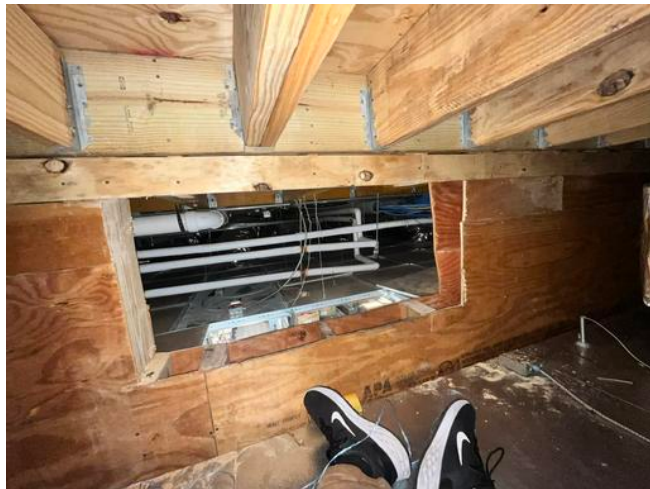
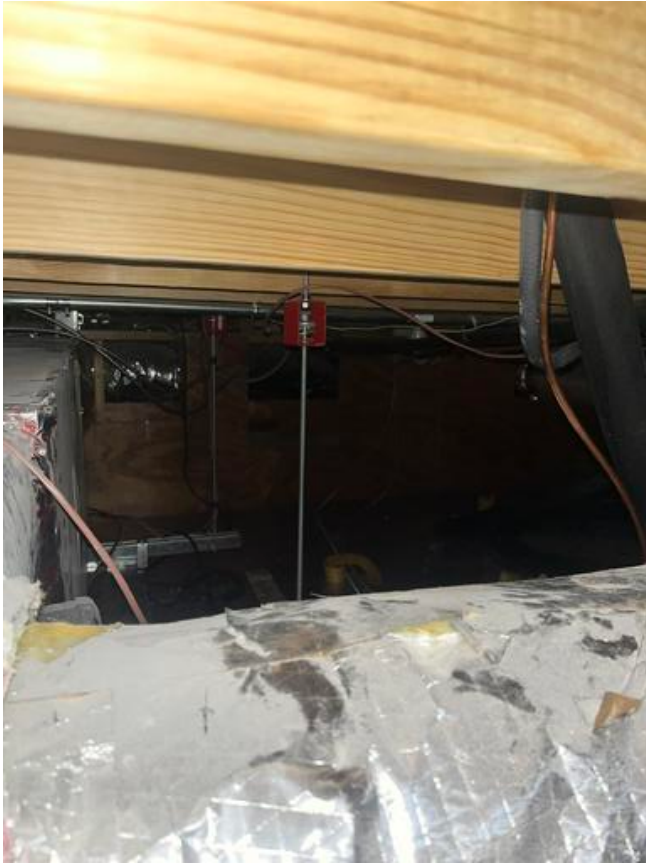
AHU-1, which is located above the walk in cooler has limited access to the units due to the tight space between the cooler and ceiling.
