HVAC Findings

Prepared by David Annan

Sep 17, 2024

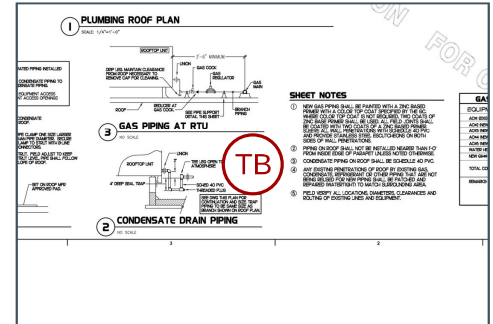
Sheet
P3.1

All condensate drains for the RTUs only have 1 union. The plans show 2 unions between the P-traps. Refer to page P3.1 "detail 2" for specifications.

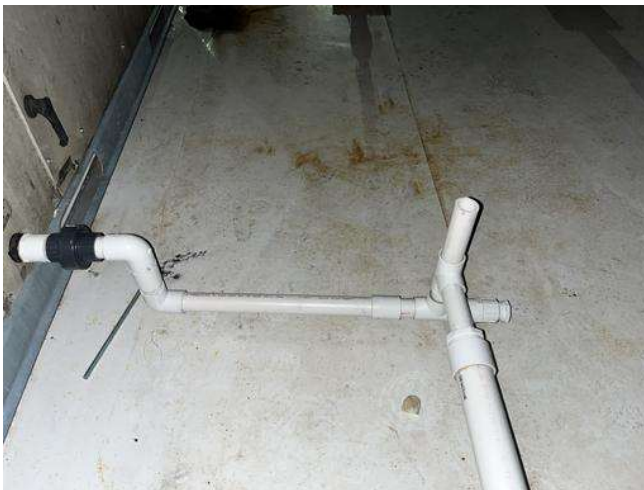
IMG_5354
David Annan
Sep 17, 2024 5:26 PM

#302 Condensate drains only have 1 union

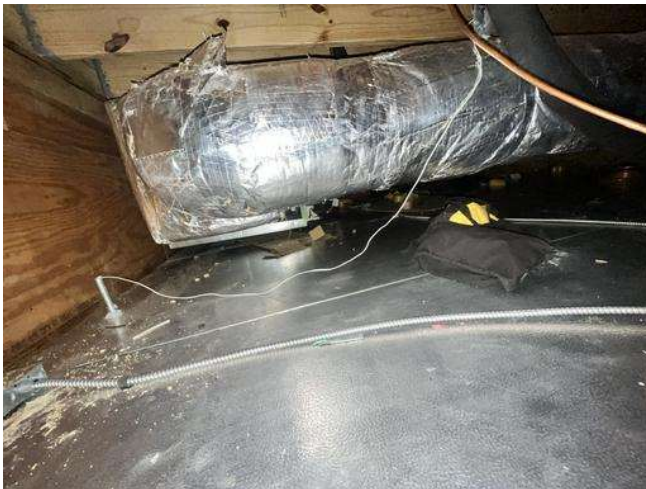
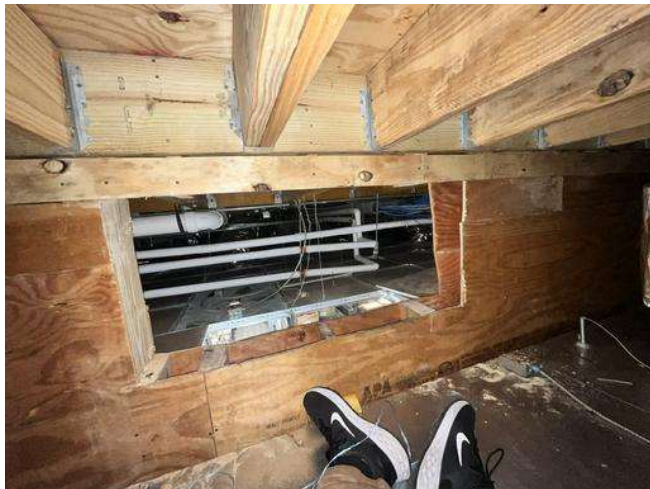
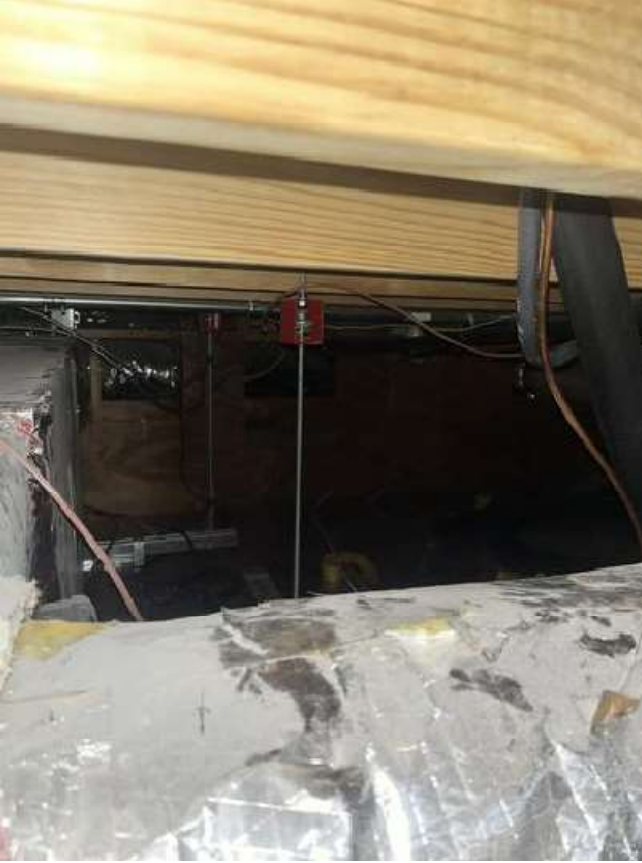
#301 Info Only: AHU-1 has limited access

AHU-1, which is located above the walk in cooler has limited access to the units due to the tight space between the cooler and ceiling.
